ASSESSMENT OF EVAPORATOR TUBES CORROSION IN LOW-EMISSION STEAM BOILERS

Degradation examinations of outer surface of low-emission steam boiler evaporator tubes are presented in the paper. Metallographic evaluation of scale morphology, its micro sites chemical composition analysis and distribution of elements on cross sections have been performed. Water-wall tubes were exposed in steam boiler for up to two years period. Common tubes made of 16Mo3 steel suffered sulfide and molten salts corrosions. Thermal sprayed tubes with the single layer of 70%Ni 30%Cr alloy show better corrosion resistance, but become also susceptible to sulfide corrosion due to presence of internal voids and cracks. Double layer Al₂O₃/Ni-30Cr coatings withstand corrosion attack for more than one year operation, then failed due to internal heterogeneity and cracks generation.

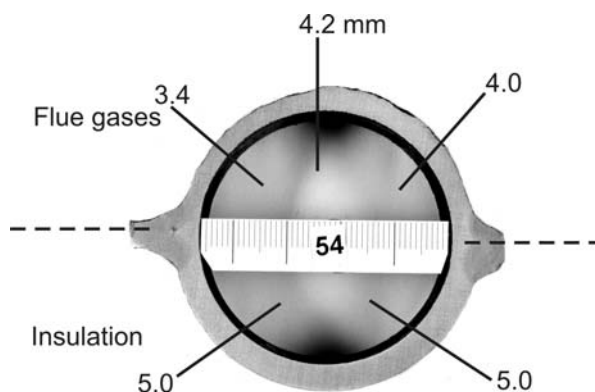
The appearance of cross section of uncoated tube after one year exploitation is shown in Fig.1. Thickness of tube wall was measured at the points indicated in Fig. 1.

The reduction in wall thickness was not uniform on tube perimeter. The front side of the tube facing the combustion radiant heat suffered the worst metal wastage and reaches 68% of its nominal value. Reductions in wall thickness from insulation side of tubes were not recorded.

Fig. 1. Cross section of $\varnothing 57 \times 5.0$ mm evaporator tube after one year exploitation in low-emission boiler

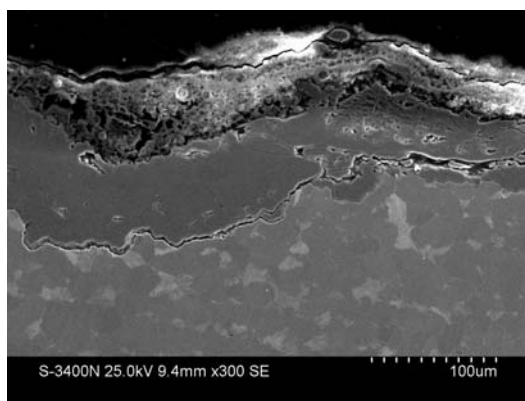
Investigations show that both mechanisms of corrosion (sulfide corrosion and molten salts corrosion) took place on uncoated tubes. Chemical analysis indicated presence of alkaline metals (K, Na, Mg, Ca) and iron sulfides (FeS , FeS_2) in the scales. The morphology of scales consisted of two layers. External, which is porous and weakly connected with the tube surface, and internal, which is dense and adherent to the base metal (Fig. 2 and 3). In these two layers the bands rich in sulphur were detected. Concentration of sulphur in these bands reached 22 wt.%. Outer layers consisted of iron, oxygen, sulphur, silicon, aluminium and alkaline metals. Inner layer consisted mainly of iron oxides and iron sulfides. The traces of chlorine were also detected mainly at the interface of inner layer and base material.

Fig. 2. Cross section of $\varnothing 57 \times 5.0$ mm evaporator tube after one year exploitation. Deposits on the fireside of the tube
