# Corrosion of evaporator tubes in low emission steam boilers

**Purpose:** of this paper is to reveal the mechanisms of corrosion processes of outer surfaces of low-emission steam boiler evaporator tubes. Examinations were performed to find the reasons of different corrosion susceptibility of tubes situated at combustion chamber on various levels.

**Design/methodology/approach:** Examinations were conducted on several segments of  $\varnothing 57 \times 5.0$  mm evaporator tubes made of 16M (16Mo3) steel grade. Segments were taken from level of 10 meters and 18 meters from the chamber bottom of low-emission coal fired steam boiler after two years operation. Microstructure degradation of base material was estimated. Metallographic evaluation of scale morphology, its micro sites chemical composition analysis and distribution of elements on cross sections have been performed.

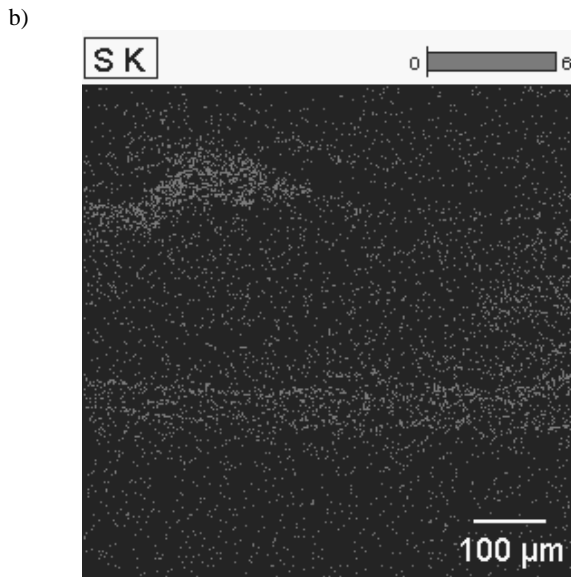
Fig. 11. Cross section of fire-side face of water wall tube subjected to reducing combustion conditions a) optical micrograph b) x-ray elemental dot map for sulphur

Dot maps confirmed observation on inhomogeneous of scale composition. Fig. 11 shows bands enriched in sulfur situated at external layer of the scale and second band close to the interface of base material and scale.
