# Corrosion of evaporator tubes in low emission steam boilers

**Purpose:** of this paper is to reveal the mechanisms of corrosion processes of outer surfaces of low-emission steam boiler evaporator tubes. Examinations were performed to find the reasons of different corrosion susceptibility of tubes situated at combustion chamber on various levels.

**Design/methodology/approach:** Examinations were conducted on several segments of  $\varnothing 57 \times 5.0$  mm evaporator tubes made of 16M (16Mo3) steel grade. Segments were taken from level of 10 meters and 18 meters from the chamber bottom of low-emission coal fired steam boiler after two years operation. Microstructure degradation of base material was estimated. Metallographic evaluation of scale morphology, its micro sites chemical composition analysis and distribution of elements on cross sections have been performed.

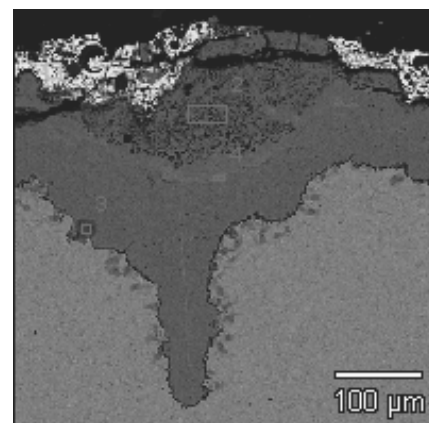
Detailed observations revealed pits and deep penetrations into the tube wall on the samples taken from the level of 18 m (Fig. 12). Such deep pits can form as a result of low melting ash constituent action. Local microanalyses of chemical composition (Figs. 13 and 14) indicated enriched concentrations of sulfur, chlorine and potassium close to the borderline of base material and scale.

Fig. 13. Chemical analysis of the scale at the corrosion pit (wt.%). Level - 18m, measure points indicated in micrograph

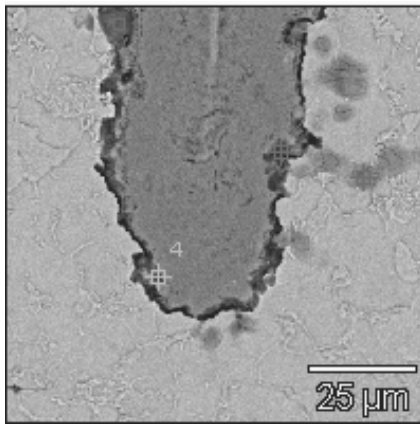
Fig. 14. Chemical analysis of the scale at the tip of corrosion pit (wt. %). Level - 18m, measure points indicated in micrograph
