## NON-DESTRUCTIVE DIAGNOSTICS OF CONCRETE CANTILEVER BEAM AND SLAB BY IMPACT ECHO METHOD

Magdalena RUCKA<sup>1</sup>, Krzysztof WILDE<sup>1,2</sup>

<sup>1</sup> Department of Structural Mechanics and Bridge Structures, Faculty of Civil and Environmental Engineering, Gdansk University of Technology

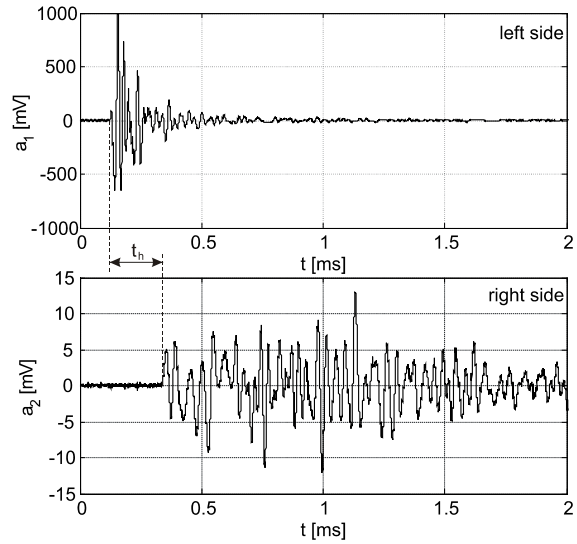
Fig. 6 shows signals registered in point no. 6 for the cantilever no. 3. The  $a_1$  signal is the acceleration measured on the left side of the cantilever, while the  $a_2$  is the acceleration measured on the right side, after passing through the structure. The time-of-flight  $t_h$  was 217.8  $\mu$ s what enabled to calculate velocity of the P-wave as 4527.09 m/s. This procedure was repeated in all selected points.

Fig. 6. Acceleration signals measured in point no. 6 for the cantilever no. 3

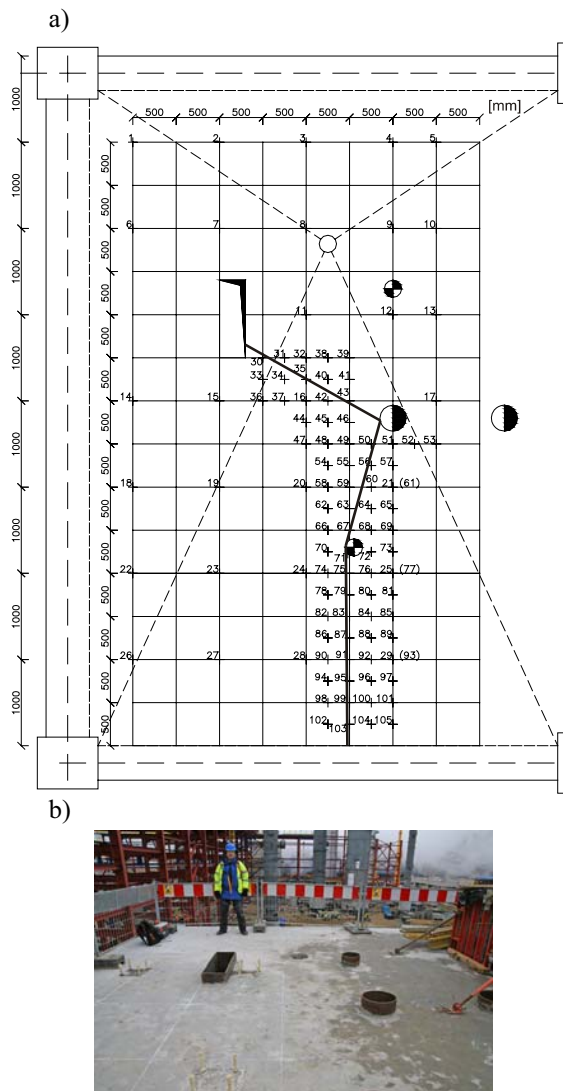
The object of the research was the concrete floor slab (Fig. 8). Due to disturbances in concrete delivery during the slab casting, the homogeneity of the concrete became in question. The non-destructive test was performed with the use of the impact-echo method to determine presence of discontinuities.

The geometry of the slab is shown in Fig. 8a. The number of measurement points was 105. They were distributed along the line of potential discontinuity, depicted as thick solid line in Fig. 8a. The hardware equipment was the same, as in the case of bridge measurements (c.f. Section 3.2). In this experiment, one-side measurement was performed, i.e. both mechanical impact and acceleration measurements were realized on the upper side of the slab only. The slab height, varied from 17 to 19 cm, was calculated in the measurement points based in known slab slopes.

Fig. 8. Concrete floor slab: a) geometry and measurement points; b) the photo
