SOME ADJUSTMENT AND EXPLOITATION PROBLEMS OF THE CONTROLLABLE PITCH PROPELLER PNEUMATIC AND HYDRAULIC CONTROL SYSTEMS

Czesław Dymarski

*Gdansk University of Technology
Faculty of Ocean Engineering and Ship Technology
11/12 G. Narutowicza Str., 80-233 Gdańsk, POLAND*

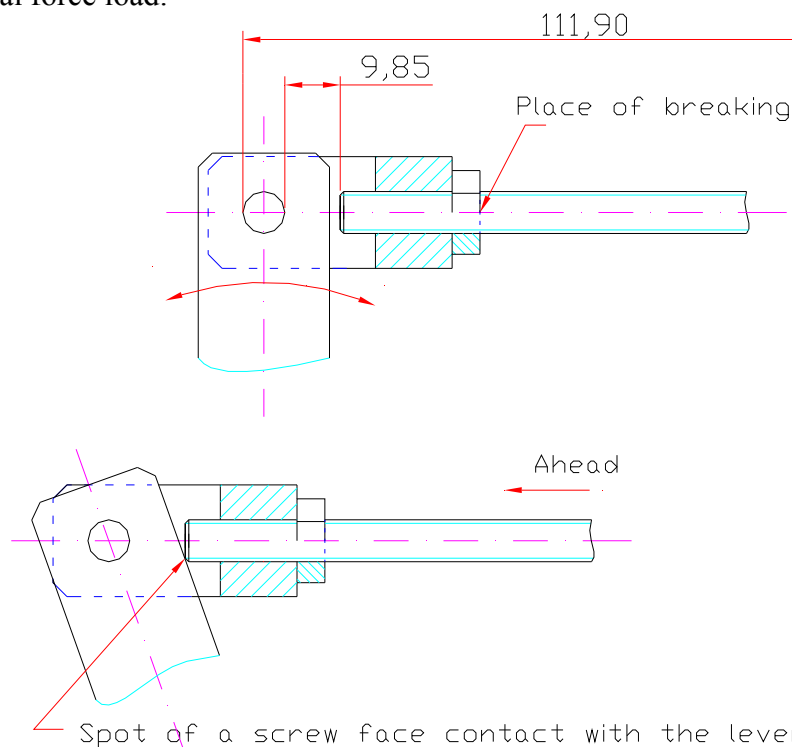
would be exactly the same as in the damaged one. Conformity of two most significant dimensions, namely a distance between outer surfaces of botch pins of connecting link and distance between the pin and face surface of the connecting link screw, which are shown on fig. 5, was checked in front of the commission.

The following tests were conducted with using the remote pneumatic control system and checking conformity of the set values with real values of the propeller pitch during a few full cycles of the pitch changing. Also this time the system worked correctly. In this situation I have decided to repeat last test changing gradually, step by step the propeller pitch and each time observing and touching the connecting link 7, gently pressing it by finger. In almost all steps the pressing connector displaced slightly crosswise in a clearance range, but just in positions “full ahead” and close to it the connector tensed and stiffened. Precise observation of this connection unit revealed a reason of this stiffness. Just in mentioned above position close to „full ahead”, a face surface of the connector link screw rested against the lever 6 in such way, as is shown on fig. 5. Because of it, a bending moment in the screw was generated. This additional bending moment load was undoubtedly many times bigger than a nominal axial force load.

Fig. 5. An articulated joint of the connecting link with the lever in “zero” and “full ahead” positions with shown two dimensions checked in front of the commission
