Operational causes of fatigue failures within passages of gas turbine engines

Zbigniew Korczewski, Assoc. Prof.
Gdansk University of Technology

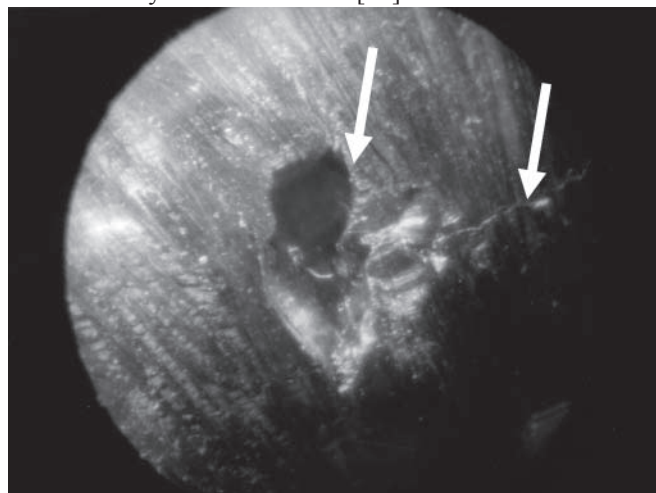
Another hazard to engine reliability, which results from rotor seizing in engine body, consists in possible cracking of the compressor body, Fig. 6. The presented failure has been identified during endoscopic examination of a GTU6a single-shaft engine (of block structure) driving ship electric generating set. Compressor's body was made of 40HNMACr-Ni low-alloy steel of a higher metallurgical purity. The situation occurred as a result of immediate switching-off the engine from operation under nominal load and passing over the cooling phase under idle running. Such decision of operators resulted from a fire observed in exhaust gas channel and entering the engine into unsteady operation range. After that the engine was dismantled and sent to its producer. Repair of the body consisted in vacuum electron-beam welding the crack.

On the basis of the character of the appeared failure of the compressor body it can be concluded that the initial cause of the crack was a material defect, e.g. presence of sulfides at place of fracture. In effect of action of dynamic loads the fatigue fracture propagating just from the edge of the material defect, was initiated. As a result of rotor seizing in the compressor body in the temperature of about 700-800 K, further propagation of the gap took place in the form of cleavage fracture. As the body was cooled more fast than the rotor the gap became separated mainly due to tensile forces (axial ones) with an influence of shear forces.

Designers of gas turbine engines take into account possible stopping the engine working under high load with passing over the cooling phase under idle-running. It is covered by manufacturer's testing program. Therefore the seizing of rotor units in engine body should not happen at all. However in the described case the engine immediate stopping was preceded by its unsteady work when a flash-back towards engine intake took place causing an inadmissible, very intensive rise of compressor material temperature much over its permissible value of 520K, determined by the manufacturer [15].

Fig. 6. Internal surface of GTU6a turbine engine compressor body, showing a fatigue fracture (acc. endoscopic examination)

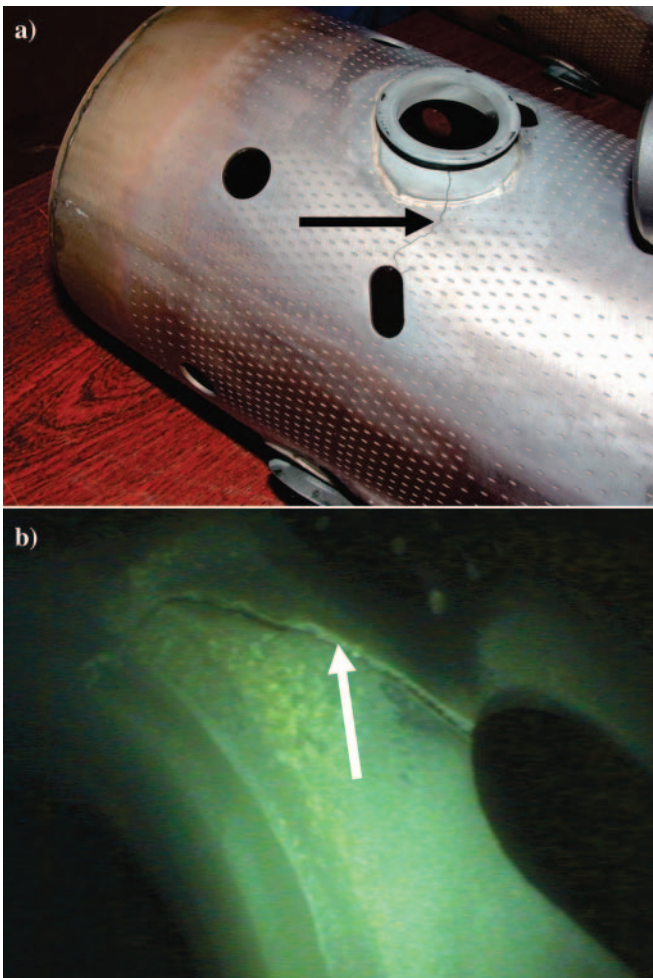
Fig. 7. Low-cycle fatigue fracture of flame tube of turbine engine combustion chamber: **a)** picture recorded just after the engine's dismantling; **b)** picture obtained by endoscopic examination

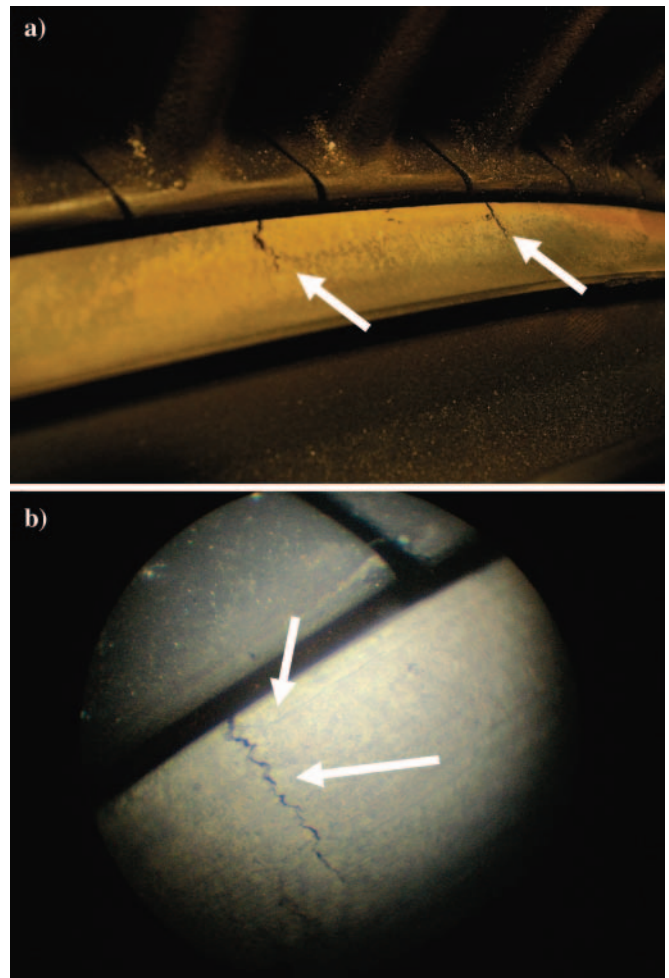
Fig. 9. Low-cycle fatigue fracture on internal body surface, under HP turbine guide vanes of a Zorya UGT3000 engine: **a)** picture recorded just after the engine's dismantling; **b)** picture obtained by endoscopic examination.

disks of rotors, in places of the greatest diameter changes, close to openings and gaps of combustion chamber flame tubes as well as in neighborhood of significant changes of profiled cross-sections of internal shell bodies, Fig. 9.
