H. Smoleńska, W. Kończewicz¹

FAILURE ANALYSIS OF THE EXHAUST VALVE FACE IN DIESEL MARINE ENGINE

The exhaust valve from marine diesel engine which was damaged after 2000 hours of service was investigated. In order to prolong the service time the valve face was clad with cobalt base alloy using laser technique. After failure microstructural and chemical analyses revealed that cladding process was conducted improperly. The chemical composition of the clad layer was far from the designed one and what more completely inhomogeneous. As a result the valve presented different properties in different regions which led to premature failure.

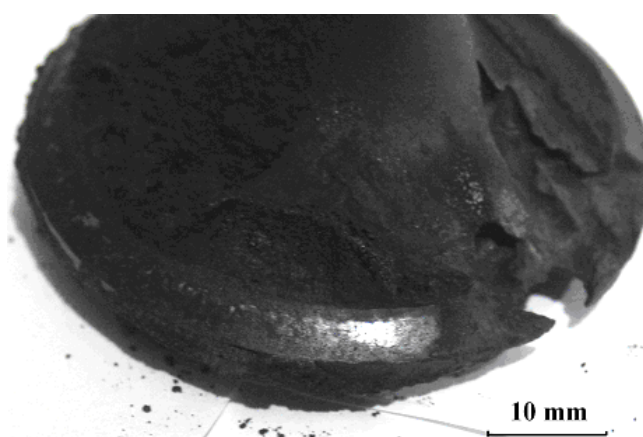
The failed valve head was presented on fig.1. The part of the face and valve disk was completely destroyed while the rest of the valve head had no visible damages. Even the valve face was still shining in the great deal.

Fig. 1. Macro photograph of the failed valve head

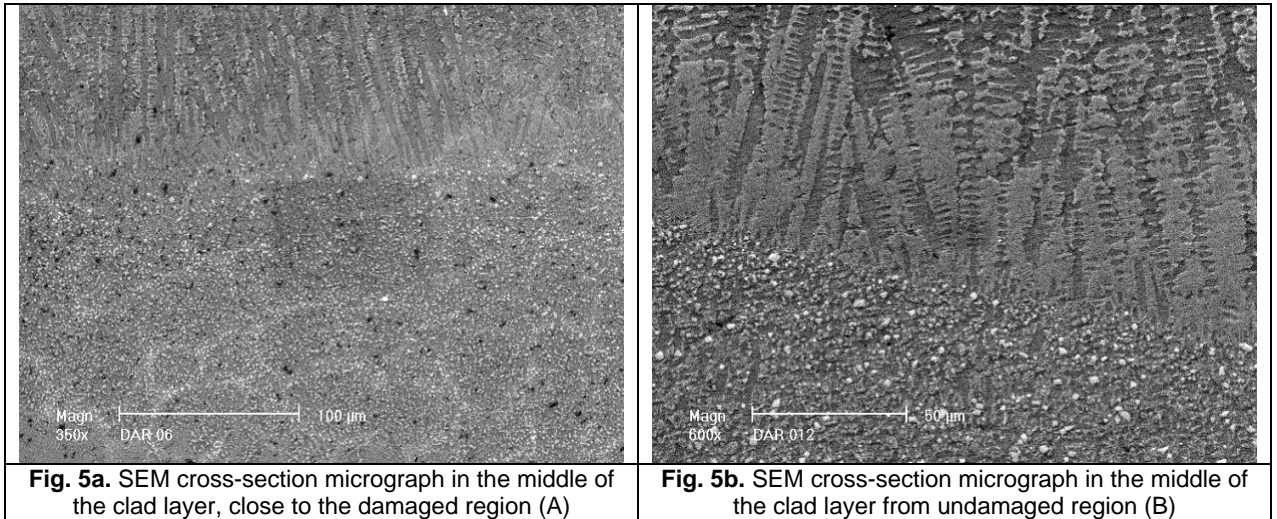
Metallurgical observation of the part of the clad situated deeper from the surface provided rather surprised picture of the microstructure. In the middle region of the clad both dendritic and globular structures are observed. Such a dual microstructure was similar for all region of the valve (Fig. 5a and 5b). Also chemical composition of these regions is different how ever for undamaged part of the valve those differences are less dramatic. Fig. 6 and 7 presents the results of the analysis.

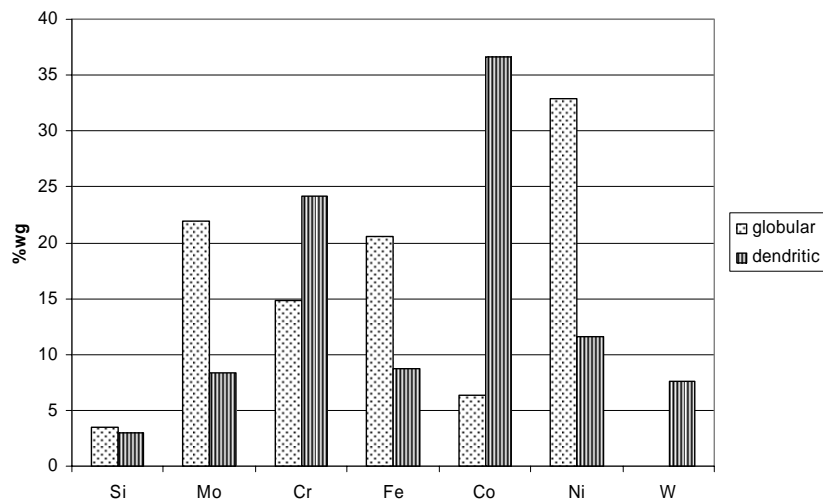
Fig. 6. Chemical analysis from the micro region situated in the middle of the clad, close to the damaged part (A) of the valve face, for globular and dendritic regions from the fig. 5a

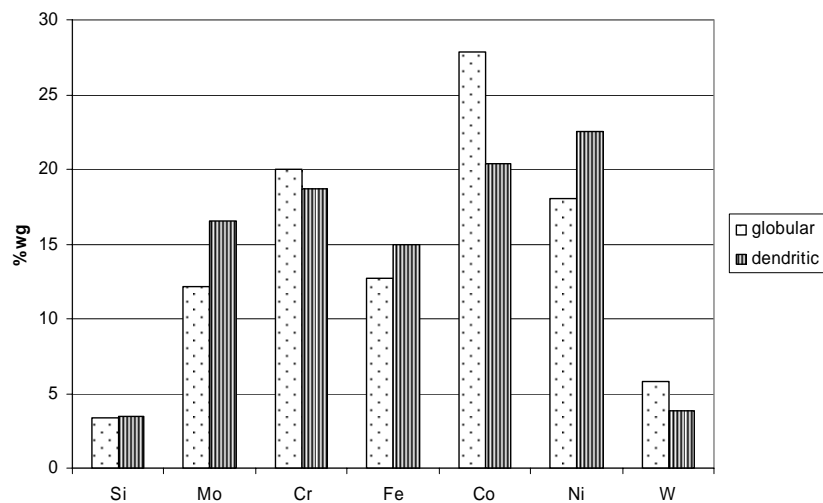
Fig. 7. Chemical analysis from the micro region situated in the middle of the clad, undamaged part (B) of the valve face for globular and dendritic regions from the fig. 5b

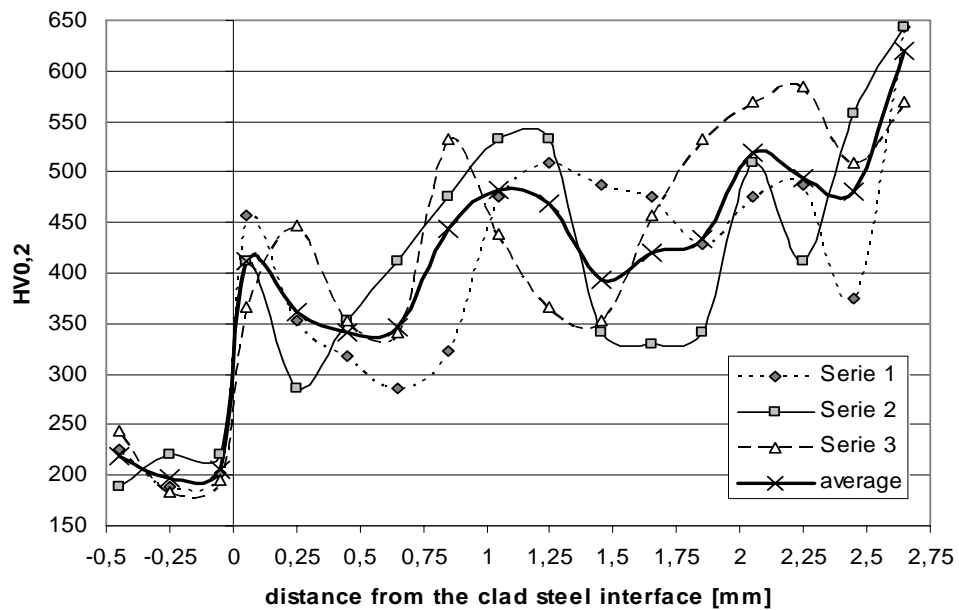
Fig. 8. Average hardness numbers for sample A (damaged region)

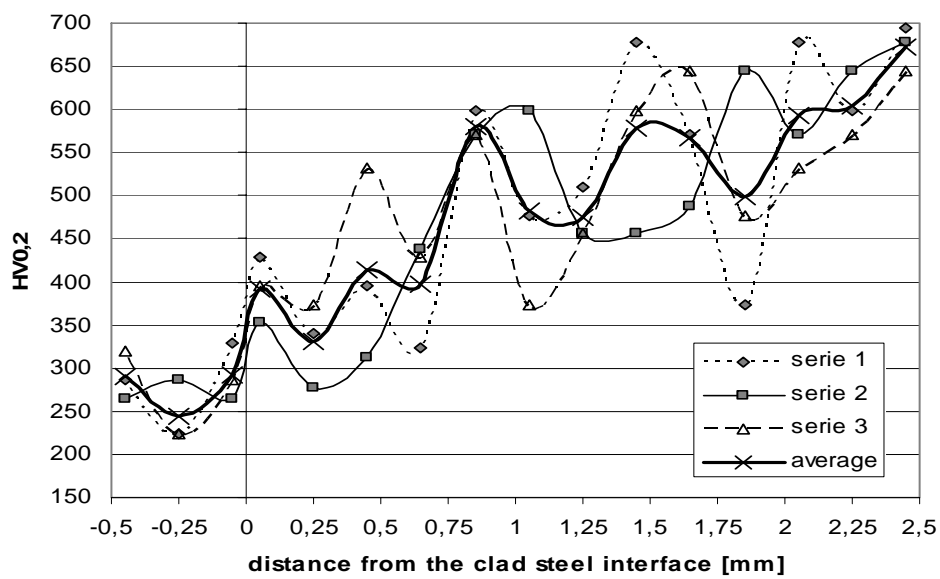
Fig. 9. Average hardness numbers in sample B (undamaged region)

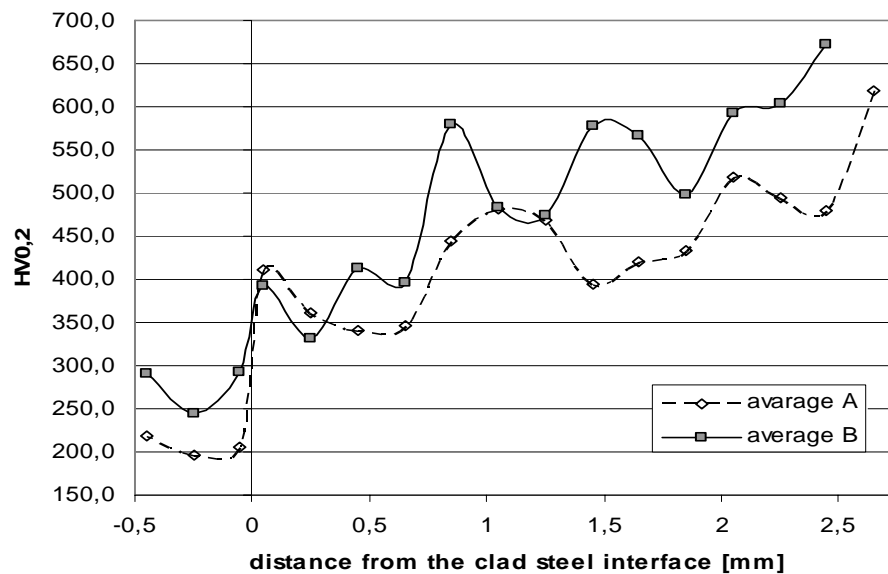
Fig. 10. Comparison of average numbers for A (damaged) and B (undamaged) region

Undamaged region presents higher hardness especially in the outer area of clad layer. It may result with the higher wear resistance and service time for this part of the valve face. However such huge differences in chemical composition, microstructure and mechanical properties are unacceptable for the safe reasons. Probably there were any disturbances during the cladding process which resulted with improper chemical composition (mixed powders) and improper microstructure (improper cladding parameters?). Generally producer did not keep regimes of the product engineering.
