H. Smoleńska, W. Kończewicz¹

FAILURE ANALYSIS OF THE EXHAUST VALVE FACE IN DIESEL MARINE ENGINE

ABSTRACT

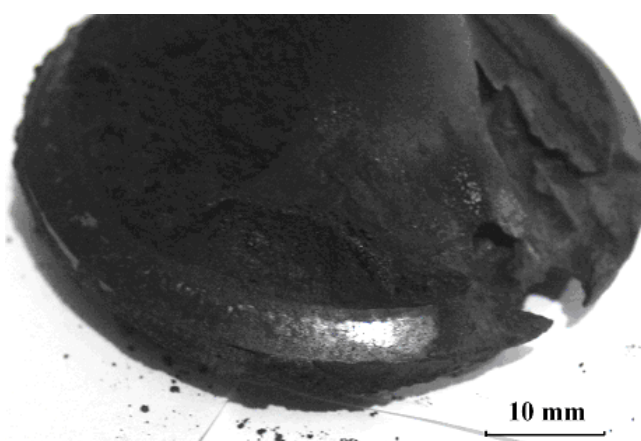
The failed valve head was presented on fig.1. The part of the face and valve disk was completely destroyed while the rest of the valve head had no visible damages. Even the valve face was still shining in the great deal.

Fig. 1. Macro photograph of the failed valve head

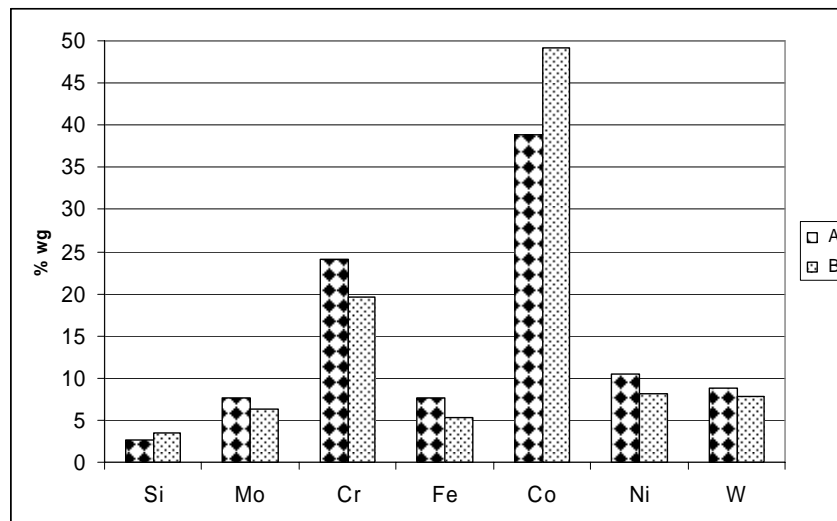
Fig. 4. Chemical analysis from the micro region situated close to the surface, on the cross-section of the clad, after service; A – close to the damaged region of the valve face, B – undamaged region of the valve face

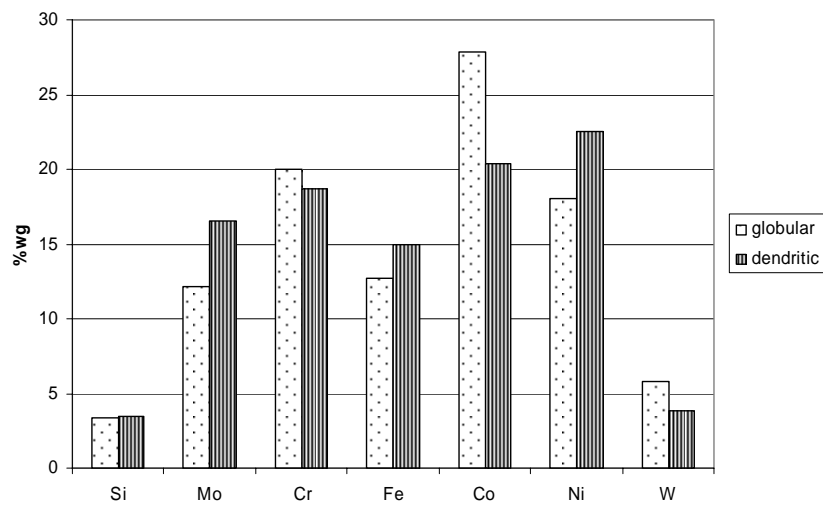
Metallurgical observation of the part of the clad situated deeper from the surface provided rather surprised picture of the microstructure. In the middle region of the clad both dendritic and globular structures are observed. Such a dual microstructure was similar for all region of the valve (Fig. 5a and 5b). Also chemical composition of these regions is different how ever for undamaged part of the valve those differences are less dramatic. Fig. 6 and 7 presents the results of the analysis.

Fig. 7. Chemical analysis from the micro region situated in the middle of the clad, undamaged part (B) of the valve face for globular and dendritic regions from the fig. 5b

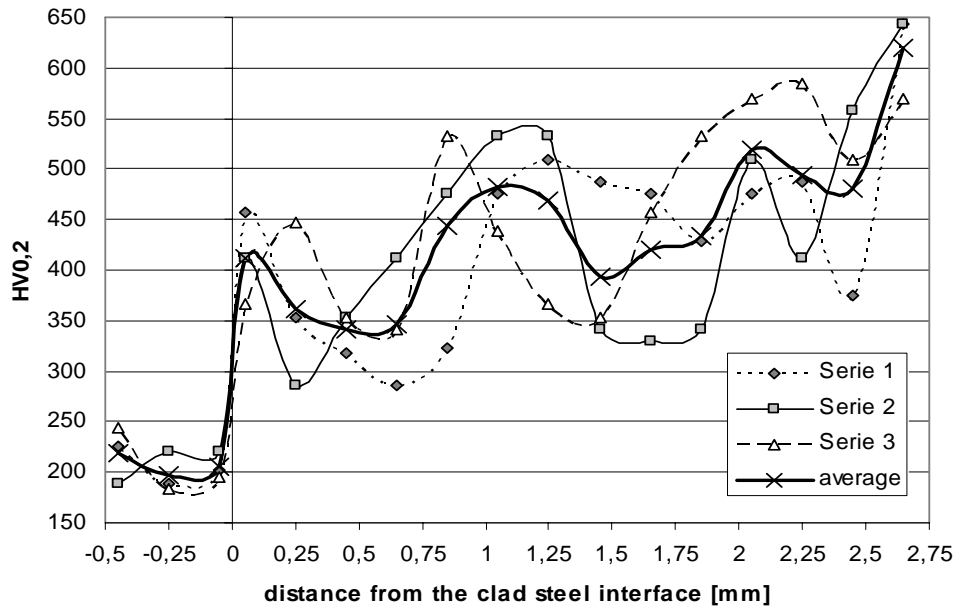
Fig. 8. Average hardness numbers for sample A (damaged region)
