J. Hucińska, G. Gajowiec

Gdansk University of Technology, Mechanical Engineering Faculty, Gdansk, Poland

ASSESSMENT OF FITNESS FOR SERVICE OF Cr-Mo STEEL TUBES IN CATALYTIC REFORMING CHARGE HEATERS

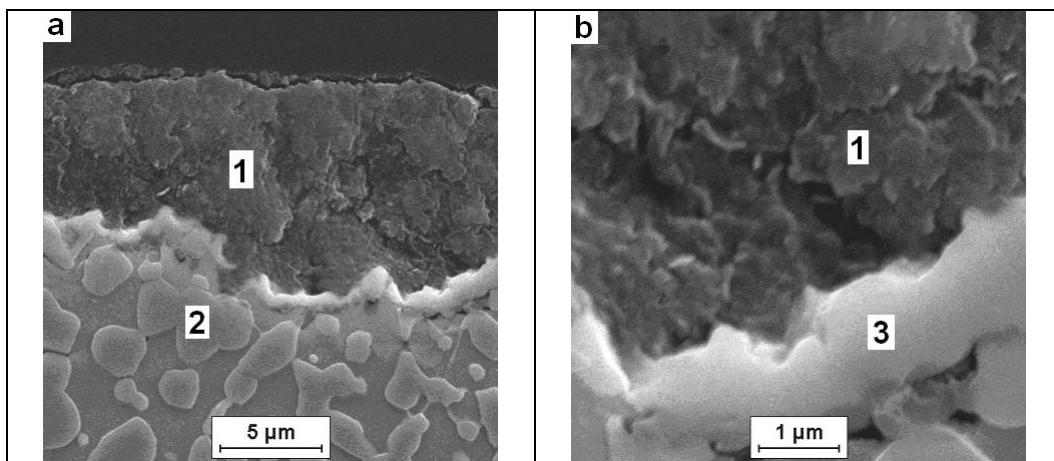
Fig. 1(a) presents a SEM micrograph of the cross section of 2.25Cr-1Mo steel sample close to the IS of the tube. The surface is rough and covered with dark compact corrosion products (1). Beneath the surface, big spheroidal and elongated carbide particles (2), uniformly distributed in the metal matrix are present. Some of the particles are linked together. Just at the surface, the carbides are so closely distributed that they form a thin not uniform layer (3). The layer reaches a thickness of about 2 μm and is ruptured in some places. At higher magnification of Fig. 1(b) some discontinuities between the layer and the underlying material can clearly be seen. It is possible to conclude that metal losses seem likely to form by separation of fragments of the subsurface layer from the substrate. The SEM/EDS analyses have revealed that the carbides within the layer and in the underlying material contain about 2-4 wt.% of chromium, 1-2 wt.% of molybdenum and 0-4 wt.% of silicon. The rest is iron. Some results of the examinations and the errors are shown in Fig. 2(a), (b).

Fig. 1(a), (b). Micrographs of the cross-section of 2.25Cr-1Mo steel tube wall close to the IS: 1 – corrosion products, 2 – big carbides in the metal matrix, 3 – a carbide layer at the surface

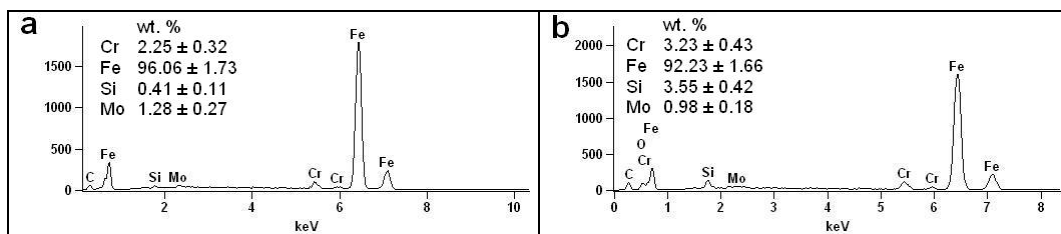
Fig. 2(a), (b). Results of SEM/EDS analyses of carbides in 2.25Cr-1Mo steel: (a) at point 2 indicated in Fig. 1(a), (b) at point 3 in Fig. 1(b)

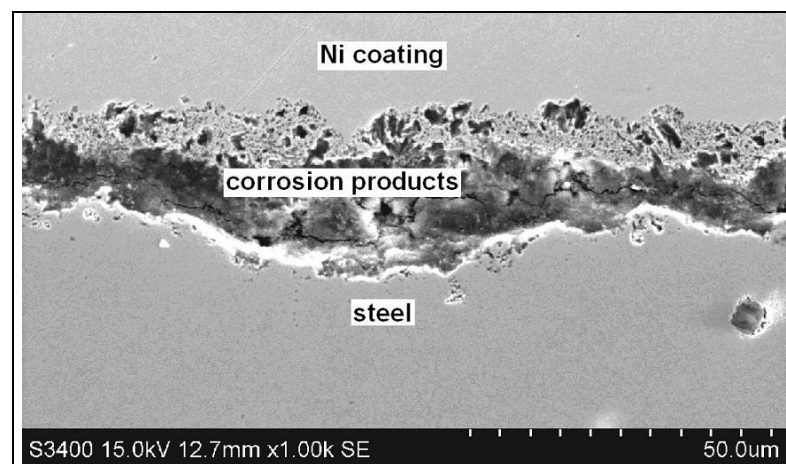
In Fig. 3 a SEM micrograph of the cross section of 9Cr-1Mo steel sample close to the IS of the tube is shown. It can be noted that the steel surface is rough, covered with fragile

and porous corrosion products, and many fine pits and fissures develop in the subsurface zone of the steel.

Fig. 3. Corrosion products on the IS of 9Cr-1Mo steel tube and a porous steel zone beneath the surface

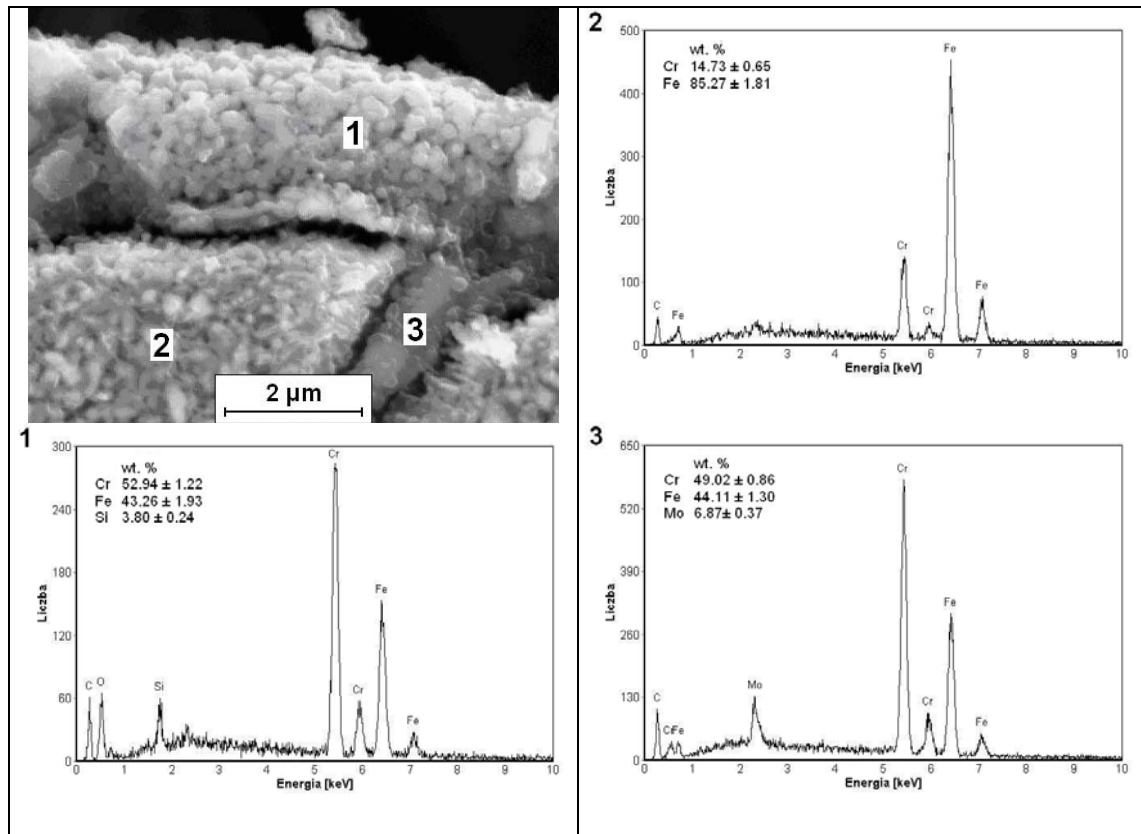
Detailed SEM examinations have revealed a complex microstructure of the subsurface steel zone. According to a micrograph in Fig. 4(a), a thin layer of about 2 μm in thickness composed of fine precipitates (1) exists just beneath the surface. There is about 50-55 wt.% of chromium and 0-4 wt.% of silicon in the layer on the average. The rest is iron. The layer is followed by a not-coherent zone containing big degraded primary carbides (2), i.e. the carbides that were present in the steel before service and underwent some unavoidable transformations. The carbides are situated in a 'matrix' composed of fine globular carbides (3), instead of alloy ferrite. The amount of the alloy elements, i.e. chromium and molybdenum in the precipitates is differentiated. Bigger primary carbides contain about 20-25 wt.% of chromium and 2-4 wt.% of molybdenum. The fine carbides which form the 'matrix' contain less of the alloy elements than the bigger primary carbides. However, the concentration of chromium and molybdenum in the 'matrix' is higher than in the alloy ferrite before service: about 14-18 wt. % and 1-3 wt.% in comparison with about 9 and 1 wt.%. Some results of the analyses are shown in Fig. 4(b). Because of the material porosity and small dimensions of the precipitates, the results refer to groups of the particles and have a comparative meaning.

Fig. 4. A micrograph of the cross-section of 9Cr-1Mo steel tube wall close to the IS and results of SEM/EDS analyses: 1 – a layer of fine carbides at the steel surface, 2 – a ‘matrix’ composed of fine carbides, 3 – degraded primary carbide

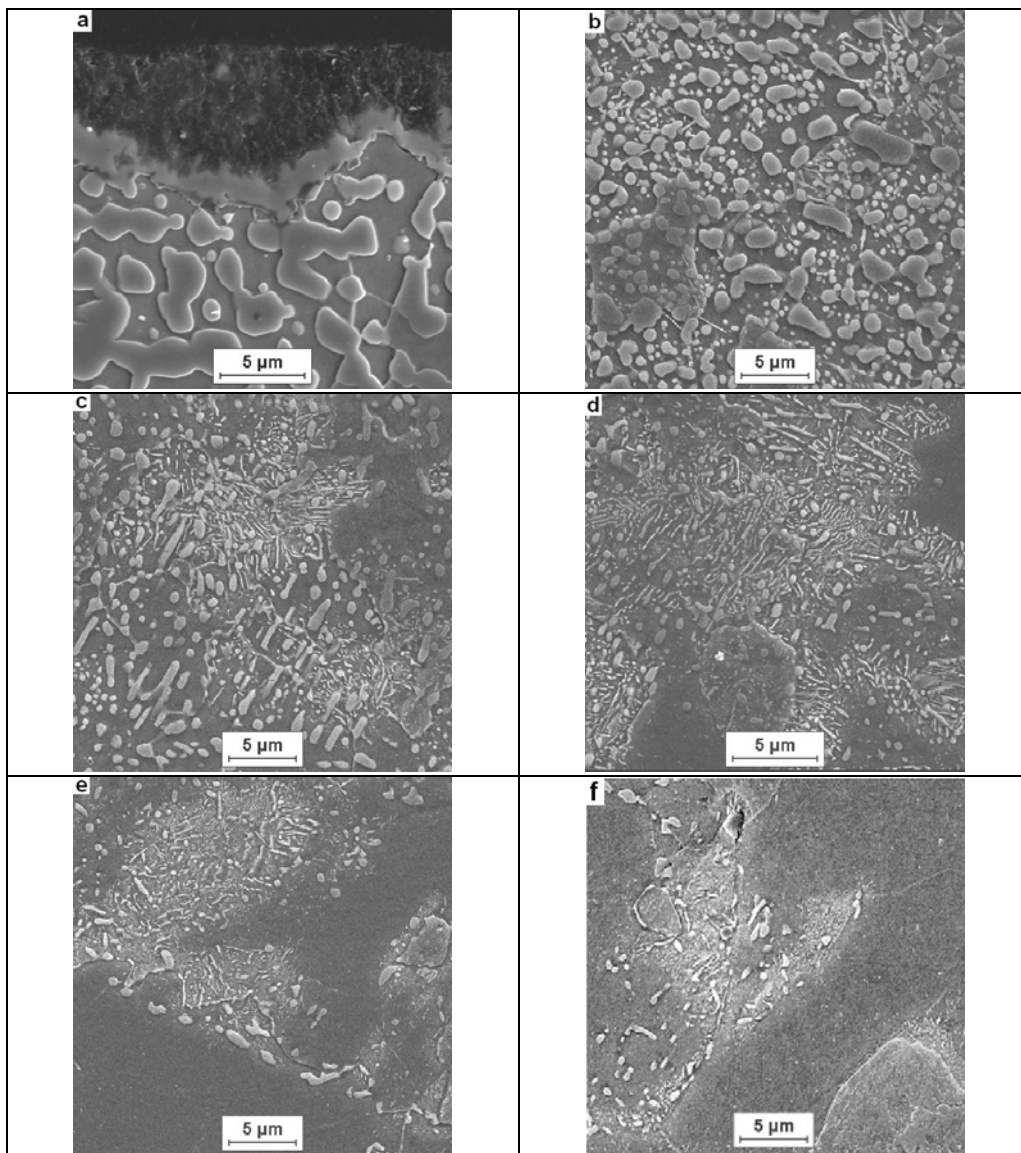
Figs. 5(a) through (f) illustrate the microstructure across 2.25Cr-1Mo steel tube wall, starting from the IS and down to the middle-wall situated at a depth of 3 mm. It can be seen that the morphology of carbides on the section is diversified: Fig. 5(a) indicates that beneath the IS, big spheroidal and elongated particles of diameter/length up to about 5 μm prevail. The particles are quite uniformly distributed in the metal matrix covering about 50 % of the area. Much smaller particles are present at a distance of 150.μm from the IS in Fig. 5(b). However, they also cover about 50 % of the area and their distribution in the matrix is rather uniform. Some thin, plate-like particles can also be noted. As illustrated in Figs. 5(c) through (e), the fraction of the carbides gradually decreases towards the middle-wall, the distribution of the particles in the matrix becomes not uniform, the carbides become smaller, and the fraction of the plate-like precipitates increases. In the middle-wall, fine carbides of not uniform distribution in the matrix dominate, Fig. 5(f).

Fig. 5(a)-(f). Micrographs of the cross-section of 2.25Cr-1Mo steel tube wall: (a) the IS, (b)-(f) 150 μm , 500 μm , 750 μm , 1 mm, 3 mm from the IS

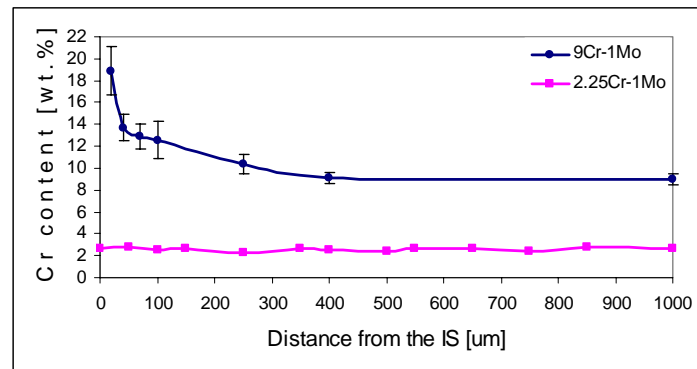
It is shown in Fig. 7 that chromium content beneath the surface of 9Cr-1Mo steel is higher than in the middle-wall, where about 9 wt.% Cr is noted. A maximum concentration of about 19 wt.% is reached at a distance of about 20 μm from the steel surface. In 2.25Cr-1Mo steel tube however, the chromium content across the wall section is uniform. Because of low concentration of molybdenum in the steels, the profiles of this element are not presented. Of course, some enrichment of the subsurface areas of 9Cr-1Mo steel was recorded up to about 2 wt.%.

Fig. 7. Profiles of chromium from SEM/EDS analyses in areas of 10 µm x 100 µm
