Case study of masts damage of the sail training vessel POGORIA.

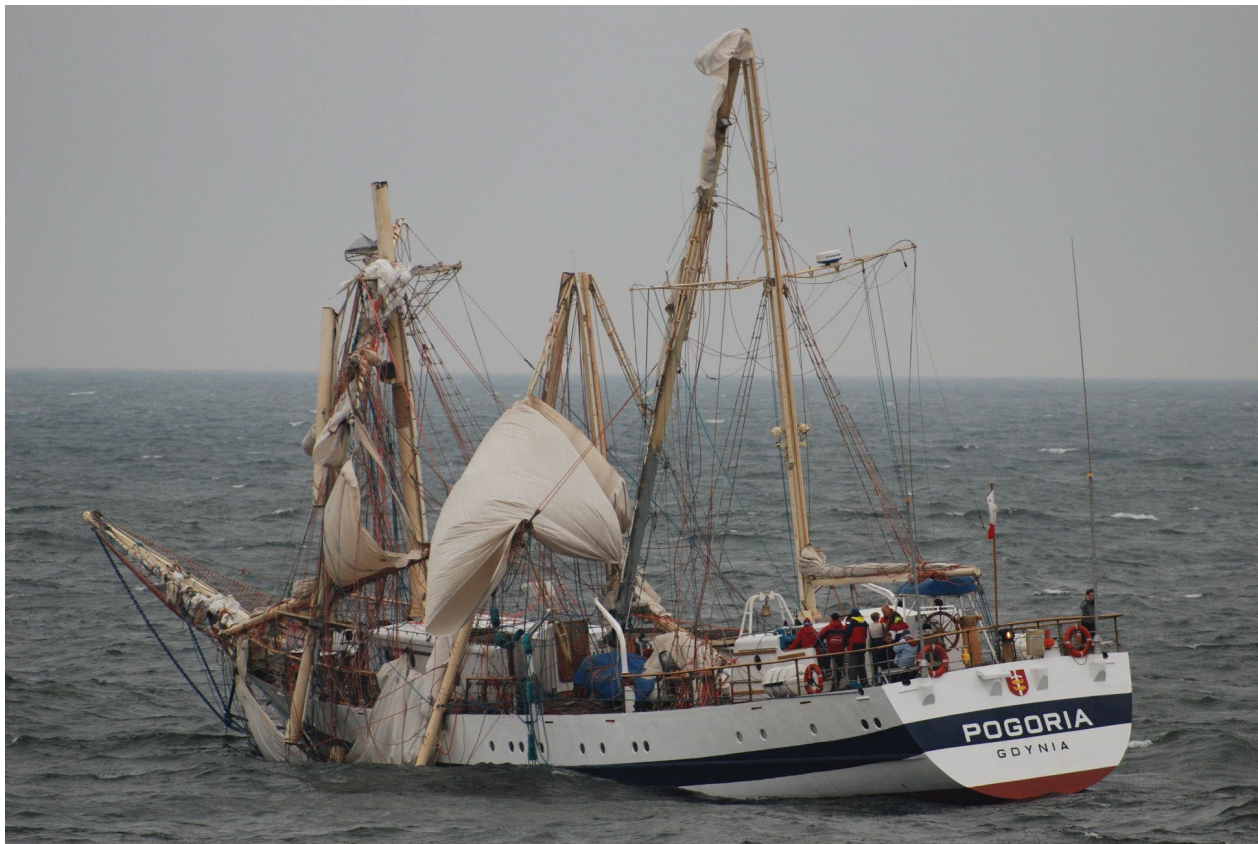
At the entrance to the Gulf of Finland (Baltic Sea), Polish barquentine Pogoria with 50 crewmembers onboard had an accident during Tall Ships Race in the first half of July 2009. All three masts were broken and destroyed both the running and standing riggings (fig. 1). Any significant consequences for the crewmembers did not come into existence.

Fig. 1. The snapshot of Pogoria made just after accident

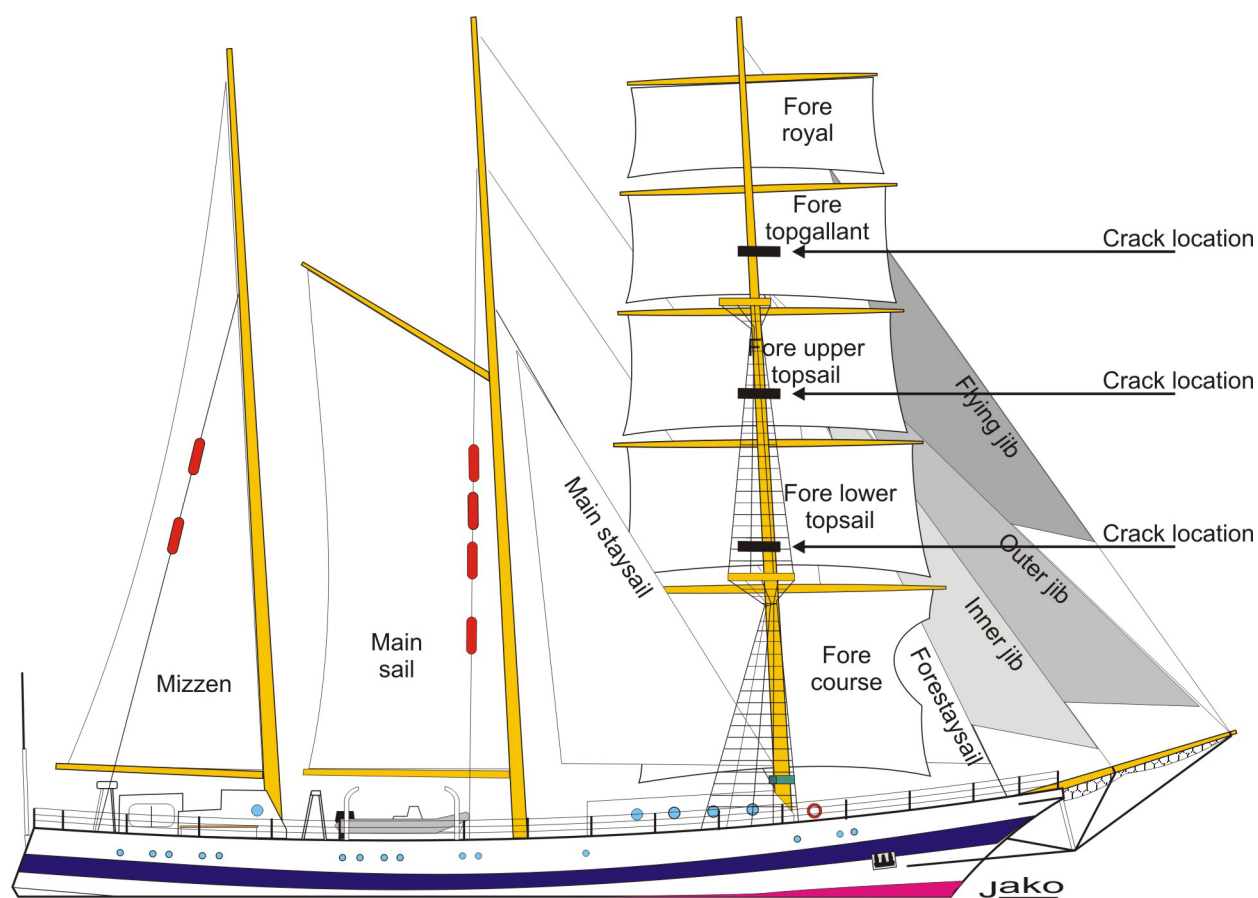
Fig.2. Pogoria sails set and foremast crack location in the moment of the accident

In our opinion, cooperation of two main factors was the direct cause of the fracture of foremast in its upper part:

- substantial weakness of the mast skin material in the determined cross-section,
- periodical action of dynamic strength triggered off by upper foremast sails called flying and outer jibs respectively.

Phenomenon explanation of the first factor will be presented in the further part of this paper. The second factor is connected with a way of sailing according to the close hauled course what means that Pogoria had the sails trimmed for sailing as close to the wind as possible. In the case of not very careful steering, this course can cause the sudden ‘down casting’ and ‘filling out’ upper triangular sails so-called stays. Several times repetition of such a maneuver triggered off the periodic dynamic forces which caused destruction of a skin material coherence of the foremast in its weakening place.

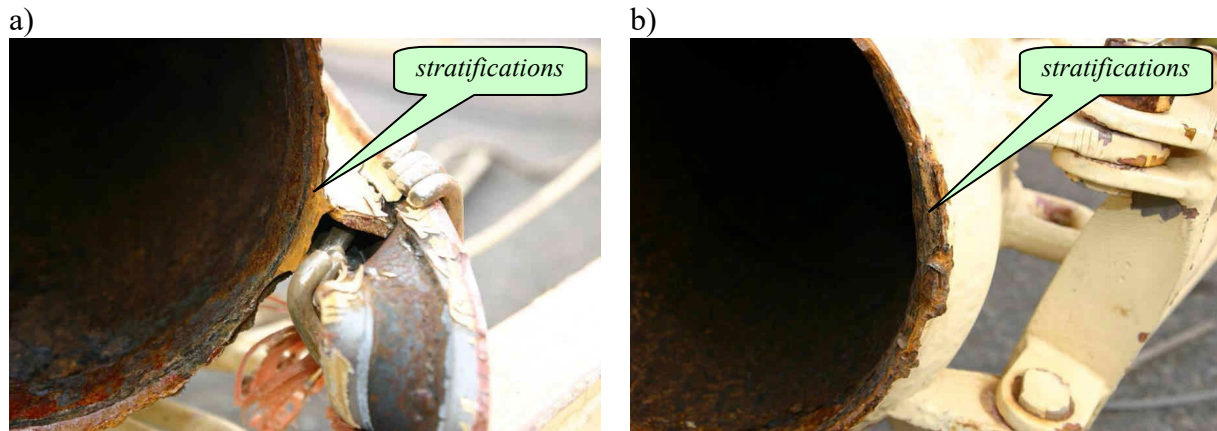
Fig. 5. Examples of the characteristic stratifications at the upper parts of the broken tubes: a) foremast; b) mainmast.

In our opinion, due to both the high transverse strain and the mast skin poor ductility in the through-thickness direction such situations occurred in welded joints of Pogoria masts because the surface of the fracture was fibrous and 'woody' with long parallel sections (Fig. 5). The orientation of the tears in butt welds of Pogoria masts are presented in Figure 6a.

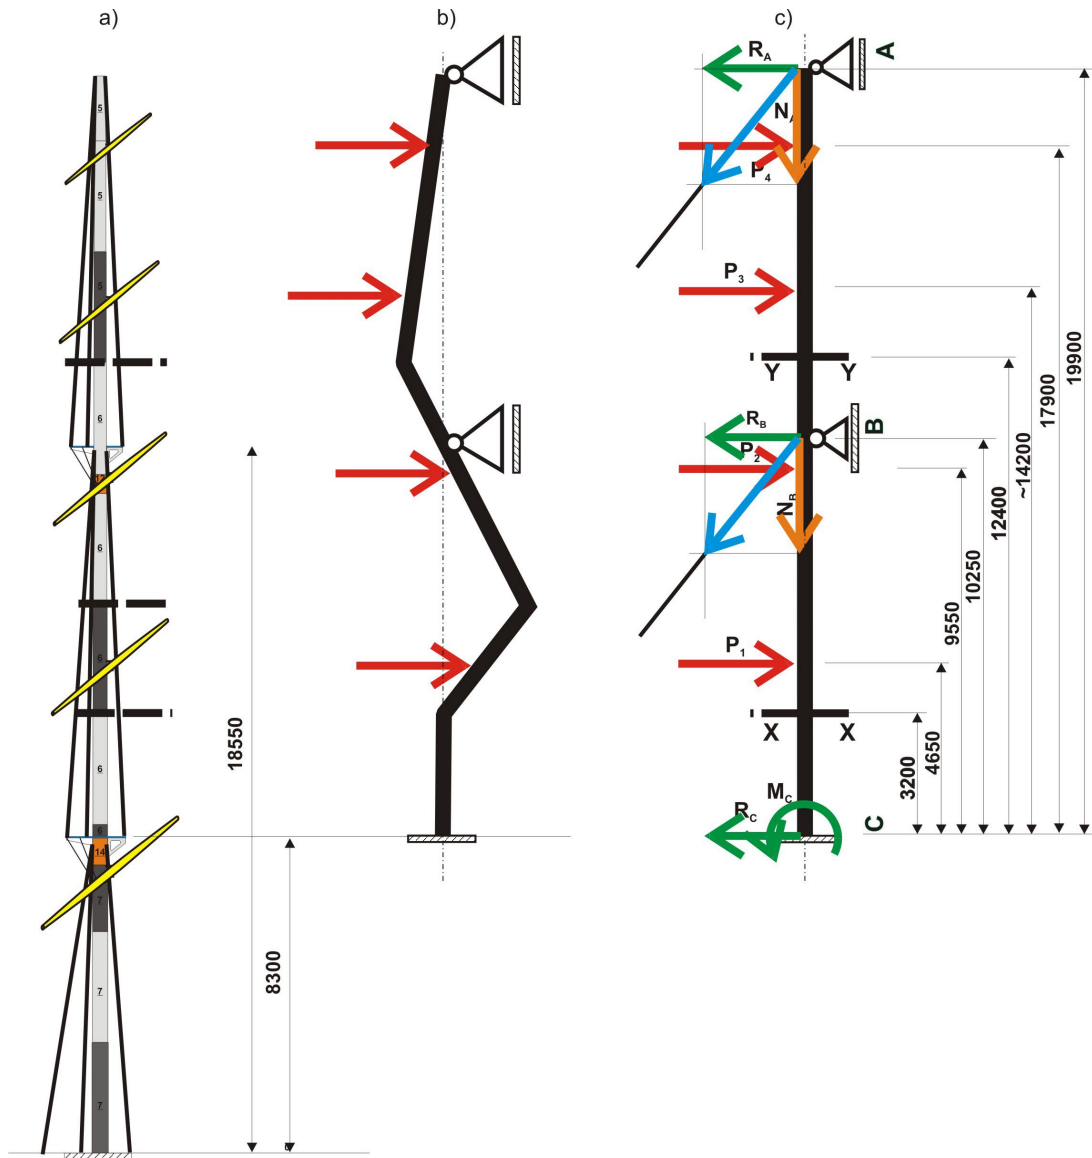
During of analyze of the pictures made just after damage (Fig.1) one can found, that beside of remained on the deck part of the foremast, rest was broken into three parts – as it marked in Fig.2 and Fig.8.b. It was certified, that during the accident, all ropes and hooks worked properly. Taking above mentioned into account, one can assumed expected model of the foremast damage – as it is presented in Fig.8.b. For the calculation, cantilever beam model semi-supported in places of platforms was applied – presented in Fig.8.c.

Fig. 8: Failure of the foremast: a) location of failures, b) model of damage, c) substitute model for calculation.

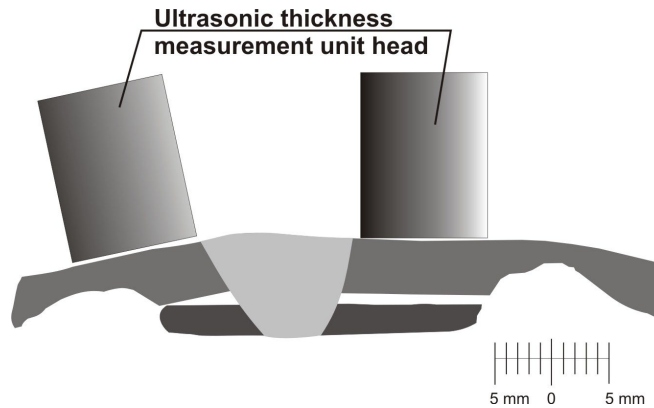
This fact means, that even after total removing of external paintings by sand blasting, it was not possible to find out of the existence of such deep corrosion losses area. From the other side application of the most common steel thickness method – ultrasonic measurement – also can bring not quite clear data due to specific of the internal joint geometry. As one can see in Fig. 11 location of the corroded regions is strictly connected with position of the welding pad in relation to butt weld centre: for one case this is region located closely to the weld fusion area, for other case – in the some distance of it. If one compare size of the typical measurement unit of ultrasonic thickness meter with size of corrosion losses, one can see that for some cases typical measurement process conducted closely to the root of the weld will not detect of the such type of corrosion losses.

Fig.11. Size of the typical ultrasonic thickness meter measurement unit on the background of contour of corrosion losses.

So during standard periodic surveying procedures, probability of detecting of such type of corrosion effects is relatively low. The last conclusion presents risk factor for such type of structure – only very careful systematic thickness measurement procedure with internal thickness profile analysis can indicate potential loosing of the safety margin.

- the possibility to predict of results of all adopted design solutions not always exists, especially with reference to a prototype unit like Pogoria,
- such a kind of event will occur in not long time maybe as a result of gravity loading,
- it is necessary to check the technical conditions on board of all sailing vessels with similar design of masts,
- it should be developed new technologies providing the high quality of welded joints in such types connections of individual segments of sailing vessel masts.
- it should be introduced new surveying standards related to the steel welded sailing vessel masts.
