The effect of long-term service at elevated temperatures on structure and mechanical properties of Cr-Mo-V steel

Design/methodology/approach: Examinations were conducted on 273 mm diameter, 32 mm wall thickness tube made of 13HMF (14MoV6-3) steel. The tube was a segment of stem pipeline used in power plant at 540°C. The service time is 168,000 hours. Microstructure of the material has been examined with the use of light optical microscopy and scanning electron microscopy (SEM). The energy dispersive X-ray spectrometry (EDS) analysis was used for phase chemical composition identification. Transmission electron microscopy (TEM) of thin foils was used for carbides structure identification. The mechanical properties of the tube material were evaluated in static tensile tests at room temperature, hardness tests and impact Charpy U tests.

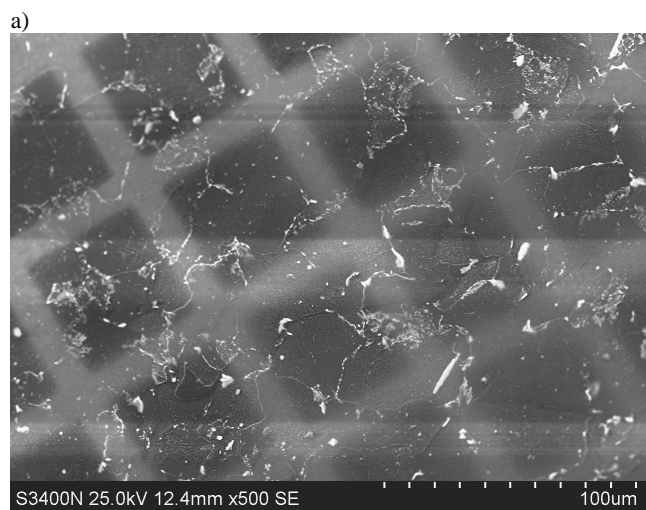
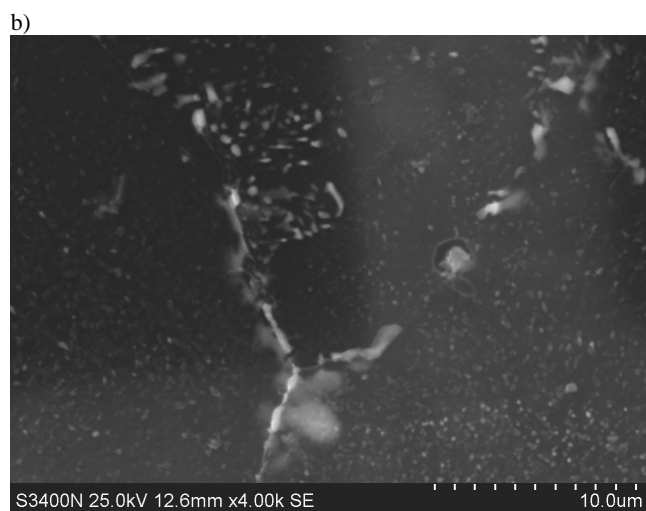
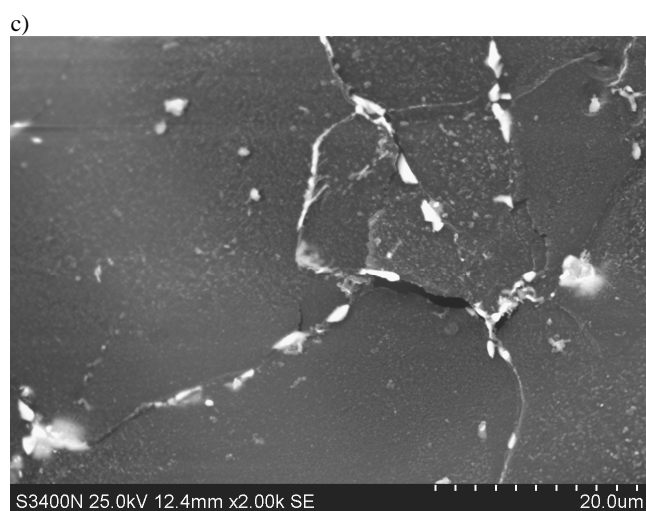
Fig. 3. Carbides morphology in 13HMF steel, tube $\varnothing 273 \times 32$ mm. Extraction replica, SEM, detector SE

Carbides morphology disclosed on a replica is shown in Figs. 3,4.

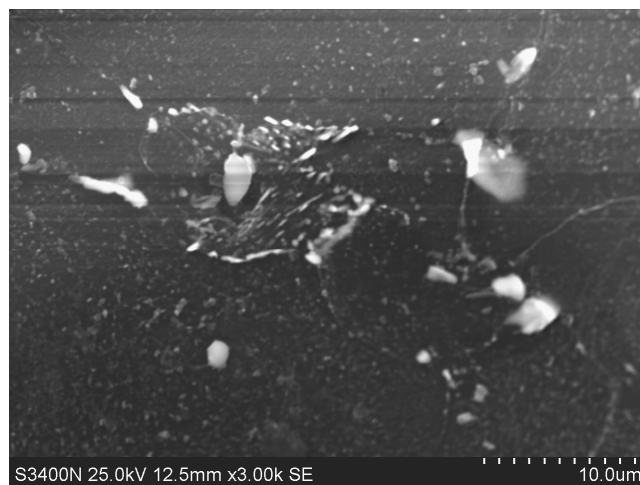
Fig. 4. Carbides morphology in 13HMF steel microstructure, tube $\varnothing 273 \times 32$ mm. Extraction replica, SEM, detector SE
