The effect of long-term service at elevated temperatures on structure and mechanical properties of Cr-Mo-V steel

Purpose: of this paper is to reveal the microstructural changes in 13HMF steel exposed to long-term service at elevated temperatures. The degradation of bainite structure was determined and carbides morphology has been examined. The influence of carbides evolution was discussed in dependence of creep rupture strength and mechanical properties of the steel.

Design/methodology/approach: Examinations were conducted on 273 mm diameter, 32 mm wall thickness tube made of 13HMF (14MoV6-3) steel. The tube was a segment of stem pipeline used in power plant at 540°C. The service time is 168,000 hours. Microstructure of the material has been examined with the use of light optical microscopy and scanning electron microscopy (SEM). The energy dispersive X-ray spectrometry (EDS) analysis was used for phase chemical composition identification. Transmission electron microscopy (TEM) of thin foils was used for carbides structure identification. The mechanical properties of the tube material were evaluated in static tensile tests at room temperature, hardness tests and impact Charpy U t

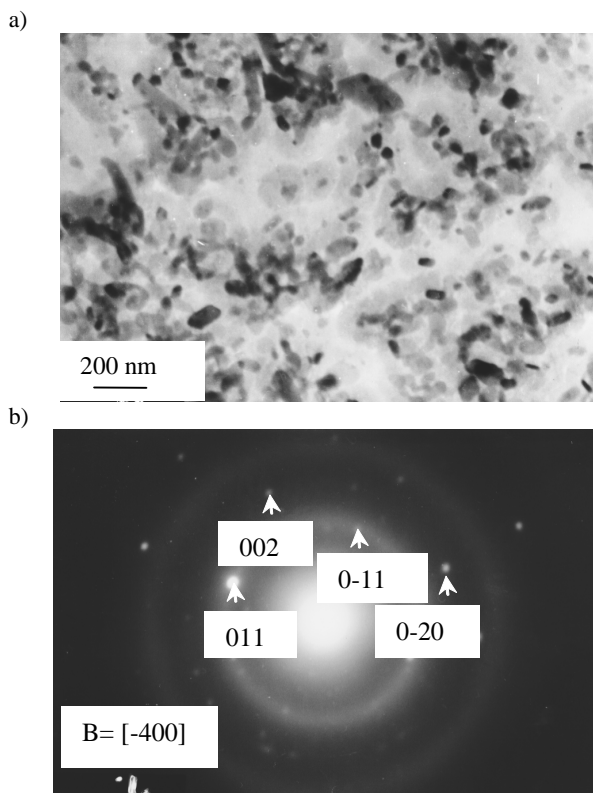
Fig. 5. a) Dispersed MC precipitates, TEM image b) Diffraction pattern of MC precipitates

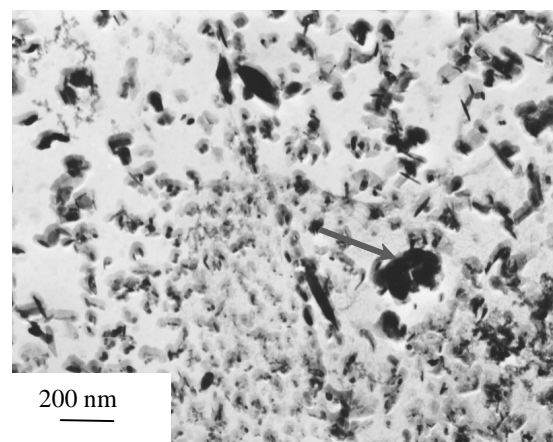
Fig. 7. The diverse morphology of the precipitates. Arrow marked the precipitation where the diffraction was performed

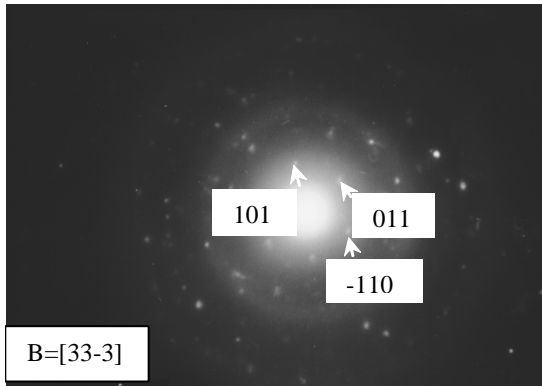
Fig. 8. Diffraction pattern of particle shown by arrow in Fig. 7, $M_{23}C_6$ precipitate

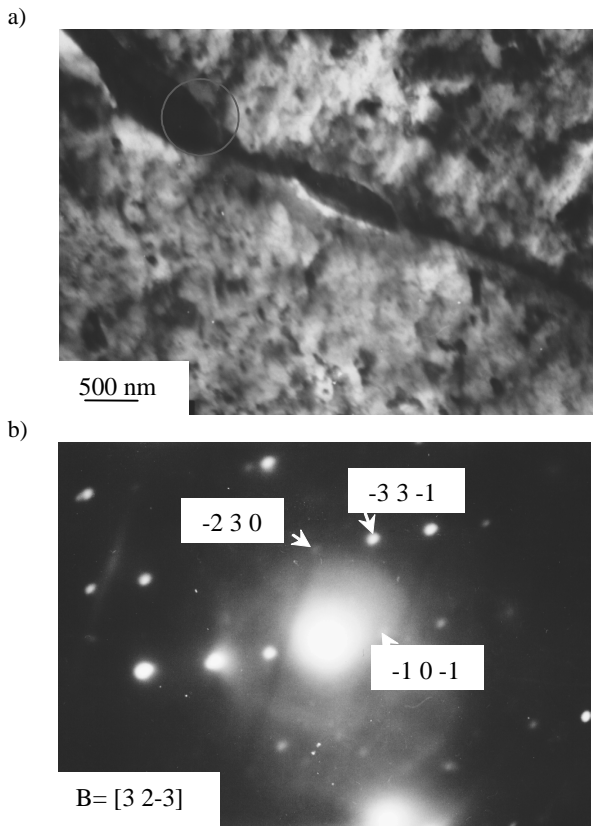
Fig. 9. a) Dispersed M_7C_3 precipitates, TEM image b) Diffraction pattern of M_7C_3 precipitates
