ENDOSCOPIC IMAGE PROCESSING AND ANALYSIS OF PISTONS' SERVICE FAILURES OF MARINE DIESEL ENGINES

Zbigniew Korczewski

Abstract

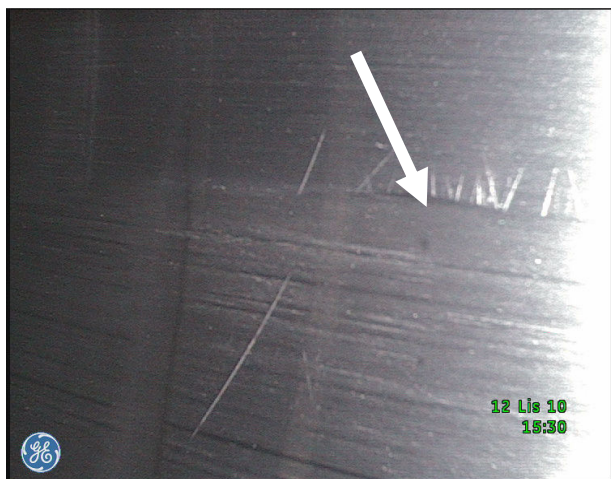
A considerable, local piston head's overheating, up to exceeding a plasticity border of the constructional material, causes its local upset. If a temperature growth of the piston's head is only temporary there could be also affected a temporary wearing down and even seizing the piston's crown in the cylinder bearing surface - Fig. 2a [4].

a) cylinder bearing surface - friction traces originated from the piston leading part

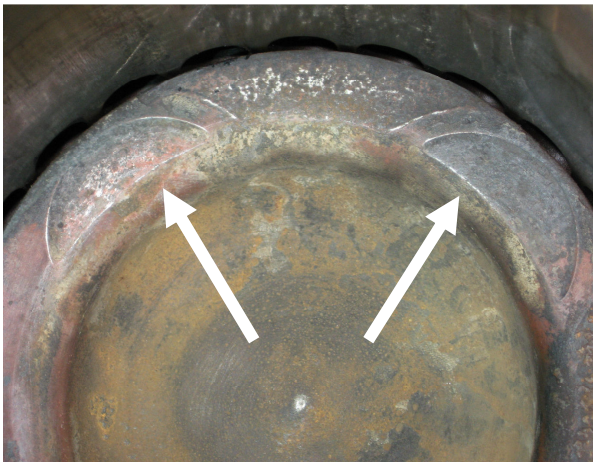
c) piston head – traces of the piston strokes over the valves (a state after the “water hammer”)

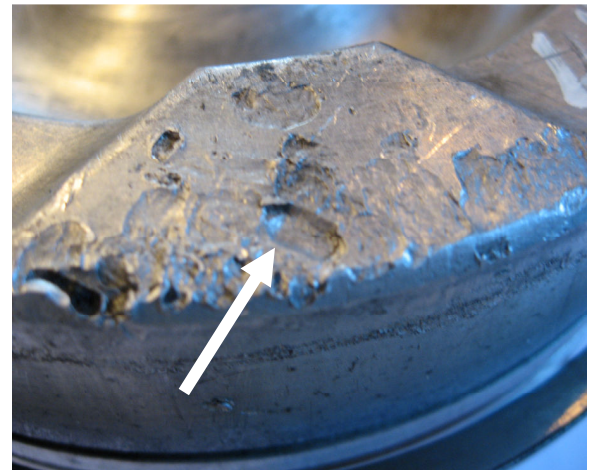
Piston mechanical deformations represent its relatively often occurred damages. They are usually caused by the valve's part (the exhaust valve generally) e.g. a broken off valve's head, which has fallen into the combustion chamber - fig. 3d. During its operation the cylinder valve is forced to move along its spindle in the guide which undergoes irreversible friction wear. The process goes at high temperature of the spindle whose additional task is to absorb heat from the valve head. As a result an excessive increase of radial clearance is produced between the guide and spindle, which, in all the cases, leads to an undesirable skew of the valve especially, that it is loaded with transverse component from the pressure of the timing lever or cam. Consequently, a loss of cylinder tightness (compression pressure drop), gas eruption, returnable flows, lubricant leakage from the spindle – guide precision pair until an

d) piston head's crown – traces of the strokes made by the broken-off part of the valve head

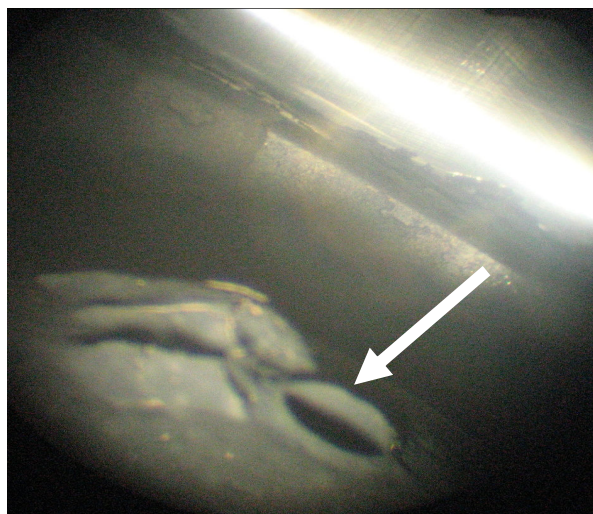
A presence of the punctual dent on the piston head, that is placed in an injector's axis (fig. 3e,f) testifies about the piston's mechanical strokes over the injector resulting from e.g. the elongated piston stroke (for some high- speed engines, a distance between the piston head and injector's ending at TDC is not more than 3-4 mm [11]). Such a situation might represent a consequence of excessive clearances in an assembly of crank-shaft or intensive wear and tear of bearing pans.

e) piston head – a dent after the piston stroke over the injection sprayer

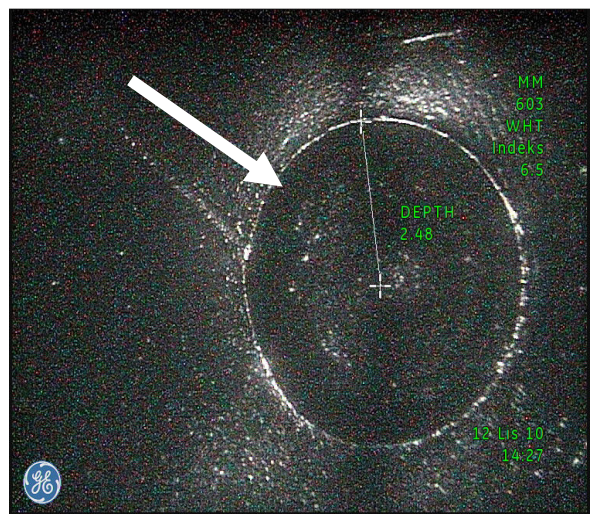
f) piston head – a measurement of the dent's depth by means of the „Shadow” method (2,48 mm)
