Failure of austenitic stainless steel tubes during steam generator operation

Purpose: of this study is to analyze the causes of premature failure of steam generator coil made of austenitic stainless steel. Special attention is paid to corrosion damage processes within the welded joints.

Findings: Examinations of coil tubes indicated severe corrosion damages as pitting corrosion, stress corrosion cracking, and intergranular corrosion within base material and welded joints. Causes of corrosion was defined as wrong choice of austenitic steel grade, improper welding technology, lack of quality control of water supply and lack of surface treatment of stainless steel pipes.

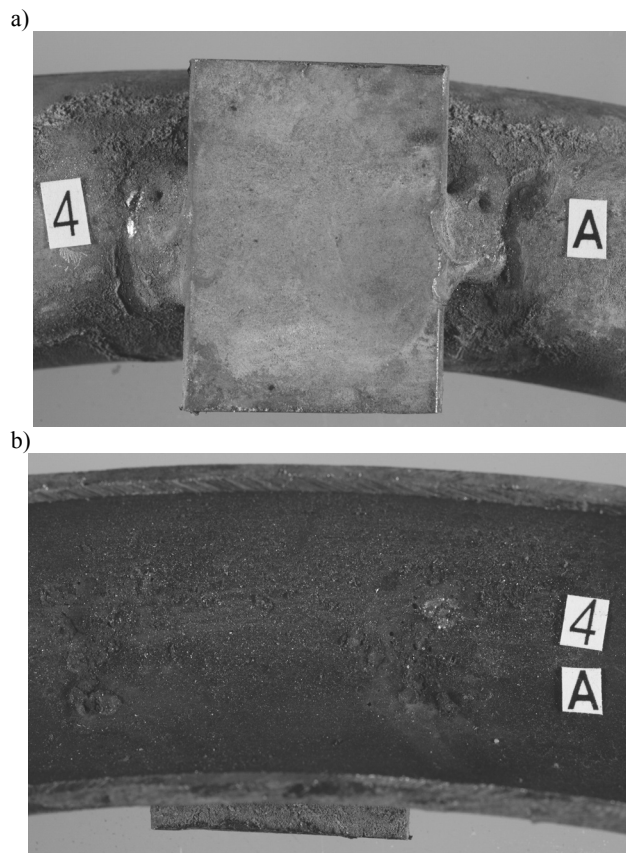
Intense pitting corrosion was also found on the inner surface of pipes under welds connecting coil stiffeners. Figure 7 b clearly shows two pitted areas under the welded joints where the inner surface of the pipe is heated to high temperatures.

Fig. 7. Stiffener welded to the pipe coil, a) outer surface, b) the inner surface attacked by pitting corrosion

- Avoid excessive stiffening of the tubes. Welding of the coils stiffeners should be performed with minimal heat input.
- It is advised to apply stress relief annealing after cold bending of the tubes to remove internal stresses.
- Cleaning the inner surfaces of the coil tube surface passivation of the surface should be performed after welding.
- Water quality monitoring. Keep the feed water pollution at the appropriate level.
- Flooding of the evaporator tubes with water or completely remove water and drain installation at each stopping installation.
- Procedures for the periodic removal of scale in the coils should be supplemented by passivation of the pipe.

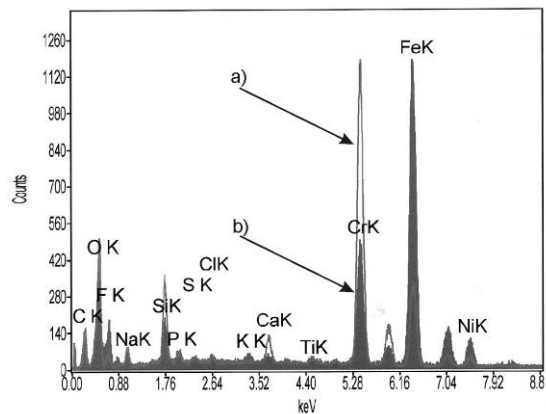
High concentrations of Cr and the presence of Ti were detected in the pit, which is the result of the destruction of the passive film. The composition of corrosion products in the pit, show a much lower content of Cr and Ti, (Table 2).

Fig. 13. The results of microanalysis of corrosion products and deposits, a) in the pit from which was initiated stress cracking (unfilled), b) in the main gap of crack
