Failure of austenitic stainless steel tubes during steam generator operation

Purpose: of this study is to analyze the causes of premature failure of steam generator coil made of austenitic stainless steel. Special attention is paid to corrosion damage processes within the welded joints.

The steam generator studied worked with a nominal pressure of 12-16 bar, under outlet steam temperature 160°C. The working time of the device was 6 months, with numerous intermissions in service. The reason for the withdrawal of the generator from the operation was leaks in the coil tube caused by corrosion damage.

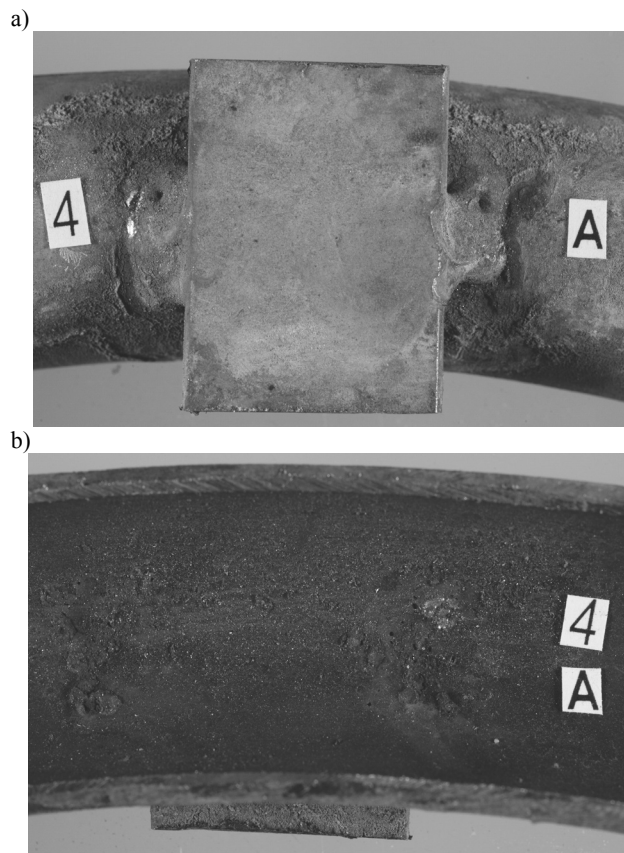
Intense pitting corrosion was also found on the inner surface of pipes under welds connecting coil stiffeners. Figure 7 b clearly shows two pitted areas under the welded joints where the inner surface of the pipe is heated to high temperatures.

Fig. 7. Stiffener welded to the pipe coil, a) outer surface, b) the inner surface attacked by pitting corrosion

- Avoid excessive stiffening of the tubes. Welding of the coils stiffeners should be performed with minimal heat input.
- It is advised to apply stress relief annealing after cold bending of the tubes to remove internal stresses.
- Cleaning the inner surfaces of the coil tube surface passivation of the surface should be performed after welding.
- Water quality monitoring. Keep the feed water pollution at the appropriate level.
- Flooding of the evaporator tubes with water or completely remove water and drain installation at each stopping installation.
- Procedures for the periodic removal of scale in the coils should be supplemented by passivation of the pipe.

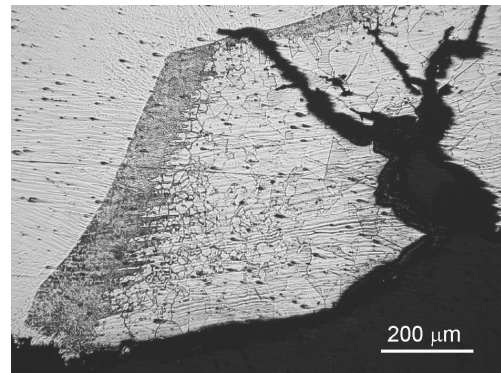
Fig. 9. The propagation of cracks initiated by intergranular corrosion

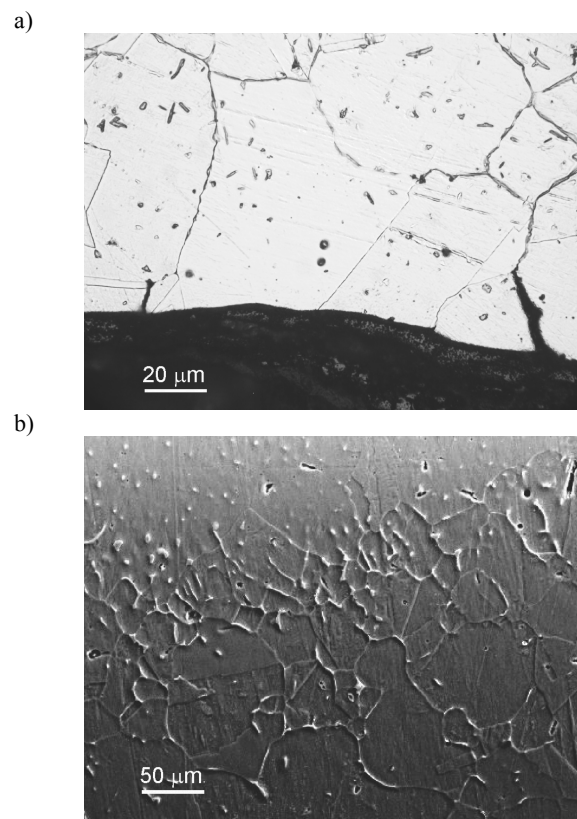
Fig. 10. The structure of sensitized zone of austenitic stainless steel, a) light microscope image, b) SEM image - visible carbides net at grain boundaries of austenite

A detailed analysis of cracks showed their intergranular propagation along the austenite grain boundaries which were decorated by chromium carbide precipitates. Figure 10 shows the microstructure of sensitized HAZ zone, with clearly visible coagulated carbides located mainly at the austenite grain boundaries, forming an almost continuous net. Such a distribution of carbides in the HAZ was also observed by scanning electron microscope, Fig.10 b. This was confirmed by EDX field qualitative analysis of the chromium distribution and is direct evidence of steel sensitization in the HAZ area where the temperature reached 500 to 800°C.

- In order to avoid intergranular corrosion austenitic steels with a carbon content below 0.02% should be selected instead of steel stabilized with Ti or Nb, which does not fully protect against such corrosion.
