DYNAMIC STATE ASSESSMENT OF THE WATER TURBINE WITH THE POWER OF 600 kW

Grzegorz ŻYWICA, Paweł BAGIŃSKI, Łukasz BREŃKACZ

Institute of Fluid-Flow Machinery, Polish Academy of Sciences
80-231 Gdansk, Fiszerka 14 str., gzywica@imp.gda.pl

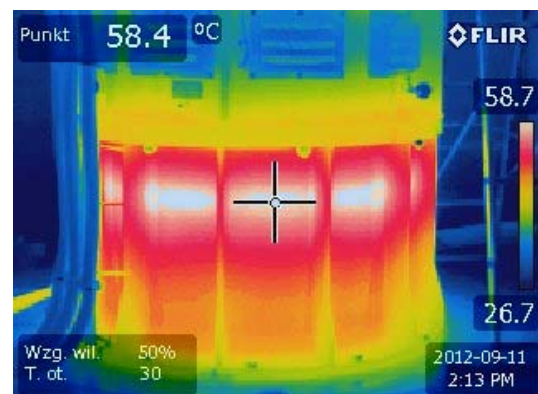
Fig. 6. The temperature distribution on the external surface of the gear housing.

In case of the examined water turbine no excessive temperature levels were observed for any of the controlled parts. The highest temperature in the housing of toothed gear was 59.7 ° C and it was in the area of connection of toothed ring with the housing (Fig. 6). The temperature on the outer surface of the generator was up to 46.4 ° C in the vents, where hot air was removed. Housings design prevented temperature measurement directly on the bearing housing, but the steel elements connected to these retainers had a low temperature. It can be concluded that the control of the temperature distribution showed no symptoms of excessive wearing or damage.
