Studies of the mechanism of metal dusting of 10CrMo9-10 steel after 10 years of operation in the semi-regenerative catalytic reformer

The purpose of this paper is to present a metal dusting mechanism for 10CrMo9-10 steel operated for 10 years in the semi-regenerative catalytic reformer.

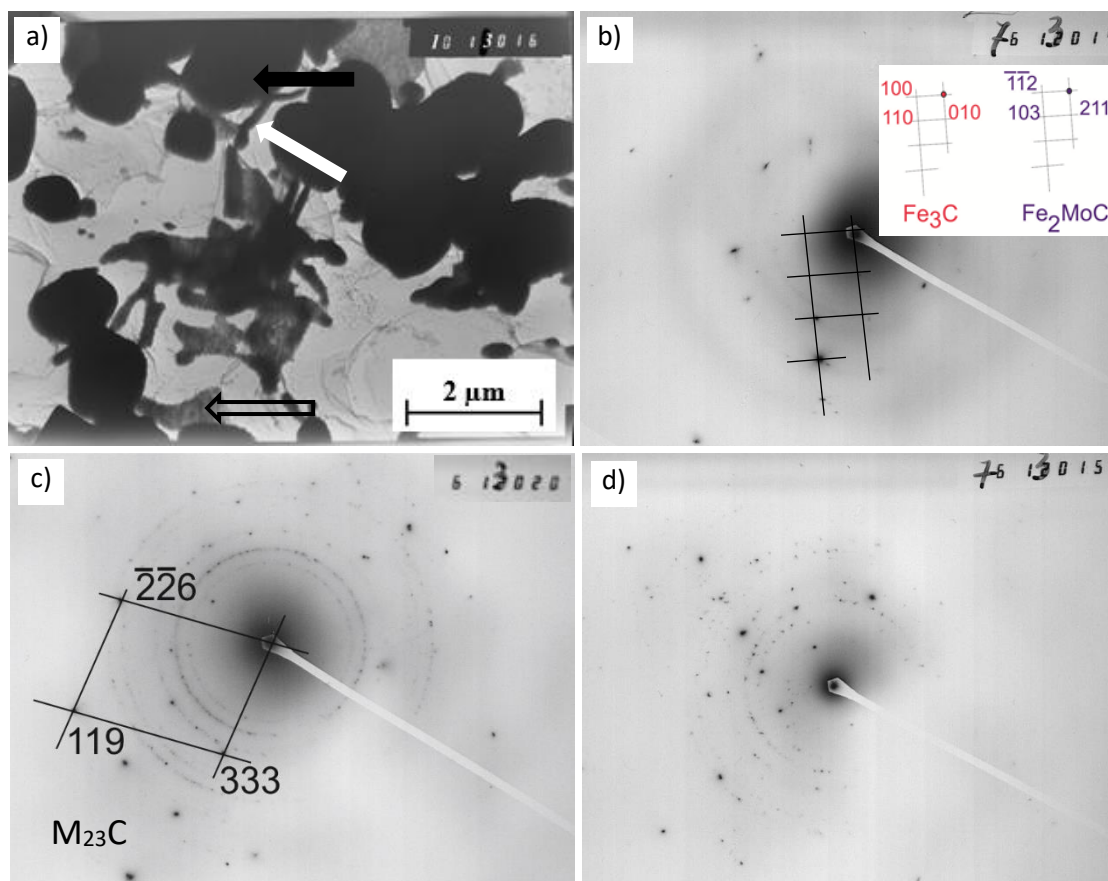
be observed. In the material located below this layer there are large spheroidal carbides between which are visible less precipitations of lamellar structure (Fig. 8a). Diffraction pattern of spheroidal precipitates (Fig. 8b) approximately fit both the Fe_3C and Fe_2MoC carbides. This will probably carbides $\text{Fe}_{3-x}\text{Mo}_x\text{C}$, where $x \in (0, 1)$. Diffraction pattern with a lamellar precipitates (Fig. 8c, d) approximately fit both Fe_2MoC , Fe_3C , and M_{23}C_6 carbides. They are likely to be undergoing transformation $\text{M}_{23}\text{C}_6 \rightarrow \text{M}_3\text{C}$ carbides. Lamellar carbides can be also observed at the bottom of large, spheroidal precipitates imprints, which could not be extracted on replica (Fig. 9). They are probably carbides, which nucleate at interfaces previously created carbide/ferritic matrix. With increasing distance from the surface of the inner tube increases the share of lamellar precipitates (Fig. 10a). Diffraction of these precipitates are equally suitable for Fe_2MoC and to Fe_3C carbides (Fig. 10b). With increasing distance from the surface of the inner tube decreases the size of spheroidal

Fig. 8. Large spheroidal, and smaller lamellar precipitates occurring in the material at a distance of 5-10 μm of a continuous layer of carbide (bright field) – Fig. a). The diffraction pattern of spheroidal precipitates depicted by black arrow in Fig. a); diffraction reflections at approximately adjust both the cementite and carbide Fe_2MoC – Fig. b). The diffraction pattern of the lamellar precipitates depicted by white arrow in Fig. a) identified as M_{23}C_6 carbide (there are deviations of the measured Bragg angles of the table values) – Fig. c). Diffraction pattern of the lamellar precipitates depicted by the transparent arrow in Fig. a): in the best approximate fit Fe_2MoC carbide, but also cementite and carbide M_{23}C_6 (with a slightly larger angular misadjusts) – Fig. d)
