## Studies of the mechanism of metal dusting of 10CrMo9-10 steel after 10 years of operation in the semi-regenerative catalytic reformer

The purpose of this paper is to present a metal dusting mechanism for 10CrMo9-10 steel operated for 10 years in the semi-regenerative catalytic reformer.

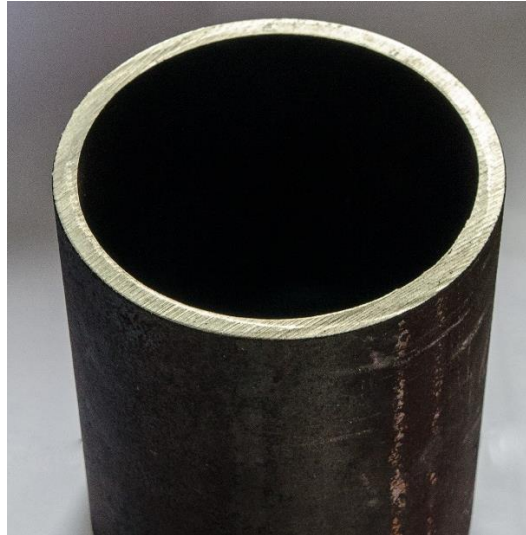
Fig. 2. View of cut portion of the tube furnace No 12

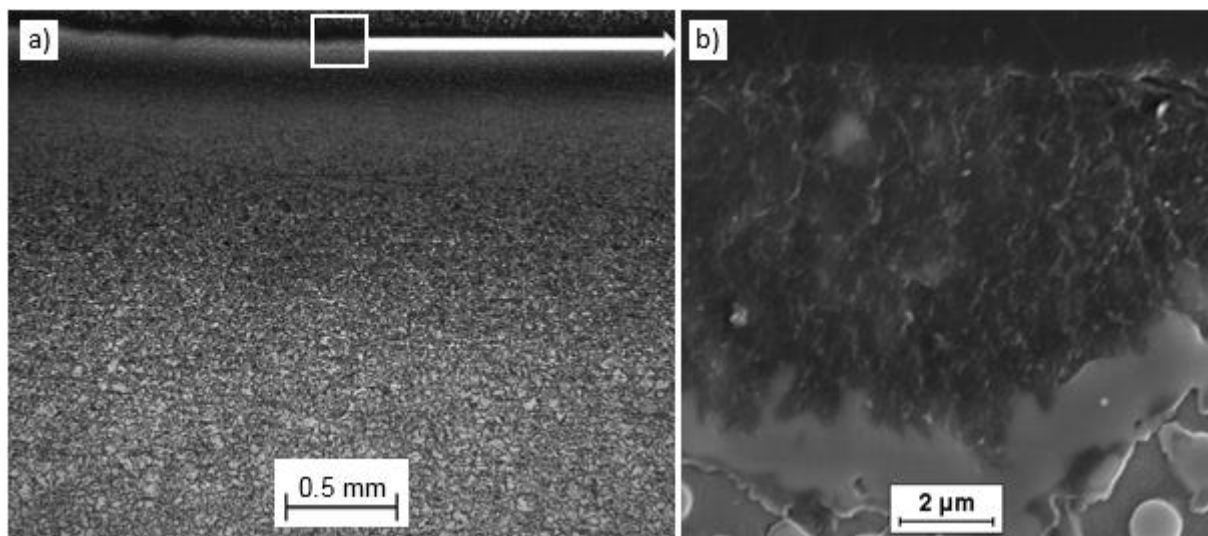
Fig. 3a shows a cross-section of the tube wall. A carburized microstructure is visible below surface of the inner pipe. Its thickness is about 2 mm. Study of the microstructure using SEM revealed the morphology of the surface layer. The inner surface of the pipe is covered with a coke layer whose thickness is in the range from 5 to 15  $\mu\text{m}$ . Directly beneath the inner tube, the thin, continuous layer of carbide having a thickness of about 1 - 2  $\mu\text{m}$  (Fig. 3b) occurs. A characteristic feature of this layer is the presence of the developed coke/carbide layer interface (Fig. 3b). A plurality of cavity- shape like of the pits filled with corrosion products are present in this layer. This carbide layer structure proves that it disintegrates in the process of metal dusting.

Fig. 3. The cross section of P22 steel pipe after 10 years of operation in the semi-regenerative catalytic reformer. The carburized layer for approx 2 mm is visible (bright field, LM) – Fig. a), and image corrosion products and disintegration continuous layer of carbides (SEM) – Fig. b)

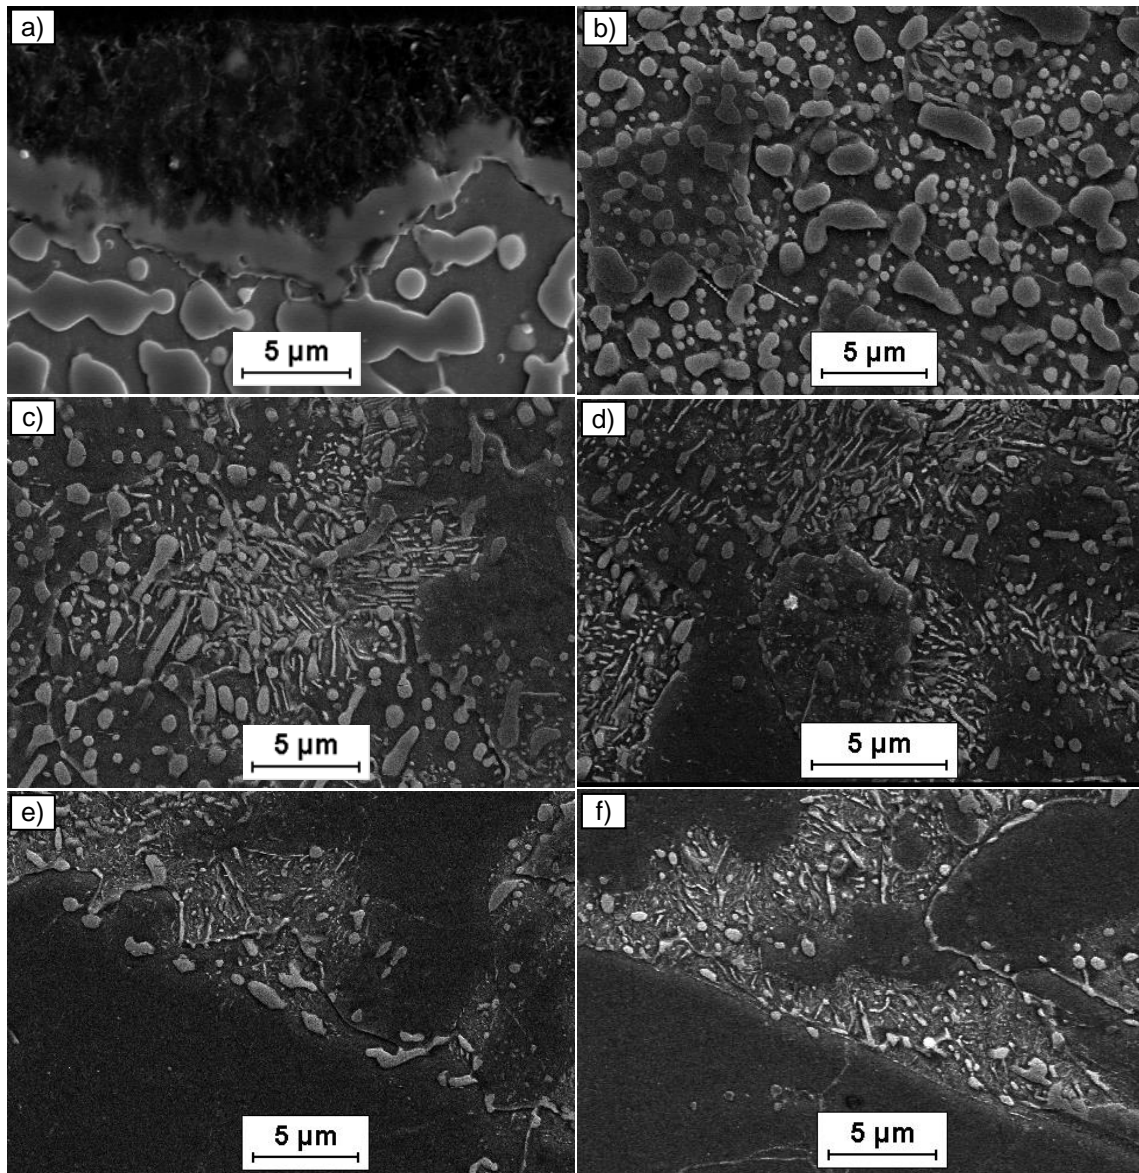
Fig. 4 shows the microstructures of the steel made at different distances from the inner surface of the pipe. Under inner surface of the pipe there are visible numerous, large spheroidal carbides evenly distributed in the ferritic matrix (Fig. 4a, b). With increasing distance from the inner surface of

the pipe, carbides contribution in the microstructure of the steel and their size are reduced. Also their structure changes - already at a depth of 150  $\mu\text{m}$  lamellar carbides can be observed (Fig. 4b), which part increases with the distance from the inner surface.

Fig. 4. Images obtained with the cross section of the tube. The inner surface of the pipe with the subsurface layer – Fig. a). Microstructure of the steel approximately 150  $\mu\text{m}$  from the inner surface of the pipe – Fig. b), 500  $\mu\text{m}$  from the surface – Fig. c), 750  $\mu\text{m}$  from the surface – Fig. d), 1 mm from the surface – Fig. e), 3 mm from the surface – Fig. f)

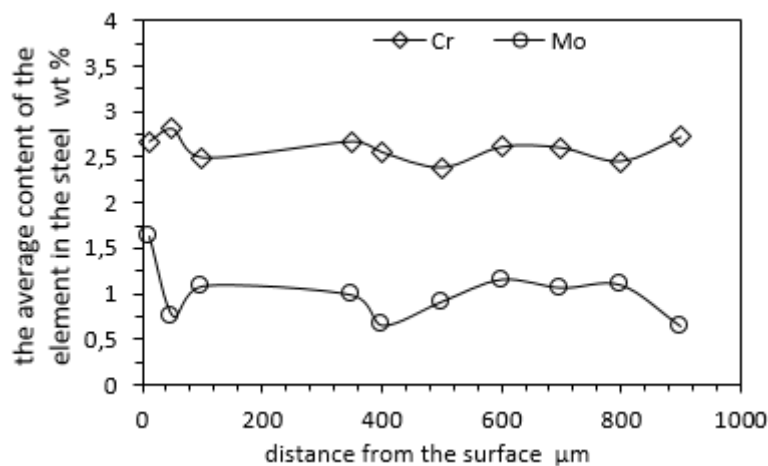
Fig. 5. Average content of the chromium and molybdenum in the steel as a function of distance from the inside surface (IS) of the tube measured by EDS

As is apparent from Fig. 5 the average content of the alloying elements Cr and Mo as a function of distance from the surface of the inner pipe is approximately constant. There is no the outward diffusion of elements forming carbide, i.e. chromium and molybdenum, as it did in the case of steel tubes X11CrMo9-1 furnaces operated in the platformer CCR [19].

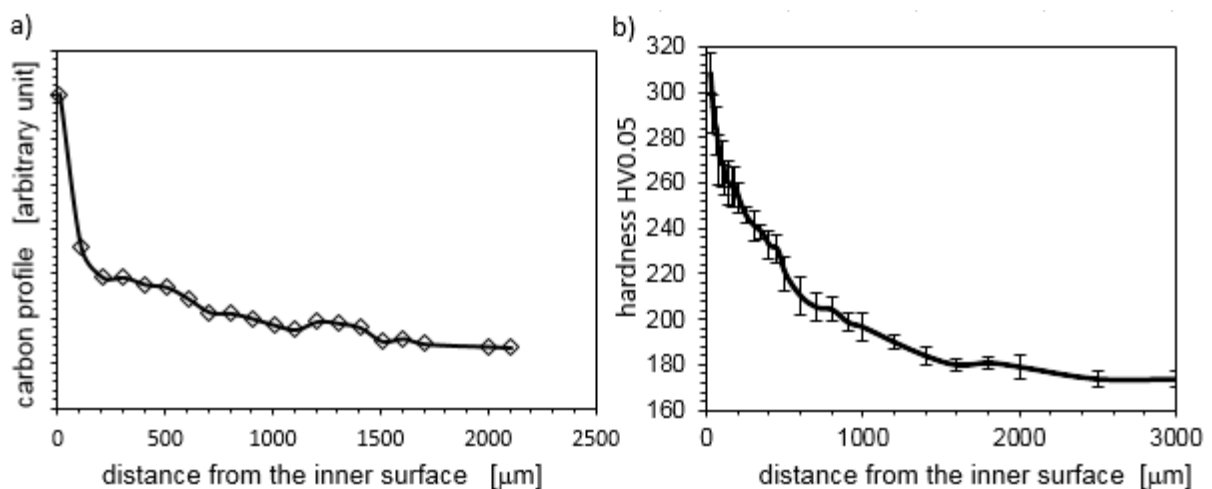
Also the qualitative distribution of carbon was performed by using a low accelerating voltage of the electron beam equal to 3 kV. The carbon content measurements were performed from  $10\ \mu\text{m} \times 8\ \mu\text{m}$  areas (see Fig. 6a). Quantitatively the carbon content in the surface layer can be calculated from the volume percentage of carbides in the structure, on the assumption that the whole carbon is in the carbides. Under this assumption, the carbon content at the surface is about 6-7%, and decreases with distance from the surface. At a distance of about 2 mm carbon content of the steel is 0.11%. Additionally microhardness test was also performed to determine the approximate distribution of carbon in the carburized layer. Due to the size of the indentation generated during the hardness measurement, the first measurement in each series was performed at depth of  $20\ \mu\text{m}$ . Fig. 6b shows the hardness profile of the steel as a function of the distance from the inner surface of the pipe, obtained from average hardness values and additionally standard deviation from each series of five measurements is indicated. On the basis of the hardness profile, the carbon distribution in the carburized layer can be qualitatively determine. As can be seen from Fig. 6b, the distribution of hardness in the carburized layer resembles a typical hardness distribution for diffusion layers. Initially, the hardness rapidly decreases, however, with increasing distance from the inner surface of the pipe fall is getting smaller and deeper than 2 mm assumes a constant value corresponding to the hardness of the steel in the core.

Fig. 6. Qualitative carbon distribution measured by EDS technique – Fig. a), and hardness profile of the cross-section tube after 10 years of operation in the semi-regenerative catalytic reformer – Fig. b)

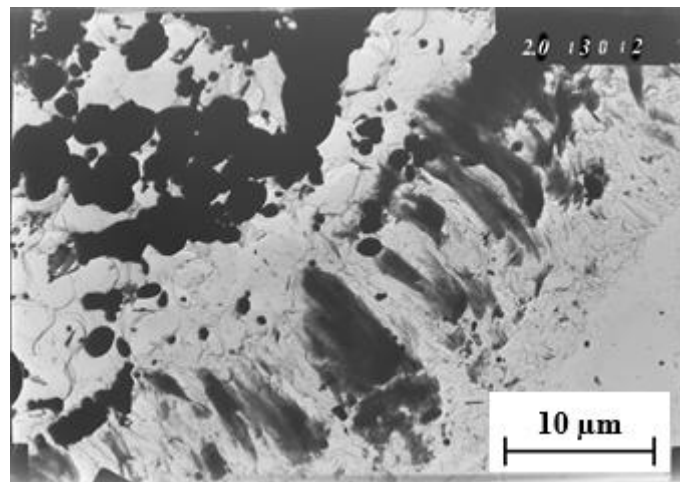
Fig. 7. The extraction replica image made on the edge of the sample. Visible parts of corrosion products on the construction of the fiber, growing perpendicular to the inner surface of the pipe, and large, spheroidal precipitation occurring in the inner surface of steel pipe, bright field

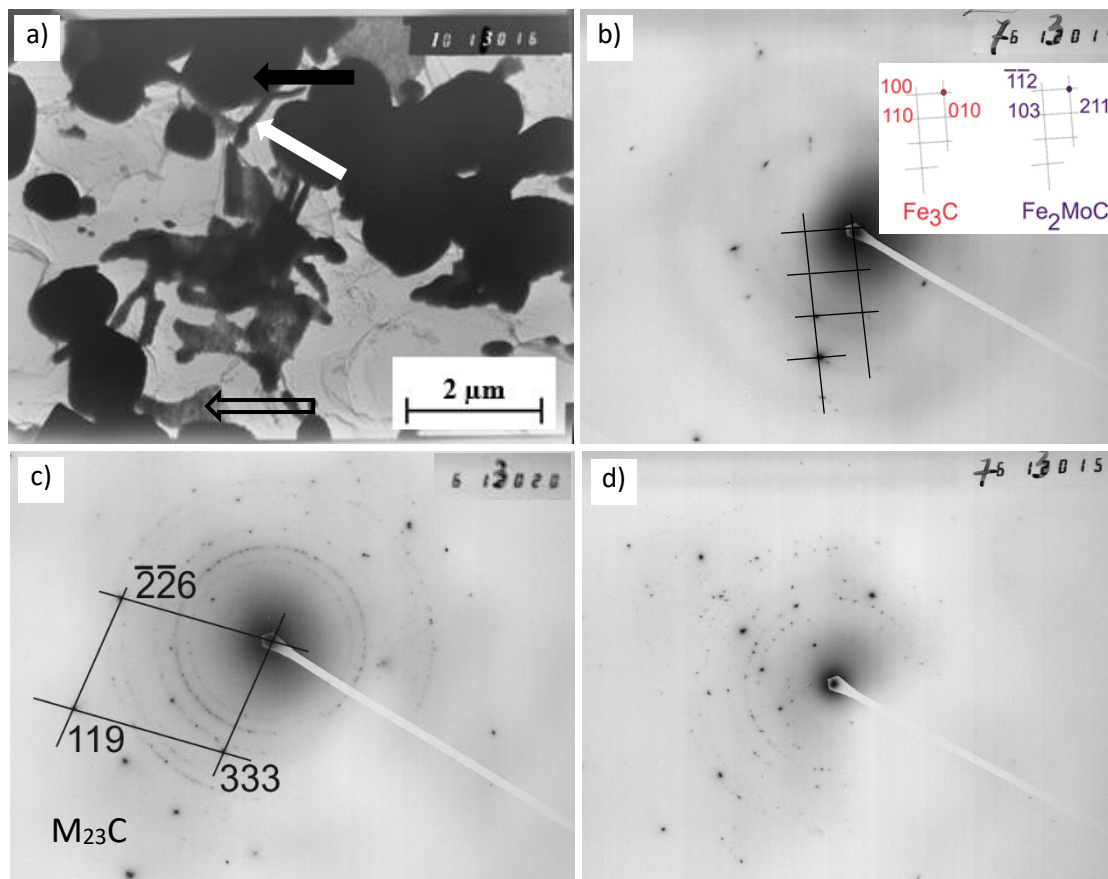
be observed. In the material located below this layer there are large spheroidal carbides between which are visible less precipitations of lamellar structure (Fig. 8a). Diffraction pattern of spheroidal precipitates (Fig. 8b) approximately fit both the  $\text{Fe}_3\text{C}$  and  $\text{Fe}_2\text{MoC}$  carbides. This will probably carbides  $\text{Fe}_{3-x}\text{Mo}_x\text{C}$ , where  $x \in (0, 1)$ . Diffraction pattern with a lamellar precipitates (Fig. 8c, d) approximately fit both  $\text{Fe}_2\text{MoC}$ ,  $\text{Fe}_3\text{C}$ , and  $\text{M}_{23}\text{C}_6$  carbides. They are likely to be undergoing transformation  $\text{M}_{23}\text{C}_6 \rightarrow \text{M}_3\text{C}$  carbides. Lamellar carbides can be also observed at the bottom of large, spheroidal precipitates imprints, which could not be extracted on replica (Fig. 9). They are probably carbides, which nucleate at interfaces previously created carbide/ferritic matrix. With increasing distance from the surface of the inner tube increases the share of lamellar precipitates (Fig. 10a). Diffraction of these precipitates are equally suitable for  $\text{Fe}_2\text{MoC}$  and to  $\text{Fe}_3\text{C}$  carbides (Fig. 10b). With increasing distance from the surface of the inner tube decreases the size of spheroidal

Fig. 8. Large spheroidal, and smaller lamellar precipitates occurring in the material at a distance of 5-10  $\mu\text{m}$  of a continuous layer of carbide (bright field) – Fig. a). The diffraction pattern of spheroidal precipitates depicted by black arrow in Fig. a); diffraction reflections at approximately adjust both the cementite and carbide  $\text{Fe}_2\text{MoC}$  – Fig. b). The diffraction pattern of the lamellar precipitates depicted by white arrow in Fig. a) identified as  $\text{M}_{23}\text{C}_6$  carbide (there are deviations of the measured Bragg angles of the table values) – Fig. c). Diffraction pattern of the lamellar precipitates depicted by the transparent arrow in Fig. a): in the best approximate fit  $\text{Fe}_2\text{MoC}$  carbide, but also cementite and carbide  $\text{M}_{23}\text{C}_6$  (with a slightly larger angular misadjusts) – Fig. d)

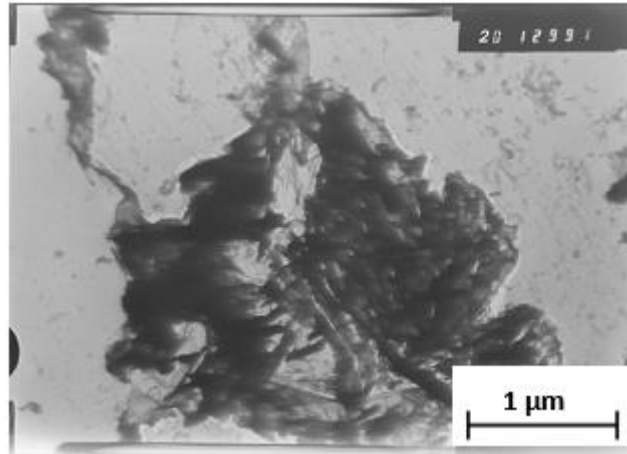
Fig. 9. Small, lamellar precipitations at the bottom of imprints, not extracted spheroidal carbide

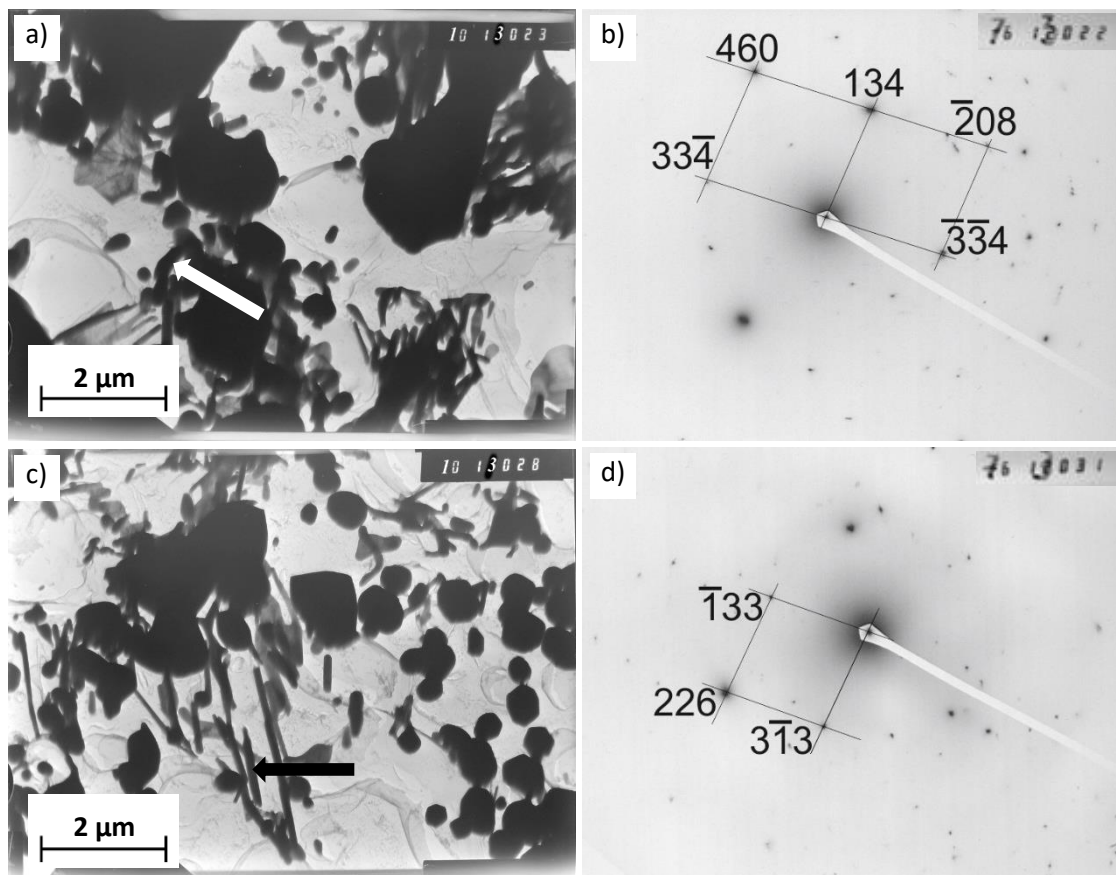
Fig. 10. Image precipitates occurring at a depth of about 50  $\mu\text{m}$  (bright field) – Fig. a). The diffraction pattern of lamellar precipitates depicted by arrow and shown in Fig. a); reflections at approximately adjust both  $\text{Fe}_2\text{MoC}$  carbide as cementite, however, for both angular deviations – Fig. b). Image precipitates occurring at a depth of about 130  $\mu\text{m}$  (bright field) – Fig. c). The diffraction pattern of lamellar precipitates depicted by arrow and shown in Fig. c), identified as carbide  $\text{M}_{23}\text{C}_6$  – Fig. d)

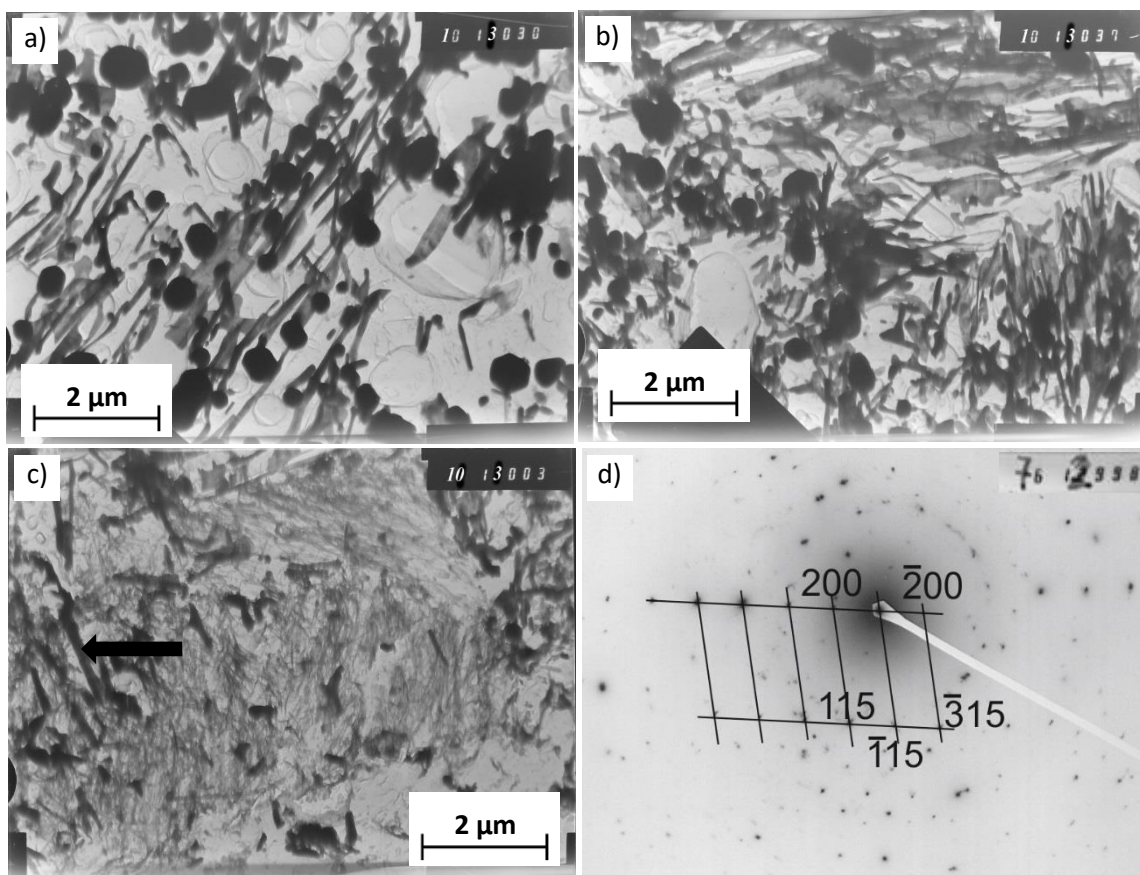
precipitates (Fig. 10c). At a depth of about 350  $\mu\text{m}$  the lamellar precipitates start predominate (Fig. 11a). Diffraction pattern of these precipitates were identified as  $\text{M}_{23}\text{C}_6$  type carbides. At a depth of about 500  $\mu\text{m}$  there is visible a distinct predominance of lamellar precipitates (Fig. 11b). The morphology of the precipitates present in the steel at a depth greater than the thickness of the carburized layer (the core pipe) is shown in Fig. 11c. Diffraction analysis showed that the dominant type of precipitates in the core tubes are  $\text{M}_{23}\text{C}_6$  type carbides (Fig. 11d).

Fig. 11. Image precipitates occurring at a depth of about 350  $\mu\text{m}$  – Fig. a), about 500  $\mu\text{m}$  – Fig. b), and the image extraction replica at a depth greater than the thickness of the carburized layer – Fig. c) (all bright field). The diffraction pattern of lamellar precipitates depicted by arrow and shown in Fig. c), identified as  $M_{23}C_6$  carbides – Fig. d)

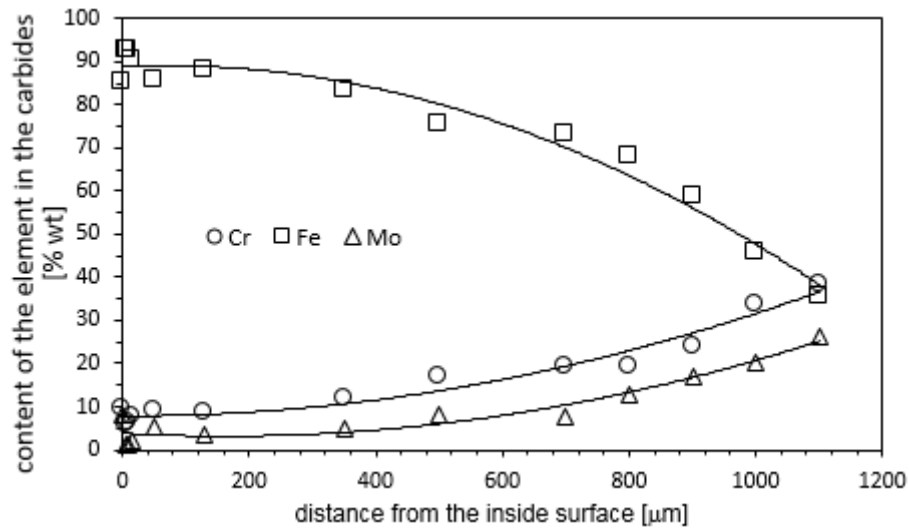
With the help of the EDS technique, an analysis of the chemical composition of precipitates were also performed. Analysis of a layer of corrosion products determined as the distance - zero. Changes in the chemical composition of the precipitates as a function of a distance from the inner surface of the

tube are shown in Fig. 12. As is apparent from Fig. 12, the content of chromium and molybdenum in precipitates increases with increasing distance from the inner surface of the tube.

Fig. 12. Content of the chromium, molybdenum and iron in the carbides as a function of distance from the inside surface (IS) of the tube
