World Multidisciplinary Civil Engineering-Architecture-Urban Planning Symposium 2016,
WMCAUS 2016

Cast Iron Staircase in Aleksandrów Kujawski (Poland) - History, Construction, Architectural Form

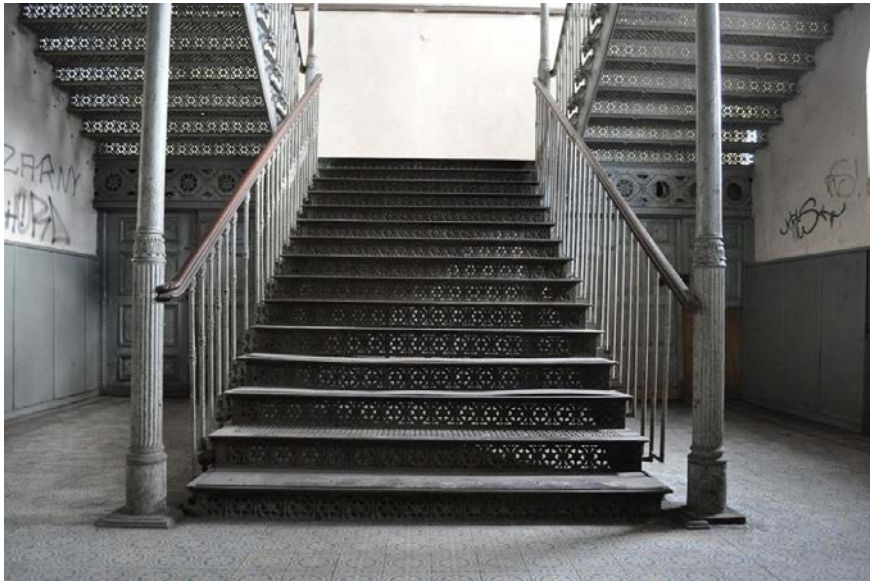
The railway station complex is entered in the register of monuments and remains under the protection of Kujawsko-Pomorskie Voivodship Regional Heritage Conservator. However the current condition of the stairs should be assessed as bad. Most parts of the barriers are damaged. Lack of some vertical bars, cast iron ornaments are broken off, or complete lack of them. The condition of some treads was so poor that, in order to further use of the steps it was necessary to mount on them additional items of flat sheet. Wooden stairs' walls which are partially damaged were repaired temporarily by the residents of the building by placing fibre panels. Interim actions allow to use that vintage construction, but it is still deteriorating (Fig. 1).

Fig. 1. Cast iron staircase: general view.

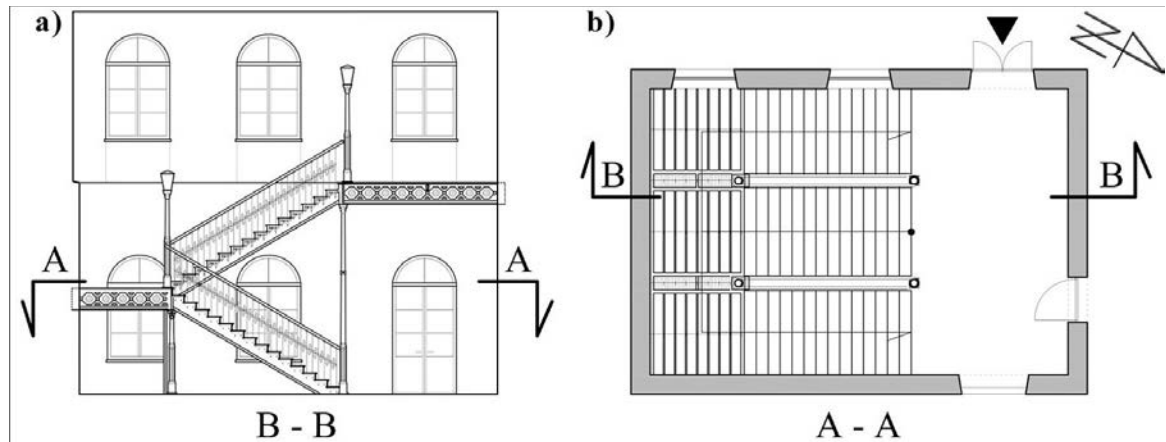
Fig.2. Cast iron staircase, stocktaking:(a) longitudinal cross section; (b) floor plan at the height of first platform.

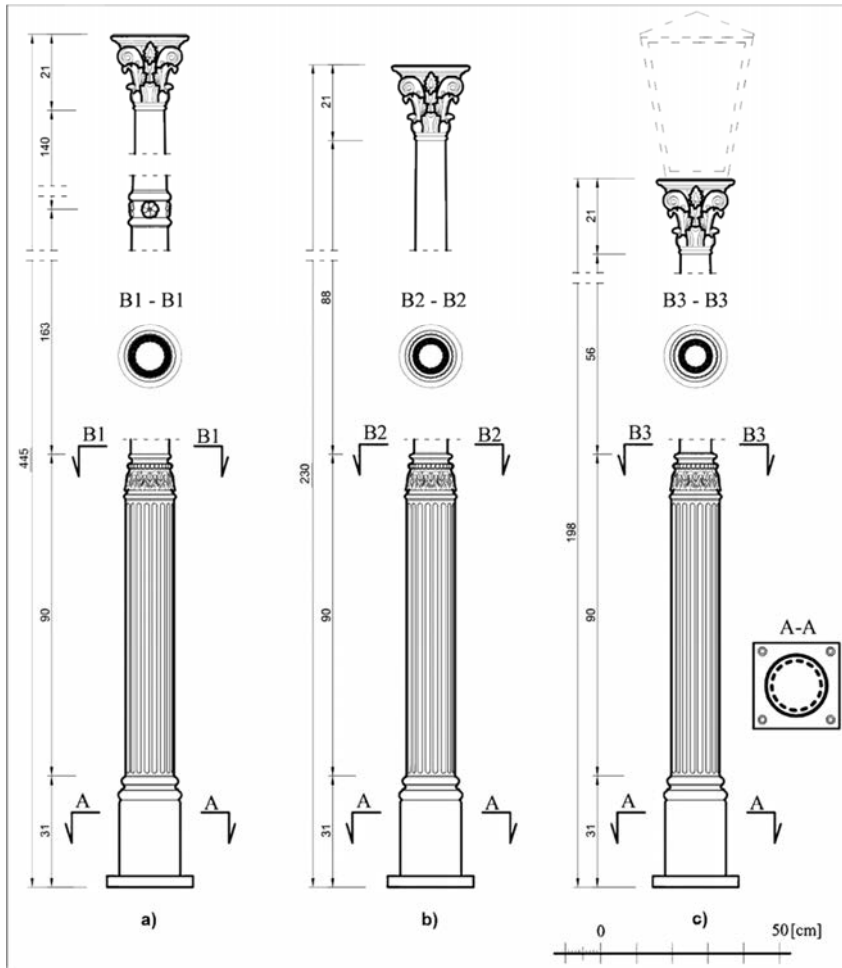
Fig. 3. Cast iron staircase, stocktaking: (a, b) columns; (c) lantern.

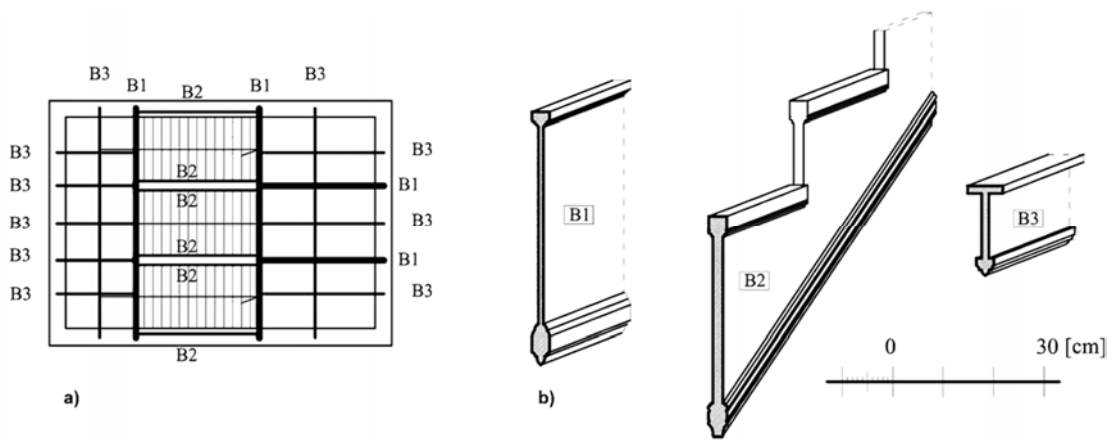
Fig. 4. Cast iron staircase, stocktaking: (a) scheme of construction layout, B1, B2, B3 – types of beams; (b) types of beams.

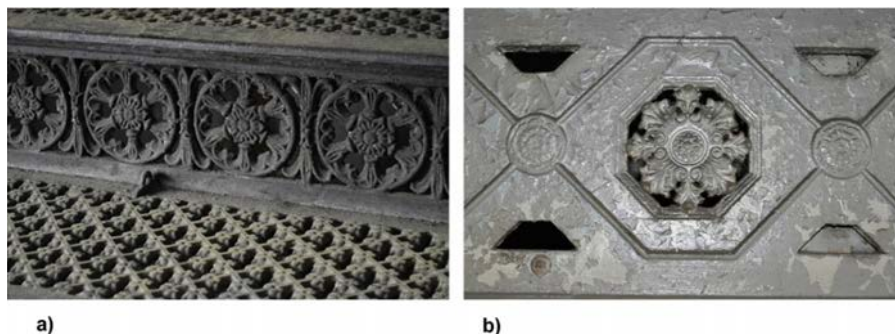
Fig. 5. Cast iron staircase, ornament: (a) the stair riser and the stair tread; (b) the main load bearing beam (B1).
