# Excavation induced cast iron pipeline failure – a numerical study

Dr inż. Krzysztof Szarf, dr inż. Rafał Ossowski

Gdańsk University of Technology, Faculty of Civil and Environmental Engineering

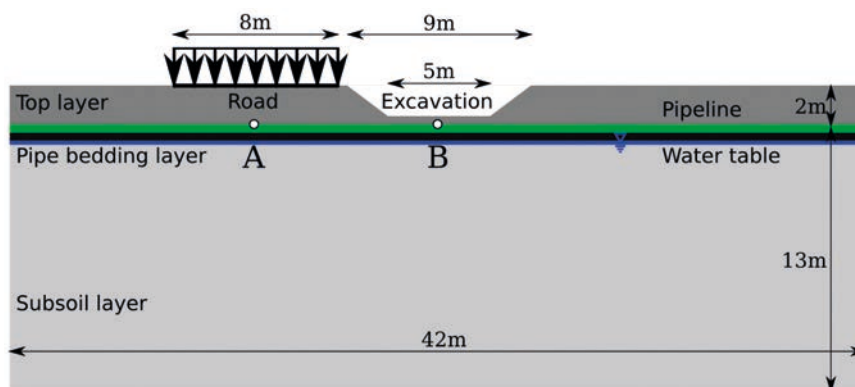
Figure 1. 2D geometry of the problem. Two points of interest, below the centerline of the road and the excavation centerline, were denoted A and B. The largest soil deformations occurred around these points

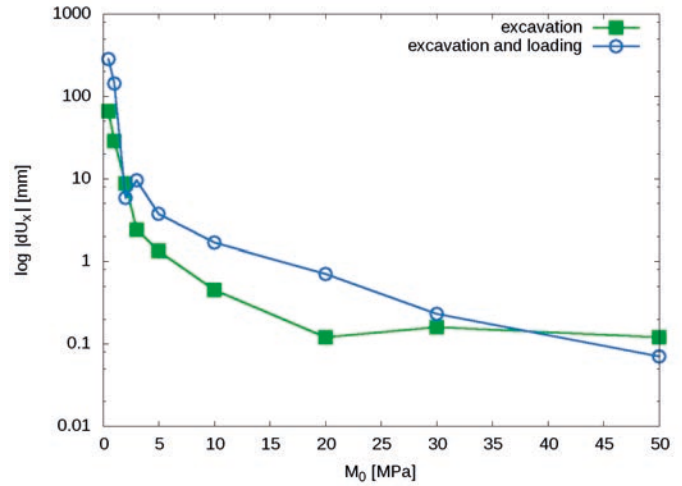
Figure 2. Upper-bound case (pipe with no stiffness) horizontal differential displacements  $|U_x^A - U_x^B|$  plotted against subsoil oedometric modulus

These simulations lead to a conclusion that the soils with oedometric modulus  $M_0 \leq 5$  MPa could cause differential settlements greater than 100 mm. Such values of displacements acting on rigid pipe elements could damage bell and spigot pipe joints. Therefore the second group of simulations was focused on these types of soils.

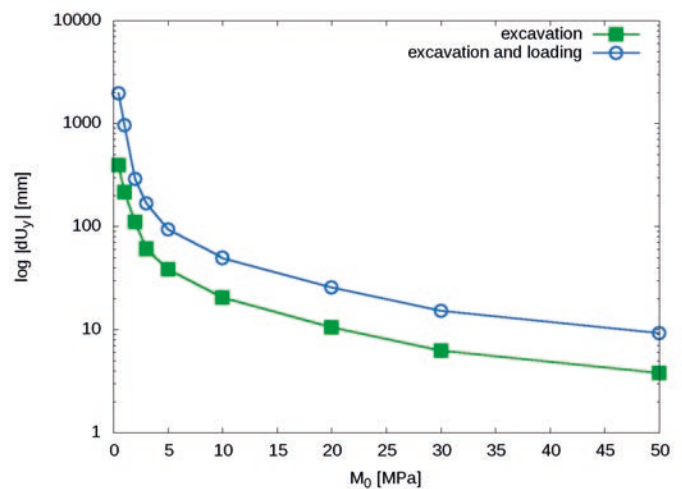
Figure 3. Upper-bound case (pipe with no stiffness) vertical differential displacements  $|U_y^A - U_y^B|$  plotted against subsoil oedometric modulus

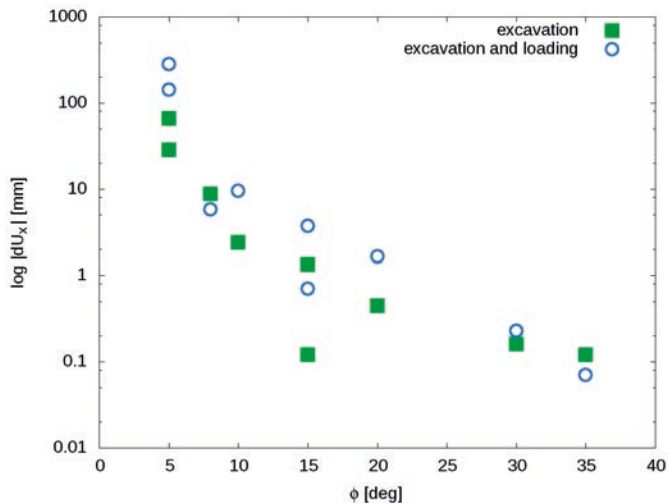
As expected, the analysis indicated the oedometric modulus  $M_0$  is the most important parameter for soil settlements. Moreover, its value is correlated to values of the other mechanical parameters. As an example, in Figure 4 and Figure 5 the differential displacements are plotted as a function of the internal friction angle and show a similar trend (it is clear however that lower values of friction angle are correlated to lower oedometric modulus, which determines soil deformations).

Figure 4. Upper-bound case (pipe with no stiffness) horizontal differential displacements  $|U_x^A - U_x^B|$  plotted against subsoil internal friction angle

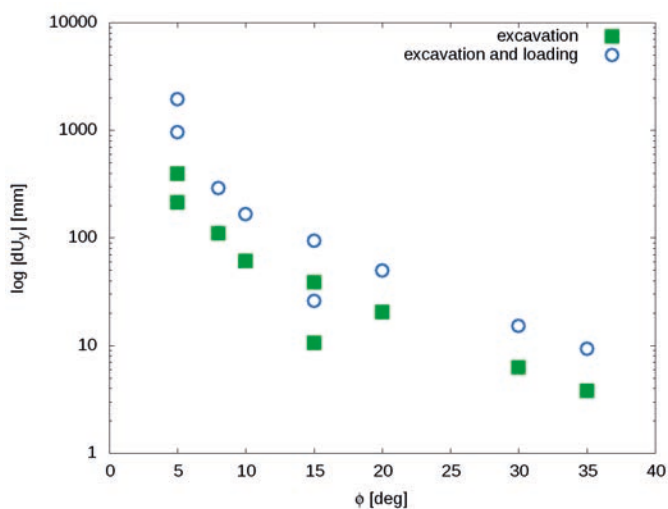
Figure 5. Upper-bound case (pipe with no stiffness) vertical differential displacements  $|U_y^A - U_y^B|$  plotted against subsoil internal friction angle

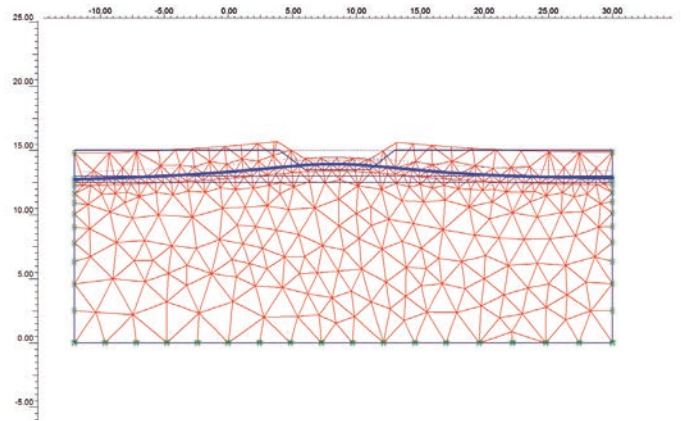
tion, but without traffic loading. Figure 6 depicts a deformed mesh with indicated uplift caused by unloading the trench. Figure 7 and Figure 8 show detailed displacement fields divided into horizontal and vertical components.

Figure 6. Deformed mesh after excavation (scaled up 10 times)  
Subsoil type: Or – Compacted mud ( $M_0 = 2$  MPa)

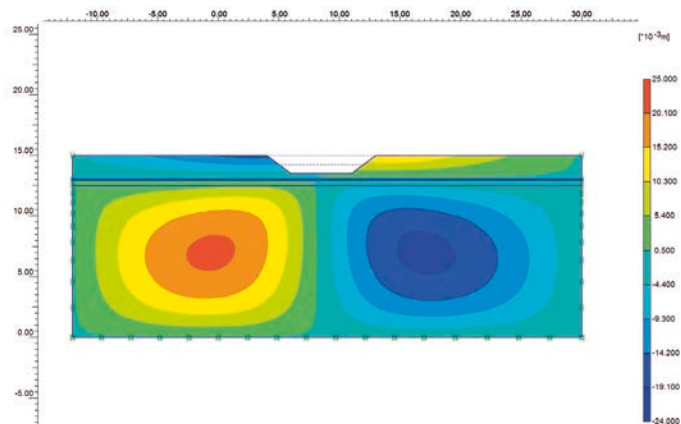
Figure 7. Horizontal soil displacements map (excavation unloading)  
Subsoil type: Or – Compacted mud ( $M_0 = 2$  MPa)

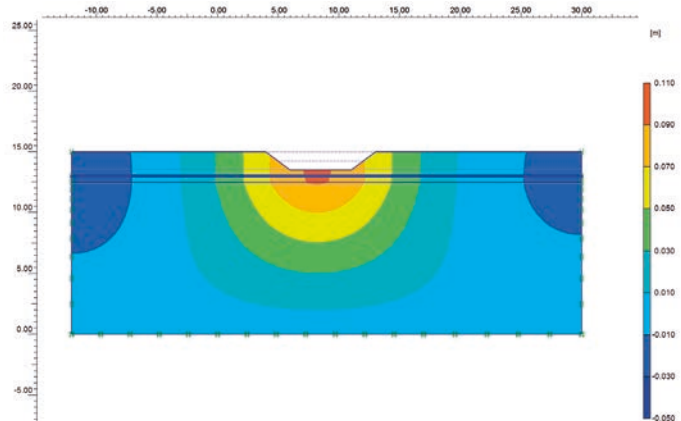
Figure 8. Vertical soil displacements map (excavation unloading)  
Subsoil type: Or – Compacted mud ( $M_0 = 2$  MPa).

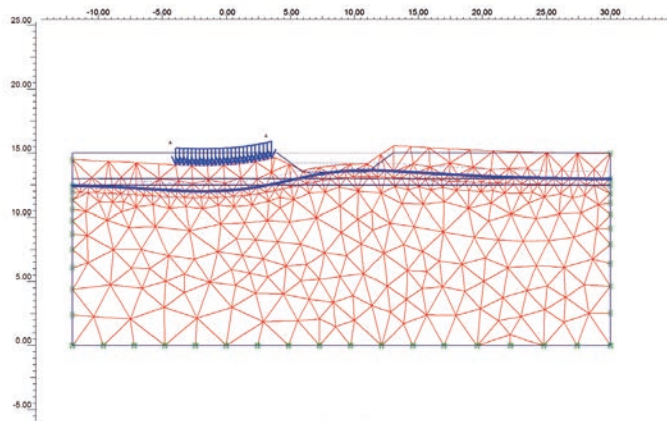
The second failure phase – after applying the loading acting on the road, are presented in Figures 9 ÷ 11. Figure 9 presents a deformed mesh with clearly visible pipe deformation as a result of traffic load. Figure 10 and Figure 11 show detailed displacement fields divided into horizontal and vertical components.

Figure 9. Deformed mesh after traffic loading (scaled up 10 times)  
Subsoil type: Or – Compacted mud ( $M_0 = 2$  MPa)

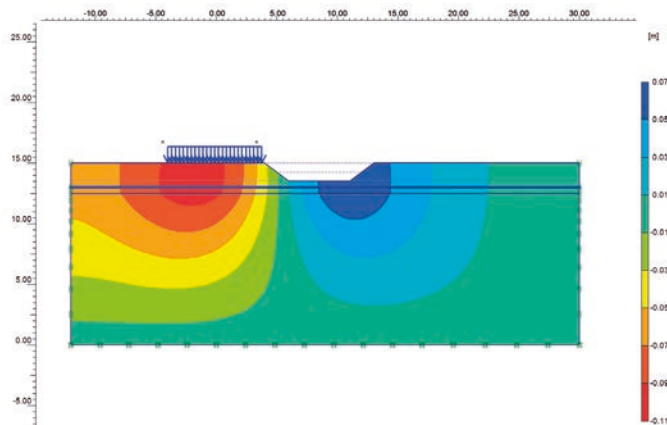
As stated previously, there is a difference in the direction of vertical displacements below the road and below the excavation, see Figure 11. Soil settlements exceed 90 mm below the road centreline, are close to 0 mm at the edge of the excavation near to the road and finally reach 60 mm of uplift on the other side of the excavation. Such differences occurring around points placed less than 15 m from each other could lead either to stress increase in the pipe joint material and possibly fracturing of the bell, or to disjoining of the pipe elements through rotation. Conversely, in Figure 10 we observe smaller horizontal displacements of the soil, in the range of 10 mm. Horizontal soil

Figure 11: Vertical soil displacements map (after traffic loading)  
Subsoil type: Or – Compacted mud ( $M_0 = 2$  MPa)

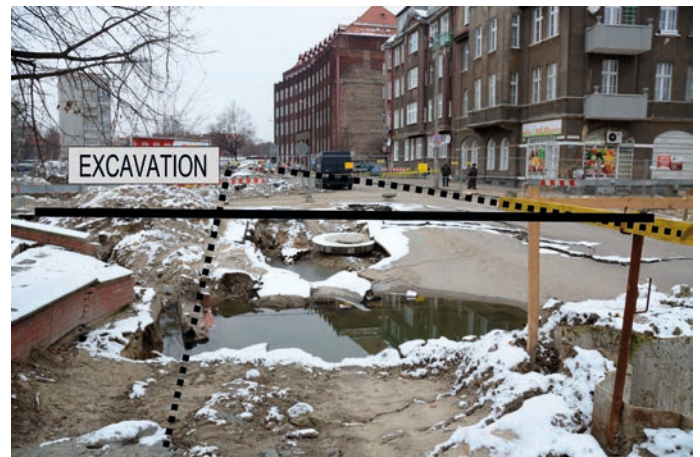
Engineers performing works in dense urban areas with long history often face unexpected complications. The existing infrastructure can pose problems due to imprecise localisation, especially when the archival data are incomplete, uncertainty of its actual technical condition, or due to being subjected to situations not accounted for during its design (e.g. additional constructions in the area or much higher loads). In such environment engineering works should be performed with great care and attention to safety. In the Figure 12 and Figure 13 one can see effects of such unexpected circumstances acting together.

Figure 12. General view of Gdańsk 2013 real-life case of a pipe failure in the vicinity of an unsecured excavation that inspired this study  
Dotted lines indicate road edges while solid line indicates the axis of the pipeline

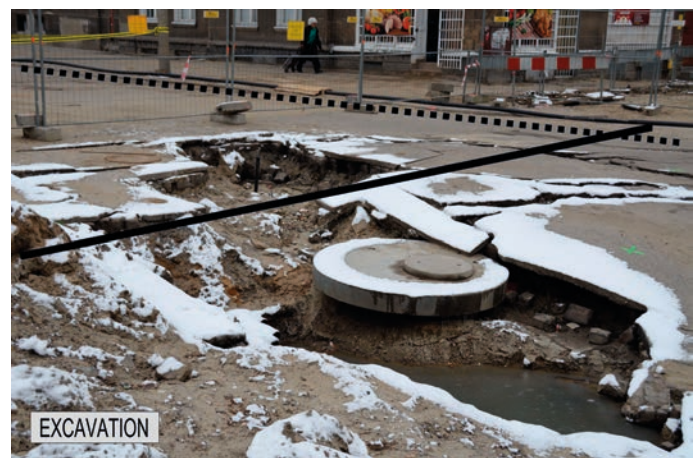
Figure 13. Close-up of the Gdańsk 2013 pipe failure area  
Dotted lines indicate road edges while solid line indicates the axis of the pipeline
