The application of non-destructive methods in the diagnostics of the approach pavement at the bridges

M Miskiewicz, J Lachowicz, P Tysiac, P Jaskula and K Wilde

Faculty of Civil and Environmental Engineering, Gdansk University of Technology, Gdansk, Poland

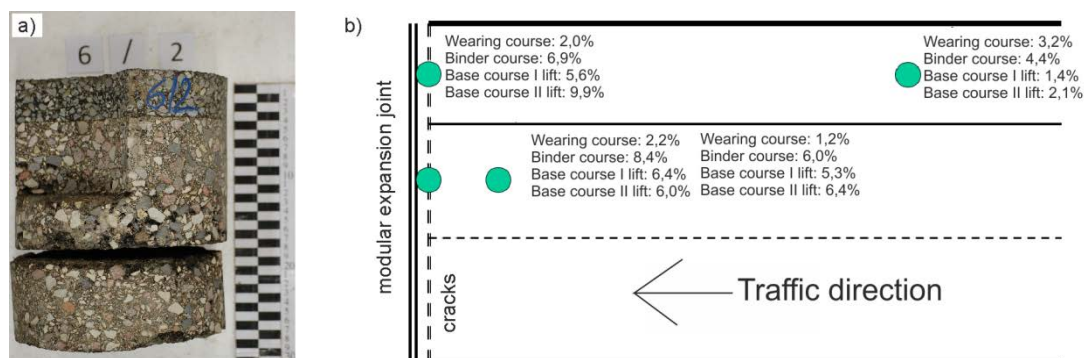
Figure 7. Invasive test results a) core picture b) results of the air voids content in the asphalt layer.

The content of the air voids in the binder course HMAC and two lift layers of the base course from HMAC in samples taken directly at joints, in the vicinity of cracks, was about 2-3 times greater than in the place located about 15 meters from the bridge joint. This would indicate a worse compaction of these layers next to the bridge, compared to the compaction on the regular section. This is confirmed by the appearance of the samples themselves. The samples taken directly at the bridge joint were heterogeneous and porous in some fragments. Tests performed in the laboratory using cores, confirmed the conclusions of non-destructive testing.
