The application of non-destructive methods in the diagnostics of the approach pavement at the bridges

M Miskiewicz, J Lachowicz, P Tysiac, P Jaskula and K Wilde

Faculty of Civil and Environmental Engineering, Gdansk University of Technology, Gdansk, Poland

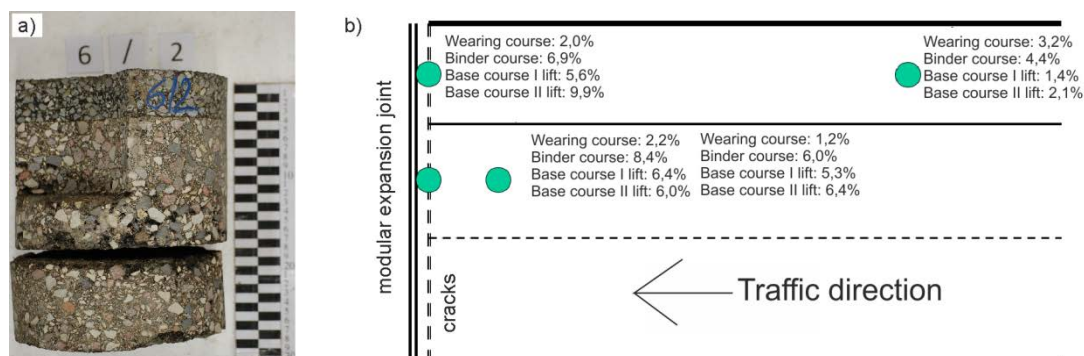
In order to verify the observed zones of inhomogeneous compaction from non-destructive methods, destructive tests were performed (Fig. 7). The cores were used to determine the air void content in the asphalt layers and to determine the range of crack propagation. In addition, information on cores made it possible to determine the thickness of the each layers.

Figure 7. Invasive test results a) core picture b) results of the air voids content in the asphalt layer.

The content of the air voids in the binder course HMAC and two lift layers of the base course from HMAC in samples taken directly at joints, in the vicinity of cracks, was about 2-3 times greater than in the place located about 15 meters from the bridge joint. This would indicate a worse compaction of these layers next to the bridge, compared to the compaction on the regular section. This is confirmed by the appearance of the samples themselves. The samples taken directly at the bridge joint were heterogeneous and porous in some fragments. Tests performed in the laboratory using cores, confirmed the conclusions of non-destructive testing.
