# INFLUENCE OF GEOTECHNICAL CONDITIONS ON DAMAGE STATES OF GDANSK BAY COAST CLIFF FORMATIONS

*A geotechnical aspect of destruction processes of seashores was identified based on the case of erosion of Gdansk Bay Coast cliff formations. Causative factors of landslide were described in the context of natural phenomena, land development and its anthropogenic transformations. Possible directions of theoretical analysis of changes in ground-water relations were indicated.*

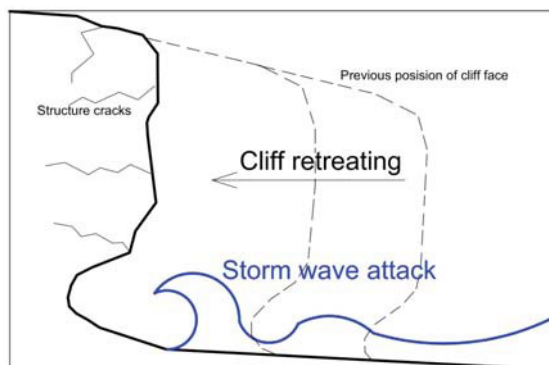
- permanent or periodical attacks of storm sea waves against cliff base [4], as a result of which cliff slope retreats step by step back into the land (Fig. 1),

Fig. 1. Erosion of cliff resulting from storm wave attack

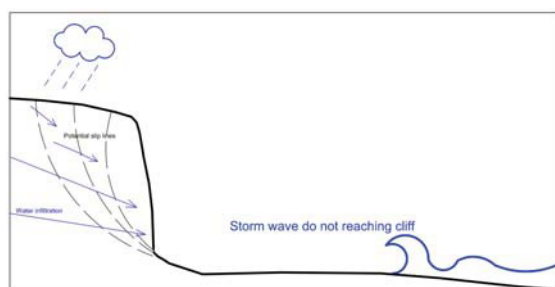
- effects of ground mass forces onto sheer slopes, that results in loss of stability and landslides,
- infiltration and flow of underground water from the side of land towards sea, which liquefies the ground and changes its state (Fig. 2).

Fig. 2. Cliff erosion due to geotechnical effects from the side of land

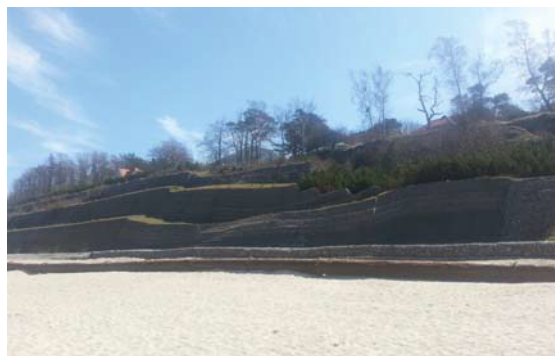
Landslide effects usually cause also destructions of shore protection structures, for instance such as the damage of cliff protection gabion structure shown in Fig. 3.

The deformations could not be caused by storm waves in view of that the beach is a dozen or so meters wide [11]; their causes should be searched in periodical changes in ground-water relations within the cliff itself.

Fig. 3. Deformations of the cliff protection structure made of reinforced ground and gabions (2014) [8]

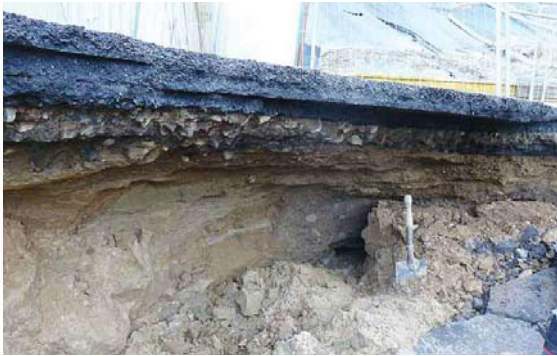
As a result of the critical water pressure produced in pores of the ground, the hydraulic piping flow and its significant pressure occurred, that caused washing away the road embankment and liquefying the ground. This is a frequent cause of building damages associated with changes in ground-water relations, that is described in the geotechnical literature [2]. In the photographic documentation there are visible a hydraulic piping flow canal and a cavern formed as a result of the washing out of

anthropogenic ground layers placed under the roadway (Fig. 4, Fig. 5a, Fig. 5b, Fig 5c).

Fig. 4. A cavern and hydraulic piping flow canal revealed after the damage [10]

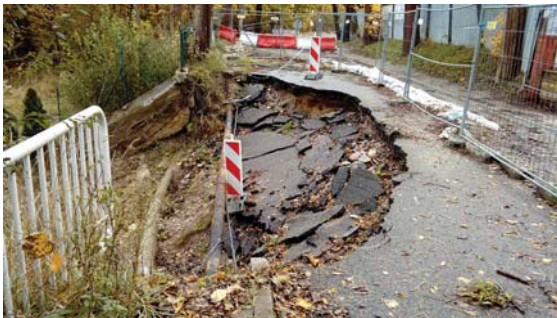
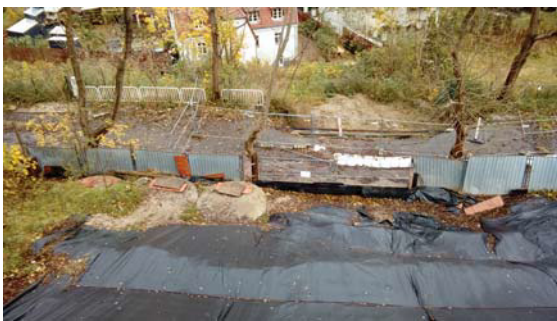
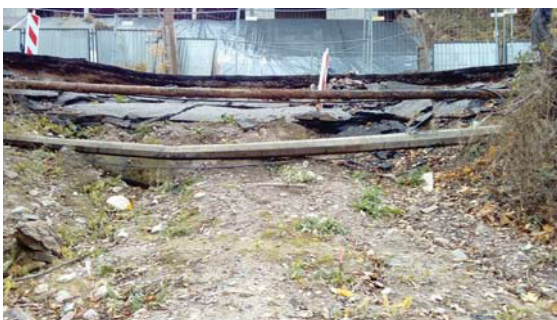
Fig. 5. State of the landslide 8 months after the damage

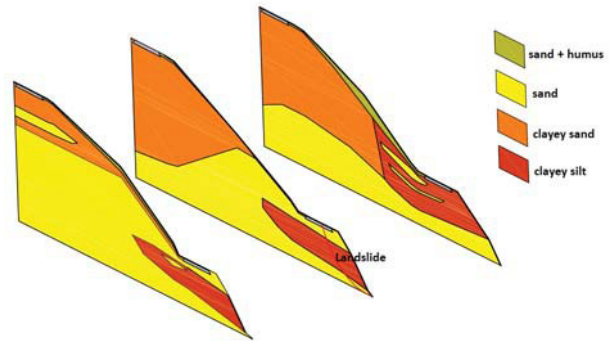
The geotechnical cross-sections in the line of the landslide have confirmed possible water accumulation in ground lens (Fig. 6). On this basis it is possible to conclude that the geological structure of the base in which ground layers of a higher and lower water permeability alternately appear, helps in forming privileged ways of water filtration in the ground and underground water flows concentrated within a rather small space. In the base there are ashy ground layers

which are characteristic of substantially decreased strength parameters in case of watering.

Fig. 6. The geological cross-sections showing stratified grounds of variable filtration ratio within the landslide

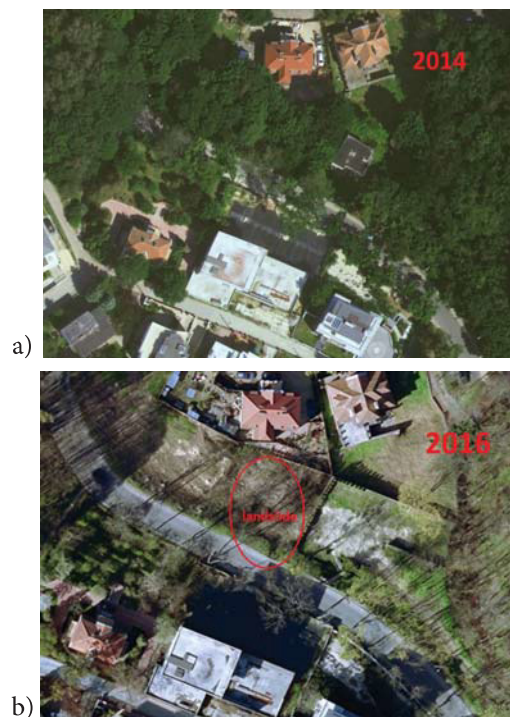
For several years before the landslide event, a devastation of the existing stand of trees has been observed. As a result, a lack of the natural factor holding the ground on the slope has been introduced. The attached photographs reveal a wastage of the stand of trees in this area (Fig. 7a, Fig. 7b).

Fig. 7. Changes in the stand of trees within the landslide, which occurred between the years 2014 and 2016, (Aerial photographs shot by MGGP AERO)

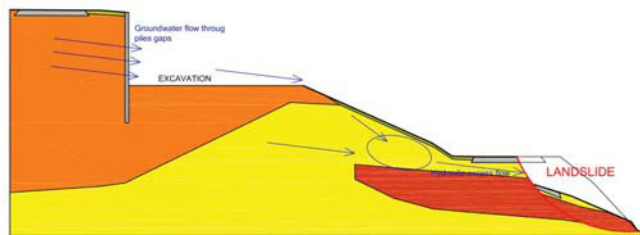
In the building site a complete drainage system has not been made. Till the break in the building works only a part of band drainage has been worked out. No storage reservoir, the crucial element of the drainage system, intended for storing the rainfall water, has been built. The completion of only a part of the rainfall water intake and storage system had more detrimental effect onto stability of the slope than a complete lack of it. The drained rainfall water was directed straight into the ground, penetrating its deeper layers, directly.

Fig. 8. Direction of hydraulic excess flow under the road of Sienkiewicz street.

Over the entire cliff area there is legally forbidden to discharge the rainfall water off the buildings and hardened surface areas directly into the ground because the terrain is deemed susceptible to landslides [10]. Till the occurrence of slope damage, the rainfall waters were discharged directly into the ground. It resulted in a degradation of its strength parameters in the analyzed area, especially in places where ashy ground layers were present. The damage mechanism is highlighted in Fig. 8.
