# INFLUENCE OF GEOTECHNICAL CONDITIONS ON DAMAGE STATES OF GDANSK BAY COAST CLIFF FORMATIONS

## ABSTRACT

*A geotechnical aspect of destruction processes of seashores was identified based on the case of erosion of Gdansk Bay Coast cliff formations. Causative factors of landslide were described in the context of natural phenomena, land development and its anthropogenic transformations. Possible directions of theoretical analysis of changes in ground-water relations were indicated.*

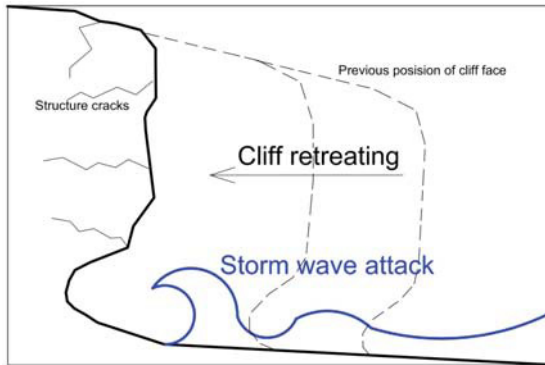
- permanent or periodical attacks of storm sea waves against cliff base [4], as a result of which cliff slope retreats step by step back into the land (Fig. 1),

Fig. 1. Erosion of cliff resulting from storm wave attack

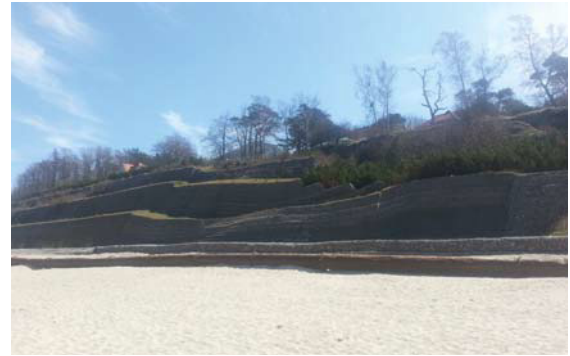
Landslide effects usually cause also destructions of shore protection structures, for instance such as the damage of cliff protection gabion structure shown in Fig. 3.

The deformations could not be caused by storm waves in view of that the beach is a dozen or so meters wide [11]; their causes should be searched in periodical changes in ground-water relations within the cliff itself.

Fig. 3. Deformations of the cliff protection structure made of reinforced ground and gabions (2014) [8]
