INFLUENCE OF GEOTECHNICAL CONDITIONS ON DAMAGE STATES OF GDANSK BAY COAST CLIFF FORMATIONS

ABSTRACT

A geotechnical aspect of destruction processes of seashores was identified based on the case of erosion of Gdansk Bay Coast cliff formations. Causative factors of landslide were described in the context of natural phenomena, land development and its anthropogenic transformations. Possible directions of theoretical analysis of changes in ground-water relations were indicated.

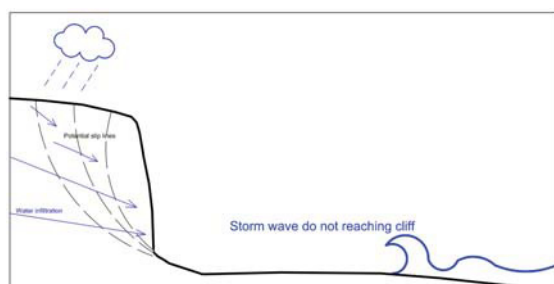
- effects of ground mass forces onto sheer slopes, that results in loss of stability and landslides,
- infiltration and flow of underground water from the side of land towards sea, which liquefies the ground and changes its state (Fig. 2).

Fig. 2. Cliff erosion due to geotechnical effects from the side of land

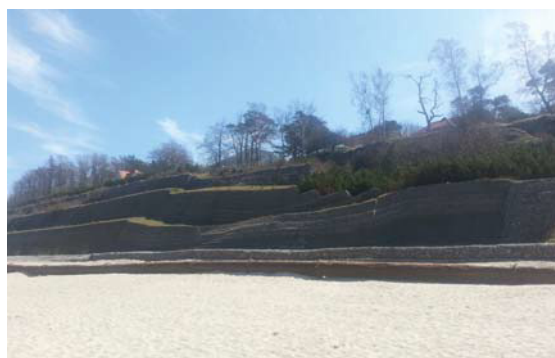
Landslide effects usually cause also destructions of shore protection structures, for instance such as the damage of cliff protection gabion structure shown in Fig. 3.

The deformations could not be caused by storm waves in view of that the beach is a dozen or so meters wide [11]; their causes should be searched in periodical changes in ground-water relations within the cliff itself.

Fig. 3. Deformations of the cliff protection structure made of reinforced ground and gabions (2014) [8]

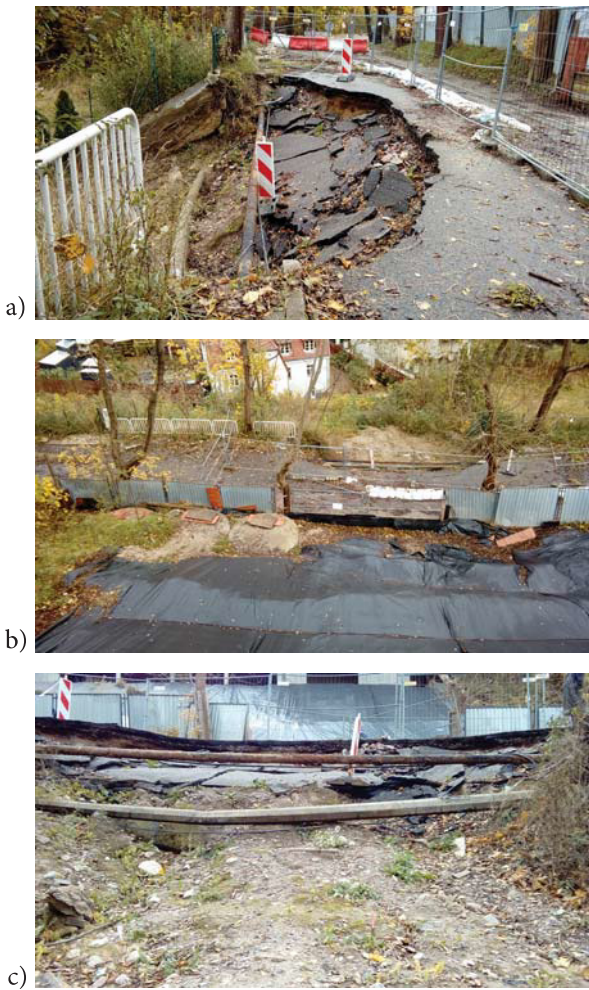
Fig. 5. State of the landslide 8 months after the damage
