DEGRADATION OF THE CONCRETE RAILWAY TRACK BED LOCATED IN THE VICINITY OF THE LOADING WHARF

Maciej Niedostatkiewicz

Gdańsk University of Technology, Faculty of Civil and Environmental Engineering, Poland

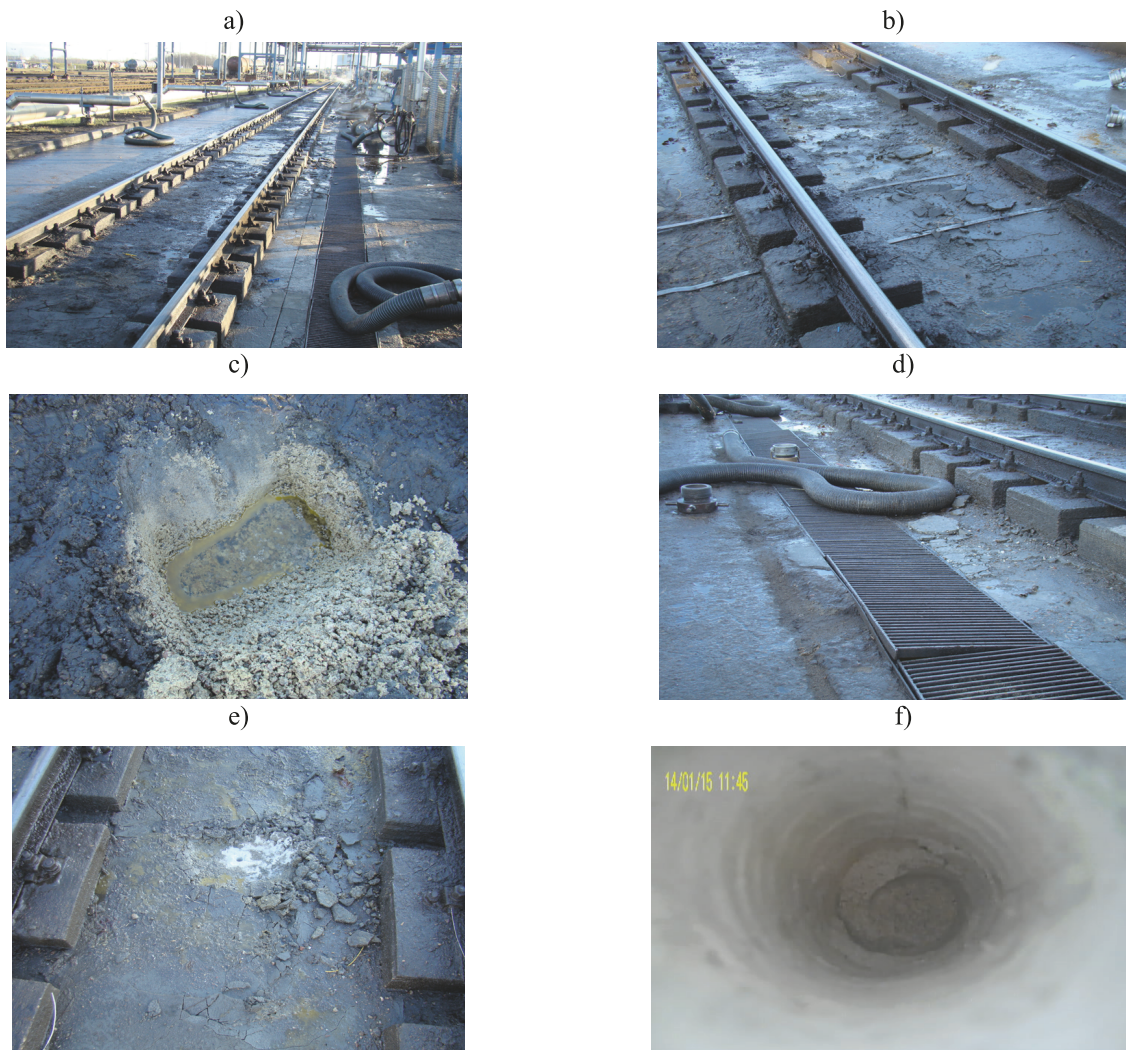
The most intense damage occurred at the length of the middle part of the track bed with a length of about 40 m. In this part the most damaged element was the middle section of the plate located between the rail heads (Fig.3a and Fig.3b). In the main part of the track bed the following damage to the upper surface of the board was found: separation of the PCC layer from the cracking ground, scratches and oil saturation of the concrete slab and PCC. Made in the past (~ 2 years ago), the layer was intensely fractured and carried traces of freezing (frosty scratches). Open pits ascertained that oil-based liquids gathered (by inflowing) from the sub-surface of the subgrade due to unloading of railway tanks (Fig. 3c). The depth of damage to the concrete layer was up to 6 cm, and structural reinforcement bars were visible. The drainage channel located along the road, located between the main part of the track bed and the drainage tray (Fig.2) was

deformed in an intensive manner. The concrete had extensive damage along drainage grates - a sectional drainage channel was replaced ~ 2 years ago as part of the works related to the reprofiling of the substrate. Despite the application of systemic repair solutions (built-in reinforced concrete, prefabricated elements of linear drainage) along the channel, the joints of the channel profiles were found to be broken and the surface layer of the concrete damaged (Fig.3d).

Fig. 3. Track with track bed: a) general view, b) damage to the main part of the track bed, c) open pit in the middle of the track between the rails, d) damage to the drainage channel, e) open pit - control hole, f) the interior of the control hole

In the described case of a concrete railway subgrade, soil saturation with petroleum products was found, based on the conducted ground tests. The soil did not soften despite the contamination. The homogeneity of concrete in the made-out pits was sufficient for surface repairs - the concrete had a compact structure [2], [5]-[6]. Also on the concrete surface, after removing the damaged PCC trip layer, no crayfish or caverns were found (Fig.3e and Fig.3f). The maximum depth of damaged concrete was 6 cm.

The direct cause of damage to the concrete substructure structure, including the PCC repair mortar layer, was the poor quality of the works performed and the use of materials not intended for use in the aggressive operating environment (with agents negatively affecting the concrete). The repair materials used did not provide the designed durability and resistance of the concrete railway sub-floor.

Due to the range of damages, renovation works had to be carried out in the STAGE system.

STAGE 1 (for urgent implementation) included:

I) ad hoc removal of loose fragments of the PCC and concrete,

II) initial geodetic surveying of rectilinearity and inclination of the track rails as well as running control measurements of the subgrade at regular intervals. It was recommended to perform geodetic measurements at intervals of 4 weeks in winter and at intervals of 2 weeks in the spring and summer. During the measurements, particular attention should be paid to the measurement of linearity, verticality and inclination of the heads of the rails with respect to each other,

III) sub-division of the subgrade to working plots and execution of works including:

- a) pressure washing with water and detergents,
- b) priming washed concrete surface: for matt-damp concrete applying a protective layer of epoxy resin for oily floors and sprinkling it with quartz sand (annealed with fire),
- c) making buffer layer of epoxy resin and sprinkling it with quartz sand,
- d) reprofiling the upper surface a mortar based on epoxy resin mixed with quartz aggregate,
- e) applying a support layer of resin resistant to petroleum products.

At the same time, work related to the repair of dilatation had to be carried out in parallel with the work related to the construction of the strain, buffer and putty layers.

STAGE 2 (for the final implementation during the overhaul) included reconstruction of the main part of the track bed and the sewage tray based on systemic prefabricates made of polymer concrete resistant to oil-based liquids - in the newly designed subgrade layer system horizontal damp insulation was to be designed, also fulfilling the role of anti-oil insulation laid on the foundation layer of lean concrete B15 (C12 / 15). As insulation material, it has been recommended to use, for example, oil and bitumen protective foil with a minimum thickness of 2 mm..
