DEGRADATION OF THE CONCRETE RAILWAY TRACK BED LOCATED IN THE VICINITY OF THE LOADING WHARF

Maciej Niedostatkiewicz

Gdańsk University of Technology, Faculty of Civil and Environmental Engineering, Poland

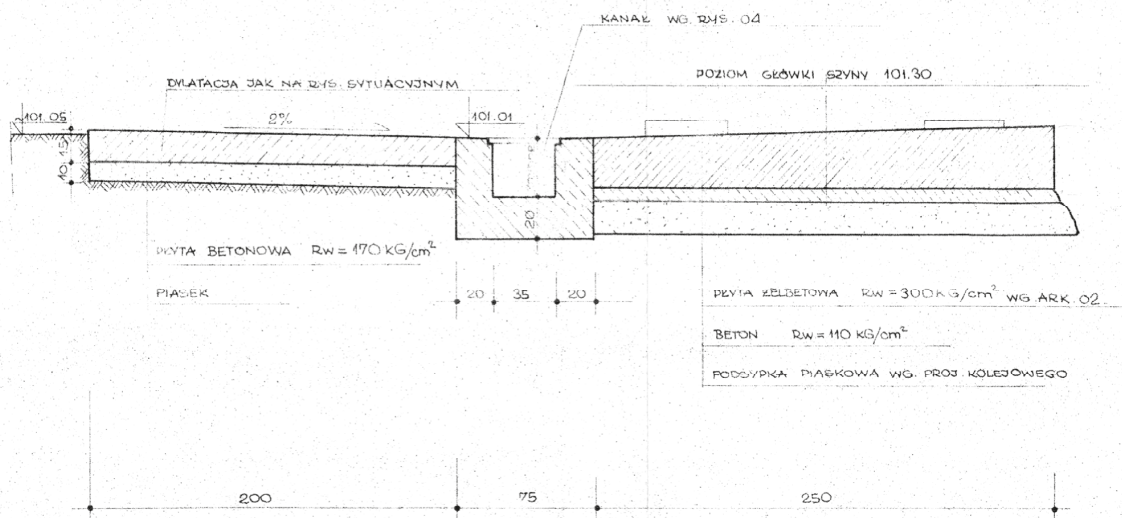
PRZEKRÓJ POPRZECZNY UTWARDZENIA 1: 20

Fig. 1. The design solution of the concrete railway subgrade-cross-section (based on archival project documentation)

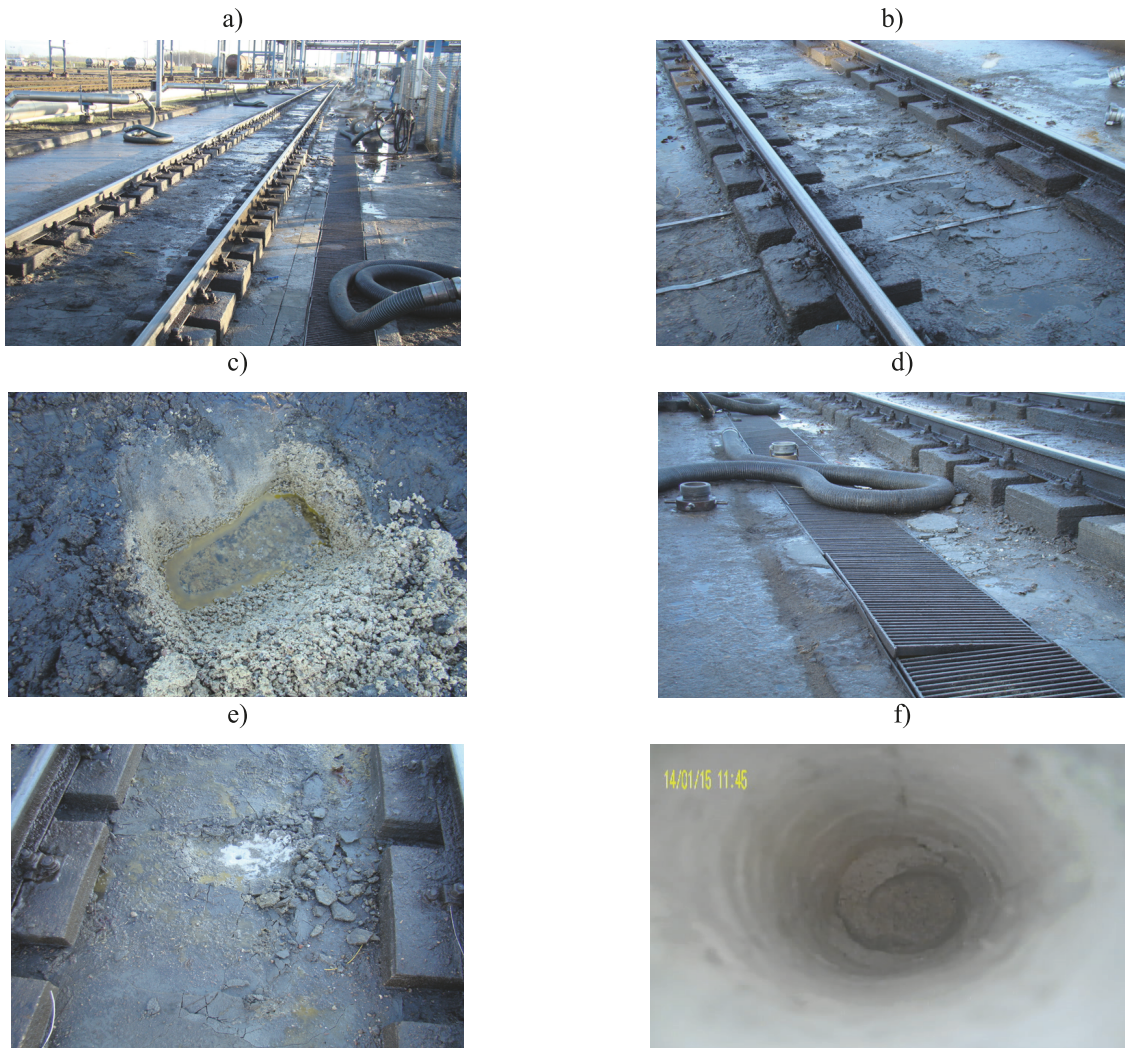
The most intense damage occurred at the length of the middle part of the track bed with a length of about 40 m. In this part the most damaged element was the middle section of the plate located between the rail heads (Fig.3a and Fig.3b). In the main part of the track bed the following damage to the upper surface of the board was found: separation of the PCC layer from the cracking ground, scratches and oil saturation of the concrete slab and PCC. Made in the past (~ 2 years ago), the layer was intensely fractured and carried traces of freezing (frosty scratches). Open pits ascertained that oil-based liquids gathered (by inflowing) from the sub-surface of the subgrade due to unloading of railway tanks (Fig. 3c). The depth of damage to the concrete layer was up to 6 cm, and structural reinforcement bars were visible. The drainage channel located along the road, located between the main part of the track bed and the drainage tray (Fig.2) was

deformed in an intensive manner. The concrete had extensive damage along drainage grates - a sectional drainage channel was replaced ~ 2 years ago as part of the works related to the reprofiling of the substrate. Despite the application of systemic repair solutions (built-in reinforced concrete, prefabricated elements of linear drainage) along the channel, the joints of the channel profiles were found to be broken and the surface layer of the concrete damaged (Fig.3d).

Fig. 3. Track with track bed: a) general view, b) damage to the main part of the track bed, c) open pit in the middle of the track between the rails, d) damage to the drainage channel, e) open pit - control hole, f) the interior of the control hole

In the described case of a concrete railway subgrade, soil saturation with petroleum products was found, based on the conducted ground tests. The soil did not soften despite the contamination. The homogeneity of concrete in the made-out pits was sufficient for surface repairs - the concrete had a compact structure [2], [5]-[6]. Also on the concrete surface, after removing the damaged PCC trip layer, no crayfish or caverns were found (Fig.3e and Fig.3f). The maximum depth of damaged concrete was 6 cm.

The direct cause of damage to the concrete substructure structure, including the PCC repair mortar layer, was the poor quality of the works performed and the use of materials not intended for use in the aggressive operating environment (with agents negatively affecting the concrete). The repair materials used did not provide the designed durability and resistance of the concrete railway sub-floor.

Due to the range of damages, renovation works had to be carried out in the STAGE system.

STAGE 1 (for urgent implementation) included:

I) ad hoc removal of loose fragments of the PCC and concrete,

II) initial geodetic surveying of rectilinearity and inclination of the track rails as well as running control measurements of the subgrade at regular intervals. It was recommended to perform geodetic measurements at intervals of 4 weeks in winter and at intervals of 2 weeks in the spring and summer. During the measurements, particular attention should be paid to the measurement of linearity, verticality and inclination of the heads of the rails with respect to each other,

III) sub-division of the subgrade to working plots and execution of works including:

- a) pressure washing with water and detergents,
- b) priming washed concrete surface: for matt-damp concrete applying a protective layer of epoxy resin for oily floors and sprinkling it with quartz sand (annealed with fire),
- c) making buffer layer of epoxy resin and sprinkling it with quartz sand,
- d) reprofiling the upper surface a mortar based on epoxy resin mixed with quartz aggregate,
- e) applying a support layer of resin resistant to petroleum products.

At the same time, work related to the repair of dilatation had to be carried out in parallel with the work related to the construction of the strain, buffer and putty layers.

STAGE 2 (for the final implementation during the overhaul) included reconstruction of the main part of the track bed and the sewage tray based on systemic prefabricates made of polymer concrete resistant to oil-based liquids - in the newly designed subgrade layer system horizontal damp insulation was to be designed, also fulfilling the role of anti-oil insulation laid on the foundation layer of lean concrete B15 (C12 / 15). As insulation material, it has been recommended to use, for example, oil and bitumen protective foil with a minimum thickness of 2 mm..

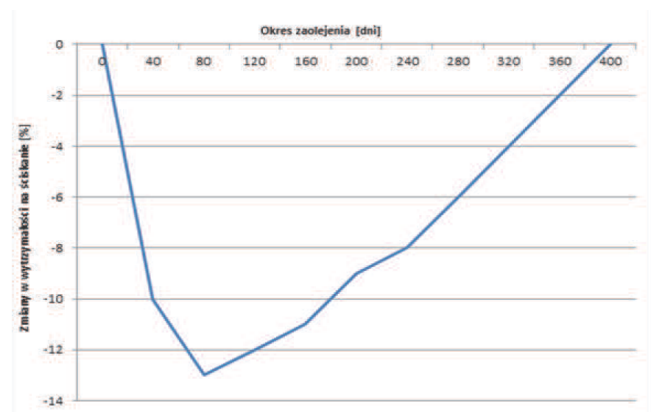
In oily concrete, bacteria (aerobic and anaerobic) develop in the presence of water, while organic acids, hydrogen sulphide are produced and the pH of the water decreases. In oiled concrete durability decreases compared to the condition before oil formation - there is the phenomenon called concrete softening, and the long-term impact of organic acids results in a decrease in the mass of concrete, as a result of the dissolution of the cement binder and increase in its porosity. As a result of the dissolution of the binder, the durability of the concrete decreases significantly. The drop in concrete strength depends on the type of oil and the time of exposure of the concrete to oiling [3-4] (Fig.4).

Fig. 4. Change in compressive strength of concrete (vertical axis-%) contaminated with diesel oil versus (horizontal axis-time (days)) (Błaszczczyński 1995)
