X-RAY COMPUTER TOMOGRAPHY STUDY OF DEGRADATION OF THE ZIRCALOY-2 TUBES OXIDIZED AT HIGH TEMPERATURES

The investigations of high-temperature oxidation of zirconium alloys, applied for fuel pellets in nuclear power plants, are usually limited to oxidation kinetics, phase transformations and microstructural characterization. The purpose of this research was to characterize the degradation phenomena occurring within oxide layer and at the interface oxide/metal, on internal and external Zircaloy-2 tube surfaces, below and over crystalline transformation temperature of zirconium oxides. The commercial tubes were oxidized at 1273 K and 1373 K in calm air for 30 min and then examined with a technique novel for such purpose, namely a high-resolution X-ray computer tomography. The light microscopy was used to examine the cross-surfaces. The obtained results show that the form and intensity of oxide damage is significant and it is in a complicated way related to oxidation temperature and on whether external or internal tube surface is studied. The found oxide layer damage forms include surface cracks, the detachment of oxide layers, the appearance of voids, and nodular corrosion. The oxidati

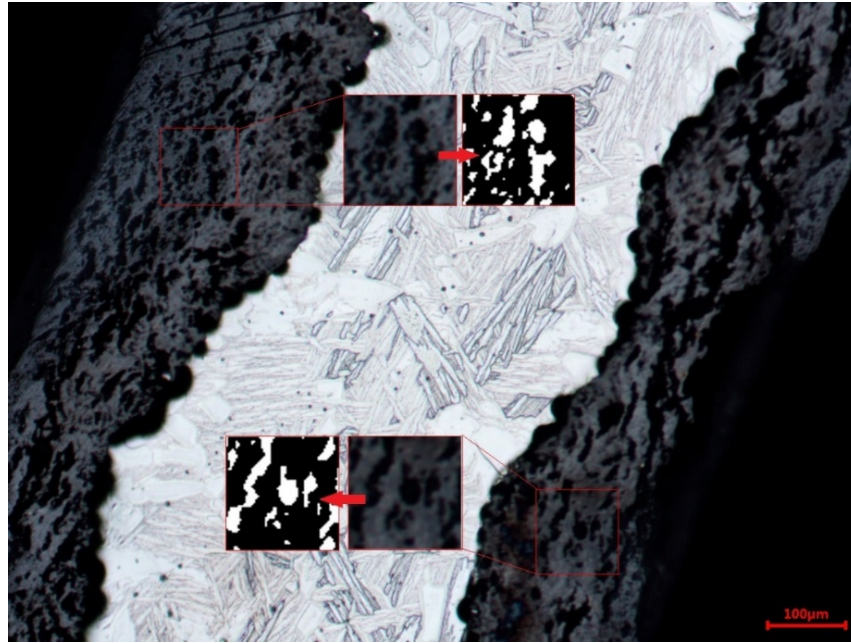
Specimens oxidized at 1273 K revealed multiple cracks in the oxide layers. The image analysis of micrographs shown in Fig. 3 discloses that the cracks occupy about 20% of oxide volume. From each image, two fragments, 0.01 mm^2 each, were taken and converted into binary images for calculation of the number of voxels and volume of cracks. Most cracks were not big enough to be directly visible on the X-ray tomography scans.

Fig. 3. Microscope images of a cross-section of Zircaloy-2 alloy oxidized at 1273 K in air and cooled in oil; the areas used for an assessment of cracks' number (small images, on the left) and their binary images (small images, on the right) and calculation of voxels' number are demonstrated

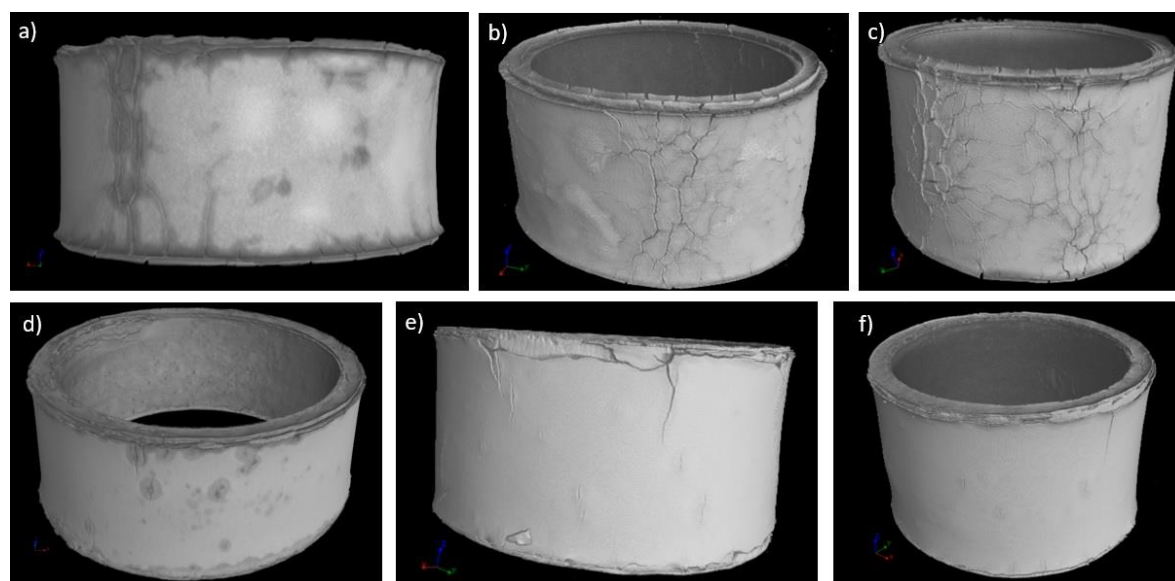
Different forms of damage were observed after oxidation at different temperatures. The damage forms may be classified as the cracks, detachment of oxide layers, an appearance of (macro)voids at the interface, formation of nodules. The presentation of observed damage at different temperature is schematically shown in Table 1. The scans of the whole claddings after oxidation at different temperature and cooling in different media are illustrated in Fig. 5 and the particular forms damage are shown separately for specimens oxidized at 1273 K (Fig. 6) and 1373 K (Fig. 7), and cooled either in air or in water (after cooling in oil similar results were obtained).

Fig. 5. Scans of the whole zirconium claddings after oxidation at 1273 K (top) and 1373 K (bottom) cooled in air (b, f), water (c, d) and oil (a, e)

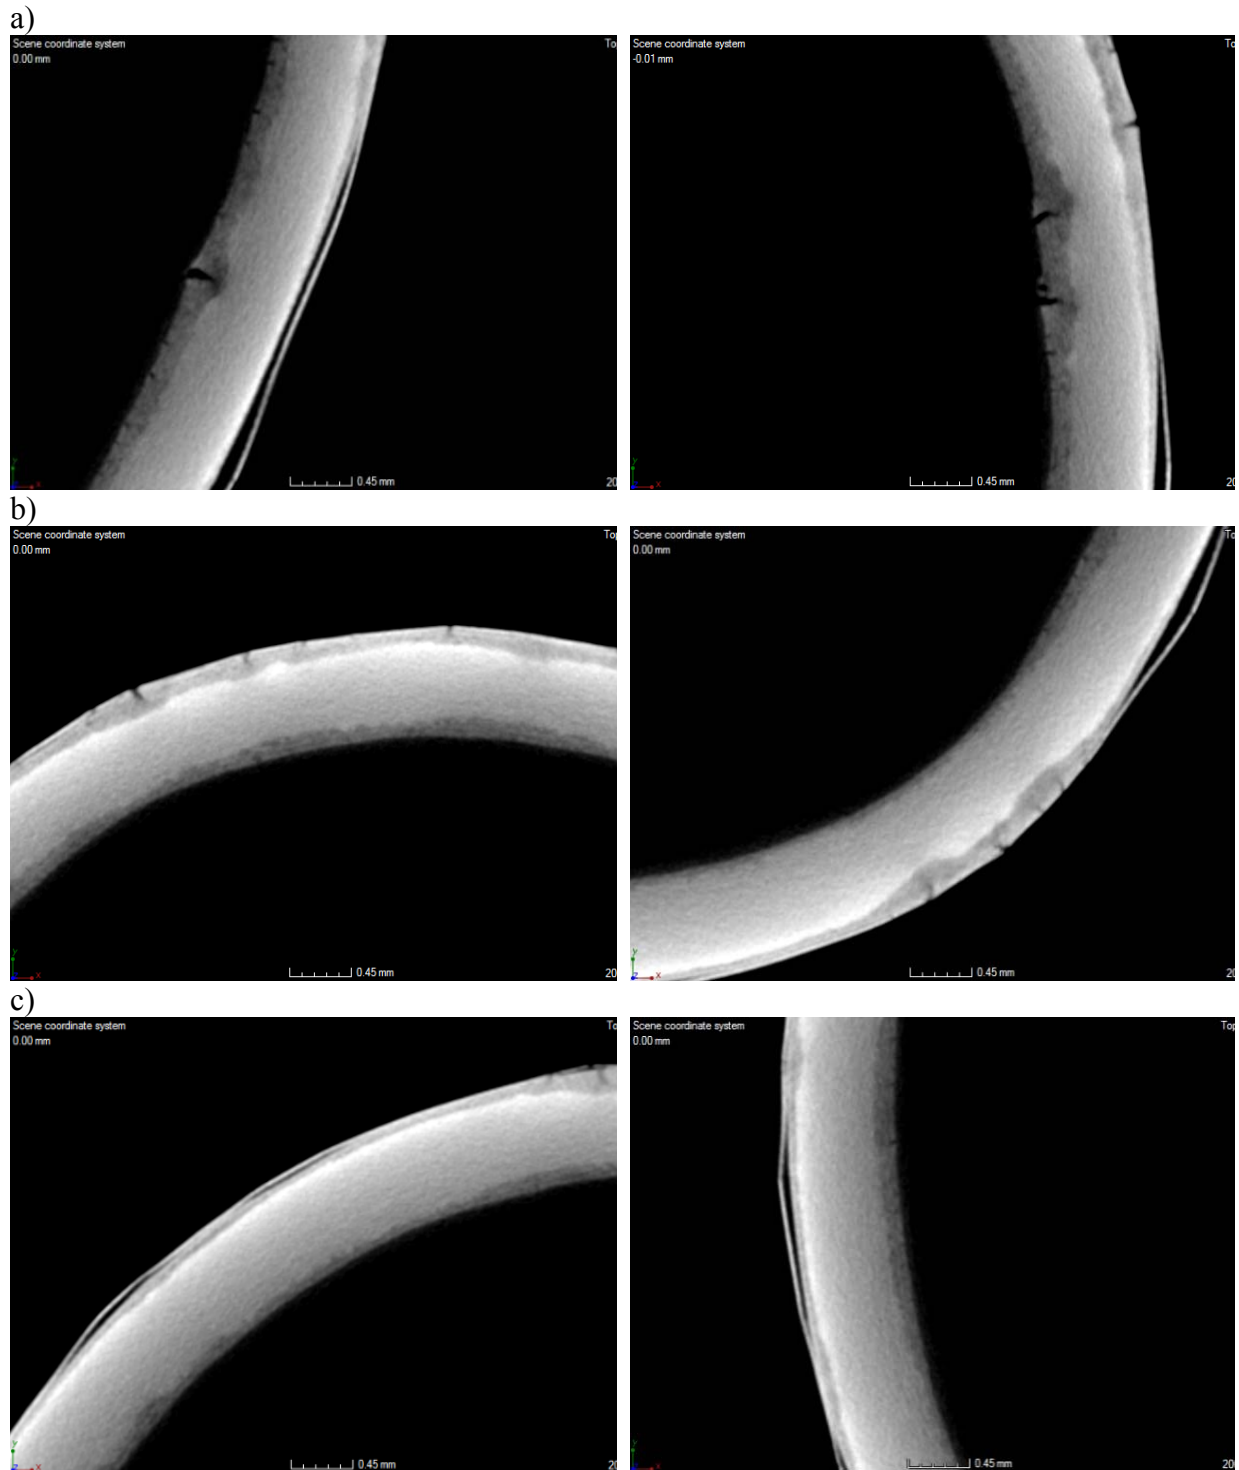
Fig. 6. Cross-sections of walls of tubes oxidized at 1273 K and cooled in air (left) or in water (right), different forms of degradation: a) vertical cracks in the inner oxide, b) vertical cracks in the outer oxide, c) detachment of the outer oxide (1273 K in air). Light microscope.

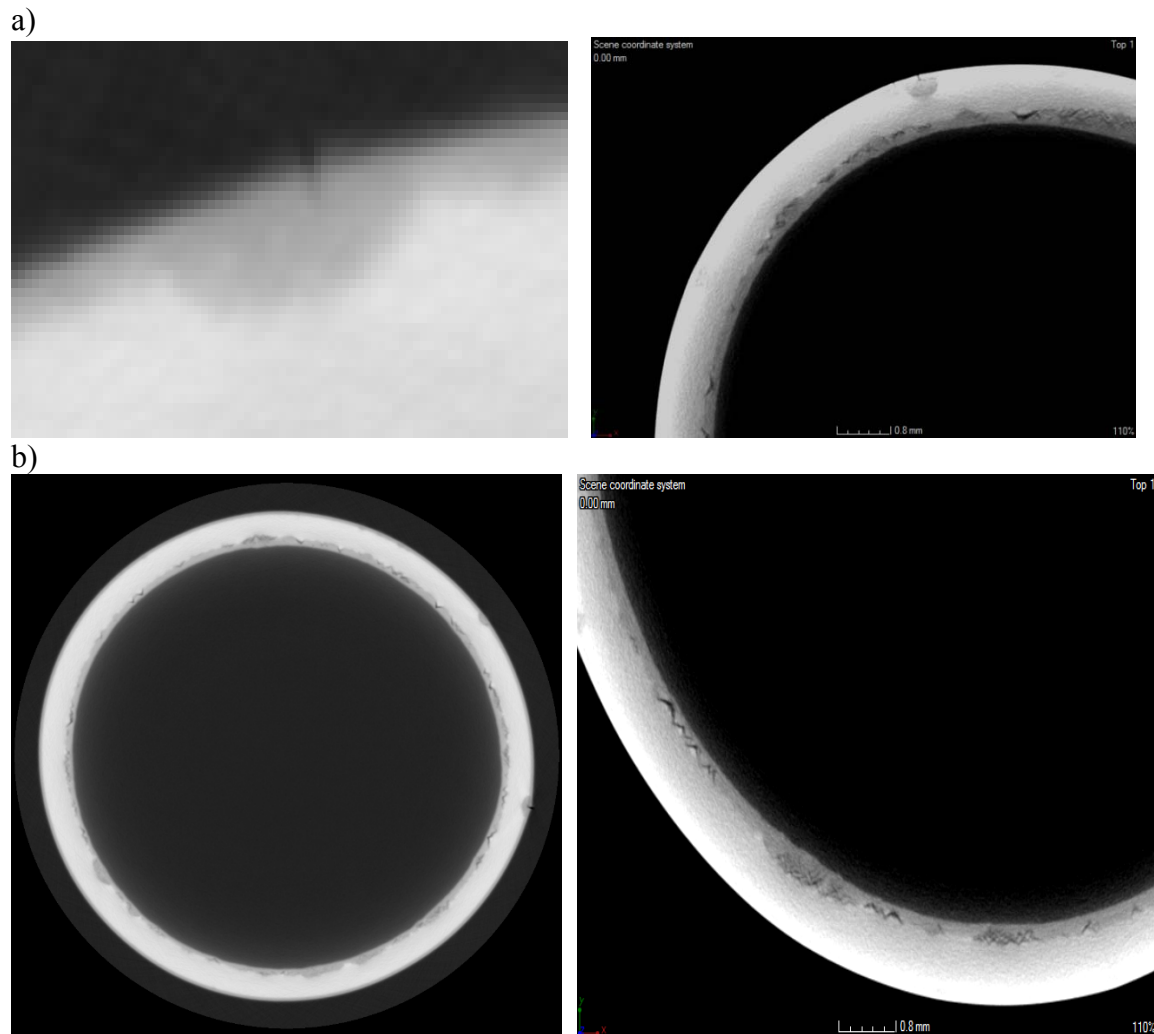
Fig. 7. Cross-sections of walls of tubes oxidized at 1373 K and cooled in air (left) or in water (right), different forms of degradation: a) vertical cracks in the oxide external layer, b) voids in the substrate. Light microscope

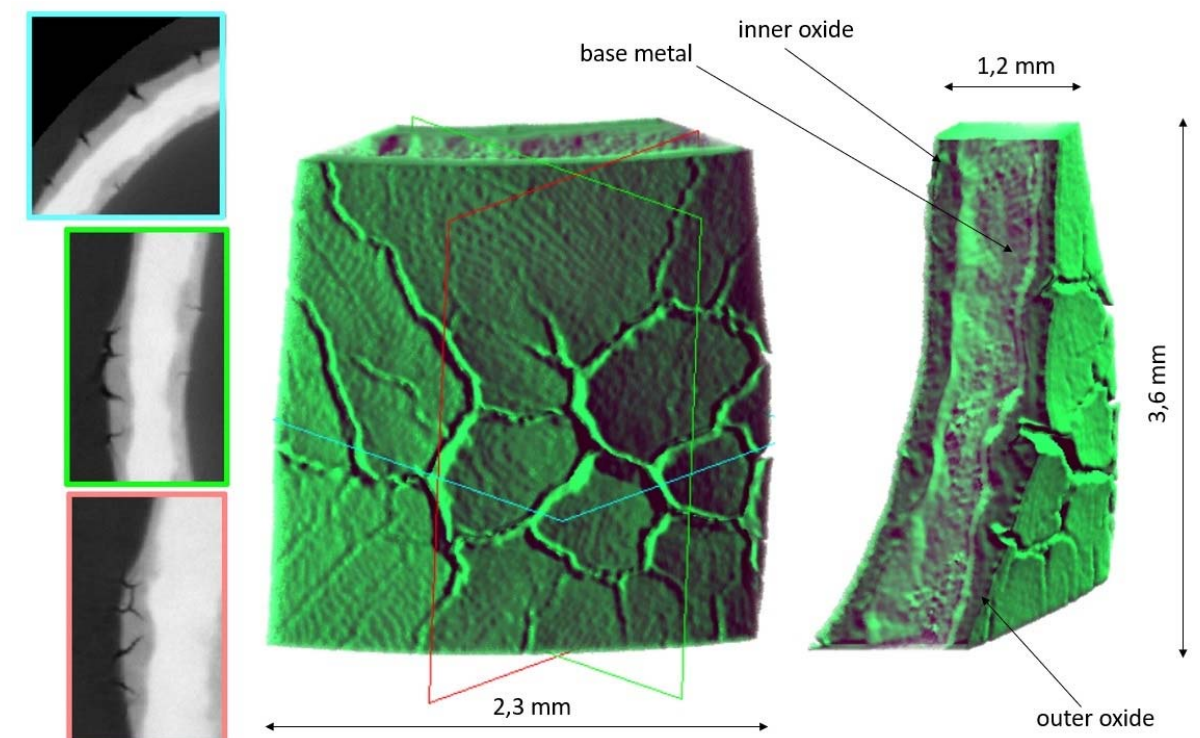
Degradation on external surface of the oxidized tubes appeared as long, spreading out and deep cracks or local, lens-like shaped small cracks. Figure 8 illustrates the long cracks observed on the alloy oxidized at 1273 K and cooled in water. The 3D views show that cracks join together and create island-like areas of size ranged from 400 μm to 1000 μm . The images on the left represent the cross-sections made along color lines marked in the middle image. The images on the right highlight the extensive oxide growth around cracks. Such behavior might be attributed to thermal stresses, but cooling medium did not affect the cracking

intensity. The oxide near the vertical crack was locally very thick due to the direct exposure of inner oxide to the surrounding gases as already observed [3].

The appearance of long and deep cracks can be easily explained. The oxides have different crystalline form dependent on temperature and exist as monoclinic ZrO_2 at here applied lower oxidation temperatures [28], but evolution of small amounts of tetragonal phase was also reported between 623 K and 1223 K [6]. The oxide layers possess small columnar grains and equiaxed grains [4]. The cracking of oxide layers at relatively low oxidation temperature was often observed [29,30]. The cracking of the oxide layer was explained by the accumulation of compressive stresses in the oxide at the interface in pre-transition stage, resulting from imperfect accommodation of the volume expansion attendant upon oxide formation [2]. Two forms of cracks, circumferential and radial, were so far described [31]. The radial cracks forming the “snakeskin” surface, very similar to the present results, were attributed [27] to the sample growth by metal creep upon the tensile stress field applied by the growing oxide layer. It is also believed that, when the oxide growth continues, the external part of the oxide scale increases its distance from the interface, the compressive stress diminishes, which results in transition from tetragonal to monoclinic phase. When a total oxide thickness exceeds a given value, for zirconia is approx. 3 μm , the oxide layer begins to form lateral cracks only in the zone consisting from large, elongated grains in monoclinic phase [32]. The probable initiation site may be different second phase particle (SPP), in particular on their side opposite to the metal/oxide interface [1,19,33,34].

Fig. 8. 3D view of cracks spotted on outer oxide of Zircaloy-2 cladding oxidized at 1273 K for 30 min in air, cooled in water. On the left, grayscale images illustrate cross-sections made along color lines marked in the middle picture. The right image shows 3D view across the wall thickness which presents an increase in oxide thickness around cracks in comparison to an area without cracks

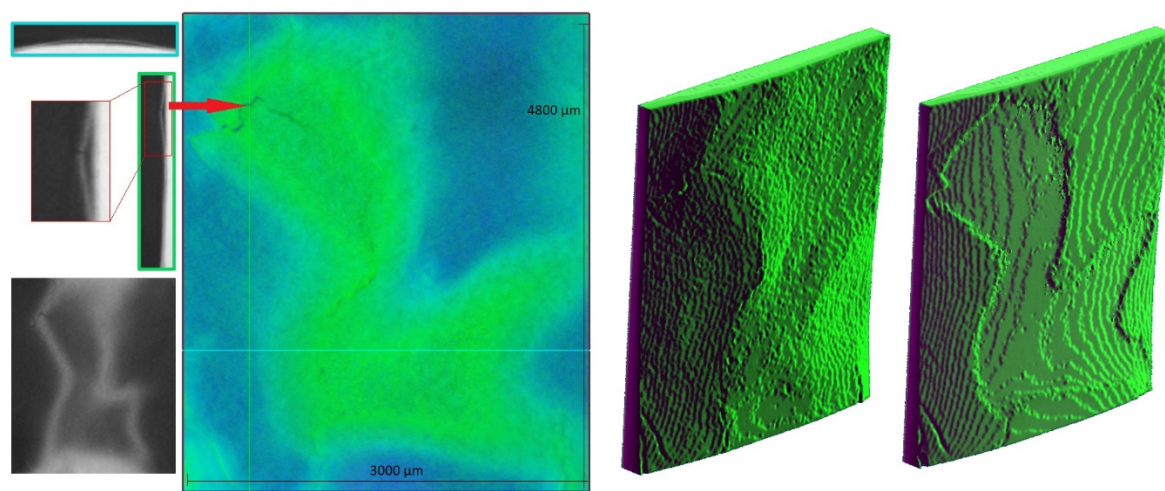
Figure 9 presents an exemplary case of oxide detachment observed for specimen oxidized at 1273 K and cooled in water. The spalled part of the layer was around 60 μm thick, and the oxide layer thickness ranged between 30 and 50 μm . The detached zone extended over an almost full area of the oxidized specimen. The green image in the middle illustrates an overall view of the oxide detachment. It visualizes bulge with a crack on the top. The image on the right shows the oxide under the detached layer. The image on the left presents orthogonal views of the area of interest. This form of detachment occurs in all the specimens oxidized at 1273 K. In all cases, the damage is sizable and exceeds 3 mm parallel to the tube and 2 mm perpendicular to the tube radius. Every specimen in this study possessed the crack or multiple cracks on the top of a bulge. The descaling, again much more intensive on the outer surface, is an obvious consequence of developing cracking as already observed [29].

Fig. 9. Detachment of the outer oxide layer on specimen oxidized at 1273 K in air for 30 min and cooled in water. On the left: views of the scanned tube, blue and green lines on the bigger picture correspond to grayscale projections and show the area in which cross-sections were taken. On the right: two green images present 3D views of the detached oxide layer; the left of both shows the outer layer, the right of both illustrates the oxide layer under the detached part

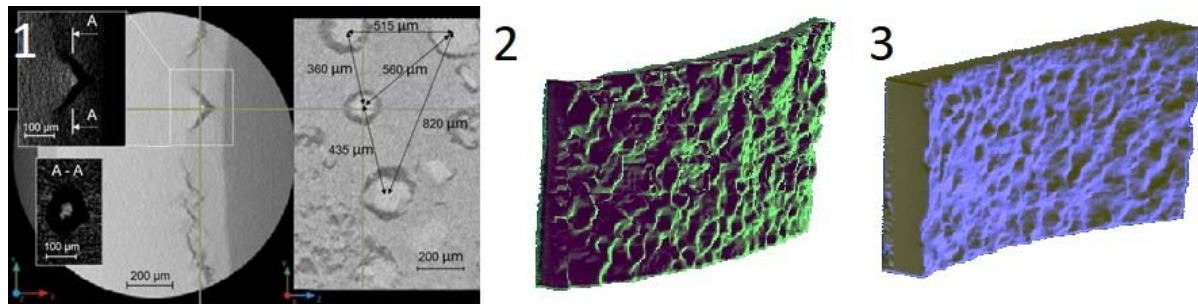
Fig. 10 shows a grey-level difference between the tops of the bright triangle-like deformations at the interface. Such bright areas are visible at the tops of most of the appearing voids.

Fig. 10. (1) Orthogonal view of 1.4 μm voxel size in the X-ray tomography image of Zircaloy-2 tube oxidized at 1373 K in air for 0.5 h; left – transversal slice showing inner oxide, substrate metal, voids and cracks at the metal/oxide interface, and void magnification; right – arrangement of voids at the metal/oxide interface. The right image is a rotation of the left image by 90° around the yellow vertical line. The cross-section A-A presents dimensions of the bright void zone. (2) 3D view of the metal/oxide interface, a green image is the oxide layer at the interface. Many dents are spotted in the area of voids present at the metal side. (3) 3D view of the metal/oxide interface, a blue image is a metal side at the interface with visible voids

The average size of the bright zone at the top is around 70 μm , as shown in cross-section A-A. Based on analysis of the substrate surface under the internal oxide layer, about four such brighter zones can be found per 1 mm^2 . The voids are spaced apart by an average distance of around 550 μm . Fig. 10 also presents an arrangement of bright deformations and cracks at the metal/inner oxide interface.

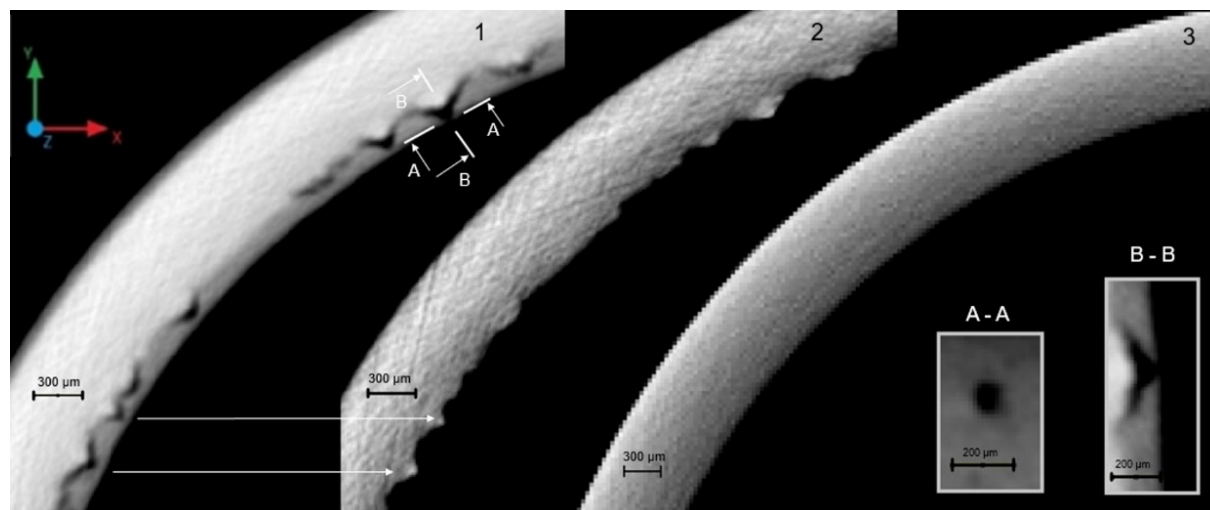
Figure 11 shows the X-ray tomography images of the oxidized tube (images 1 and 2) and the reference non-oxidized sample (image 3). Image 2, created by modifying the brightness and contrast of the image 1, presents the surfaces of the specimen after oxide removal. The arrangement of voids and cracks shown in image 1 corresponds to the bright zones in image 2. The top part of image 1 presents an open crack which exposes a base metal to the environment. Around 70% of all voids spotted on the inner surface of the tube caused the cracking of the oxide layer. The open crack created a hole of about 50 μm .

Fig. 11. 14 μm voxel size X-ray tomography image of the Zircaloy-2 tube oxidized at 1373 K in air for 0.5 h: (1) a transverse slice of the oxidized sample showing outer oxide, base metal, and inner oxide layer; (2) edited image 1 showing base metal without any oxides; (3) a transverse slice of the non-oxidized sample. Cross-sections A-A and B-B present open crack area visible in image 1, at different magnification

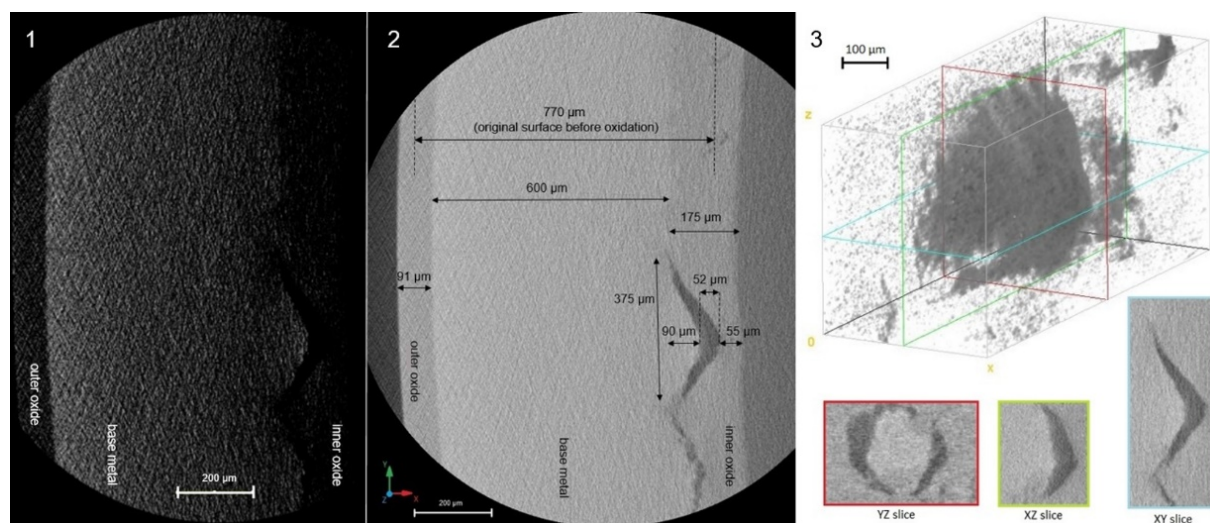
As illustrated by the image 2 in Fig. 12, the cracks along the metal/oxide interface correspond in length to the thickness of the inner oxide layers. The maximum cracks' openings are about 50 μm . The 3D geometry of the cracks is shown in image 3. The original surface before oxidation is approximately marked in image 2.

Fig. 12. 1.4 μm voxel size X-ray tomography image of the Zircaloy-2 tube oxidized at 1373 K in air for 0.5 h: (1) geometry of oxidized sample with adjusted brightness and contrast; (2) oxidized sample with shown dimensions of inner oxide, base metal, outer oxide layer, and crack present at the metal/oxide interface; (3) geometry of crack appearing at the metal/inner oxide interface

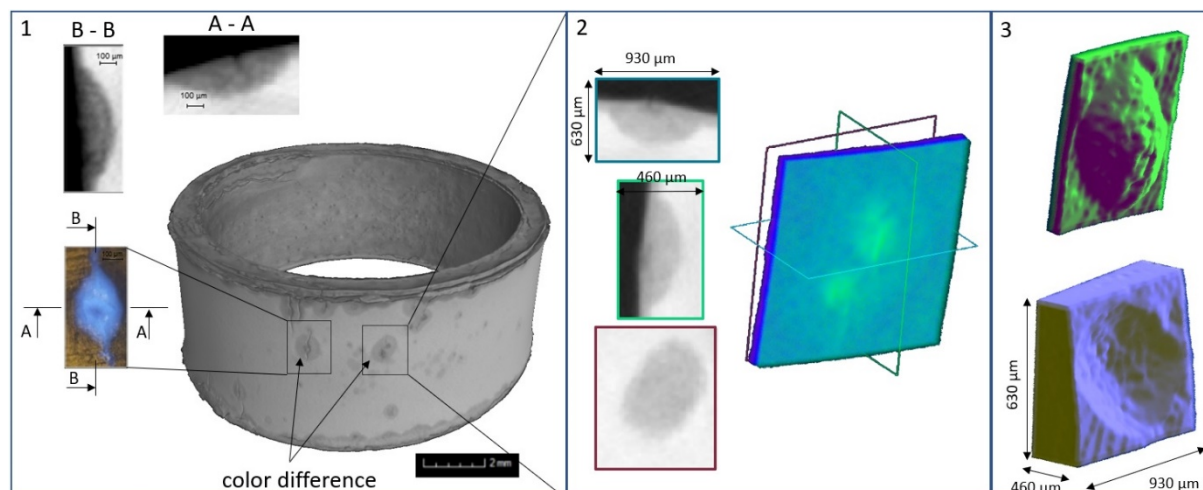
Nodular oxidation was observed only for samples oxidized at 1373 K on the outer oxide surface. Figure 13 illustrates the nodule within the oxide layer, which differs in color. The specimens oxidized at 1373 K demonstrated the black oxide layers with white oxides surrounding nodular corrosion area. That means that in this are the phase transformation has not been completed and both oxides, monoclinic (white) more prone to cracking and detachment, and tetragonal (black) less permeable to oxygen appear together.

Fig. 13. (1) overall 3D view of specimen oxidized at 1373 K in air for 30 min, cooled in air; arrows mark the white color oxides surrounding cracks; blue image on the left presents image of the crack and cross-sections A-A and B-B, obtained by polarized light microscopy; (2) 3D view of crack (nodular oxidation) on the overall 3D image; color framed pictures on the right represent cross-sections marked on the 3D model by color lines; (3) 3D illustrations of nodular type oxidation; green image shows oxide scale surrounding crack viewed on image 2; blue model represents cladding damage under nodular type oxide

Fig. 13 illustrates two areas marked as squares with shown nodular oxidation. The areas surround small cracks of length between 700 μm and 800 μm . Blue image on the left presents the marked cross-sections visualized by X-ray tomography. The crack is around 150 μm deep and is surrounded by the oxide that highly exceeds in thickness the neighboring uniform black oxide layer. The oxide in the crack zone is around 310 μm long, three times more than the thickness of a uniform oxide formed outside the crack zone. Images 2 and 3 in Fig. 13 represent a 3D model of the nodular oxide. The green model illustrates the oxide seen from ZrO₂/Zircaloy interface. Blue image shows the damage in the cladding caused by nodular oxidation.
