Assessment of technical condition and repair of steel structure elements on the example of fire damage in a warehouse building

Abstract. The paper analyses a case study on the structural assessment of warehouse building partially damaged by fire caused by external source (fire of lorries close to the building). The authors focus on the site investigations and laboratory test results prior to assessing actual condition of the structural elements. Both strengthening concept and repair procedure of a steel column are addressed here. A short literature survey in the paper regards fire damages and its impact on the entire structural systems and its members.

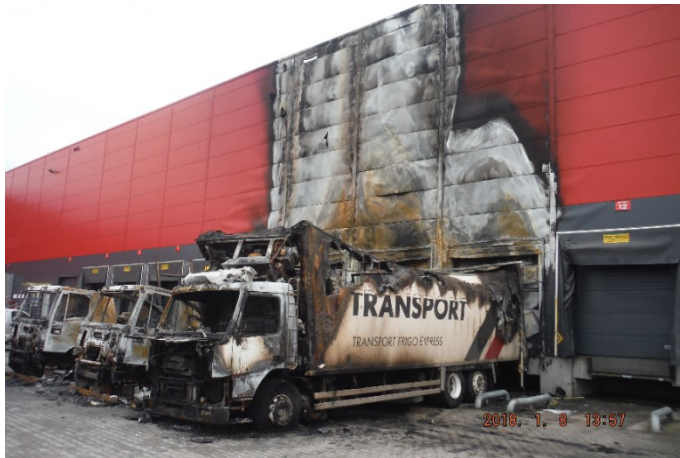
Fig. 1. View of fire damaged lorries and warehouse façade.

Partial visual inspection of a warehouse fire-impaired building was conducted (see Fig. 1, Fig. 2, Fig. 3). Safety of a steel structure can be primarily assessed observing the post-fire behaviour of individual structural steel members. Tide [20] proposed to classify the structural members into three categories, as follows:

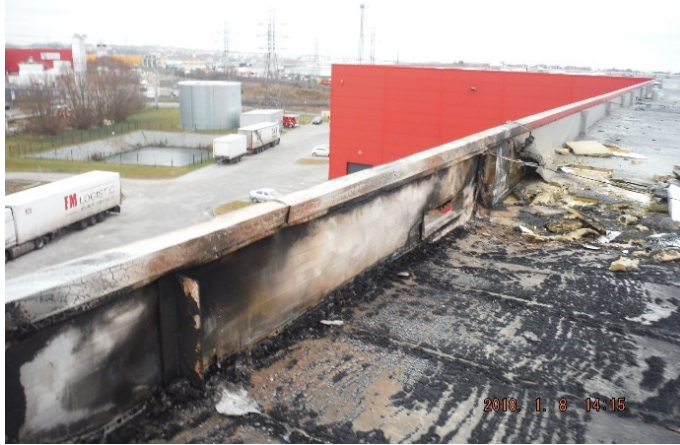
Fig. 2. View of fire damage to the roof elements.

Visual inspection shows that the insulated wall assembly with a sheet cladding and insulated membrane roofing on top of self-supporting sheets is partially damaged (see Fig.2) thus it should be removed and replaced. The main structural elements of I-section steel column and transoms (see Fig. 4) can be generally classified to the 1st category. However, small deformations of steel members were detected by visual observation, surfaces of selected structural members detect tightly adhering mill scales and surface erosion, denoting a high temperature exposure. In general, steel loses its mechanical properties in high temperatures (see e.g. [21]). Uniaxial tensile tests were further performed to assess specified post-fire parameters of I-section steel members.

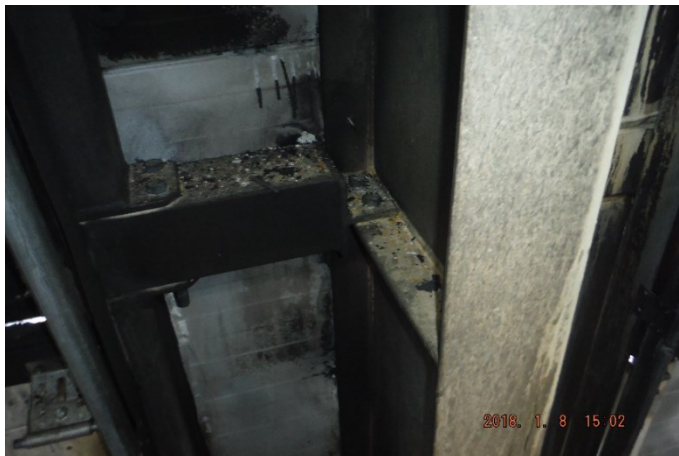
Fig. 4. Visible fire impact on steel construction elements.

In order to increase the capacity reduced buckling length of the column in the gable wall plane (from 6 to 3 m) was taken into account introducing additional transom and additional support points to fully protect the column against lateral torsional buckling. Due to this computational variant sufficient load-bearing capacity was confirmed. Finally, the assembly of steel strengthening (additional transom) was added and insulated wall assembly with a sheet cladding and insulated membrane roofing on top of self-supporting sheets was removed and replaced before the warehouse building partially damaged by fire caused by external source (fire of lorries close to the building) was being fully operational.
