Assessment of technical condition and repair of steel structure elements on the example of fire damage in a warehouse building

Abstract. The paper analyses a case study on the structural assessment of warehouse building partially damaged by fire caused by external source (fire of lorries close to the building). The authors focus on the site investigations and laboratory test results prior to assessing actual condition of the structural elements. Both strengthening concept and repair procedure of a steel column are addressed here. A short literature survey in the paper regards fire damages and its impact on the entire structural systems and its members.

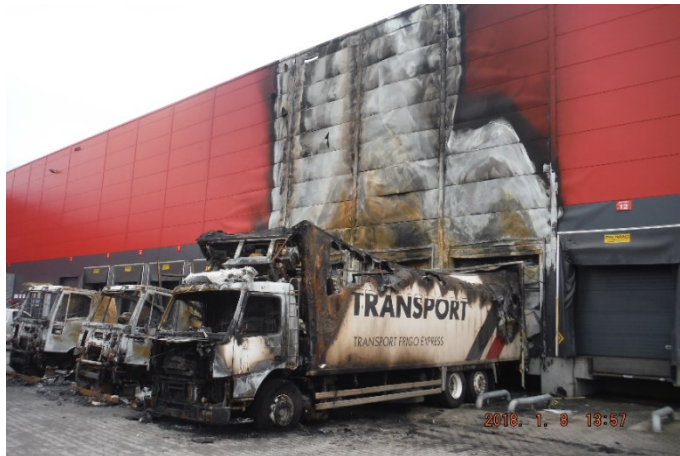
Fig. 1. View of fire damaged lorries and warehouse façade.
