# Assessment of technical condition and repair of steel structure elements on the example of fire damage in a warehouse building

**Abstract.** The paper analyses a case study on the structural assessment of warehouse building partially damaged by fire caused by external source (fire of lorries close to the building). The authors focus on the site investigations and laboratory test results prior to assessing actual condition of the structural elements. Both strengthening concept and repair procedure of a steel column are addressed here. A short literature survey in the paper regards fire damages and its impact on the entire structural systems and its members.

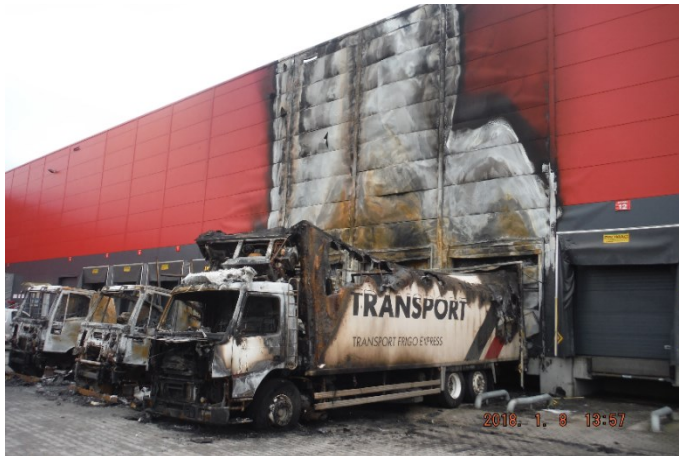
**Fig. 1.** View of fire damaged lorries and warehouse façade.

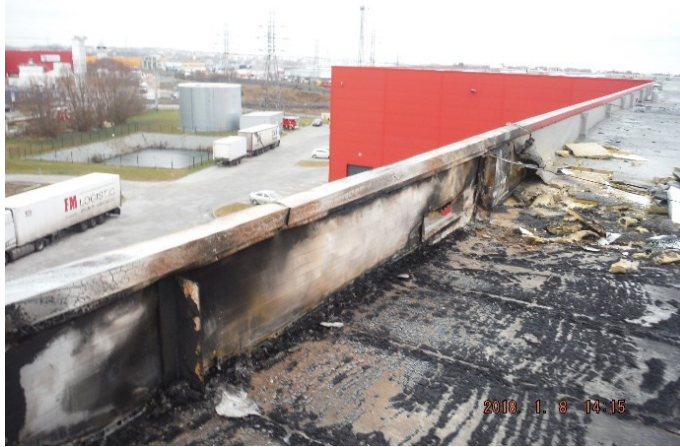
**Fig. 2.** View of fire damage to the roof elements.

Visual inspection shows that the insulated wall assembly with a sheet cladding and insulated membrane roofing on top of self-supporting sheets is partially damaged (see Fig.2) thus it should be removed and replaced. The main structural elements of I-section steel column and transoms (see Fig. 4) can be generally classified to the 1st category. However, small deformations of steel members were detected by visual observation, surfaces of selected structural members detect tightly adhering mill scales and surface erosion, denoting a high temperature exposure. In general, steel loses its mechanical properties in high temperatures (see e.g. [21]). Uniaxial tensile tests were further performed to assess specified post-fire parameters of I-section steel members.

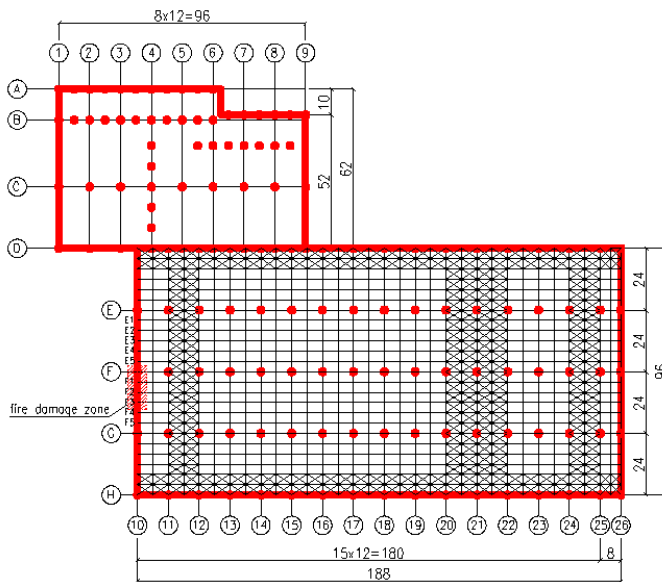
**Fig. 3.** Floor projection of warehouse building.

Geodetic measurement was aimed at displacement values and deformation of two selected I-section steel columns (denoted Sc1 and Sc2, see Fig. 3) affected visibly by fire. The measured displacements were analysed and compared to the allowable erection tolerances specified by EN 1090-2 [22]. Four types of erection tolerances were taken into

Based on geodetic measurements and determined deviations (see Table 1) it was generally found that the I-beam fire-impaired steel columns detect the allowable deviations contained in specified tolerances. It should be noted, that only for Sc1 column located in cross axis F1/10, the web undulation deviation  $\Delta^4$  insignificantly exceed standard manufacturing tolerances. It has been assumed that the indicated deviations are not significant, thus allow to apply standard procedures to determine the column's bearing capacity.

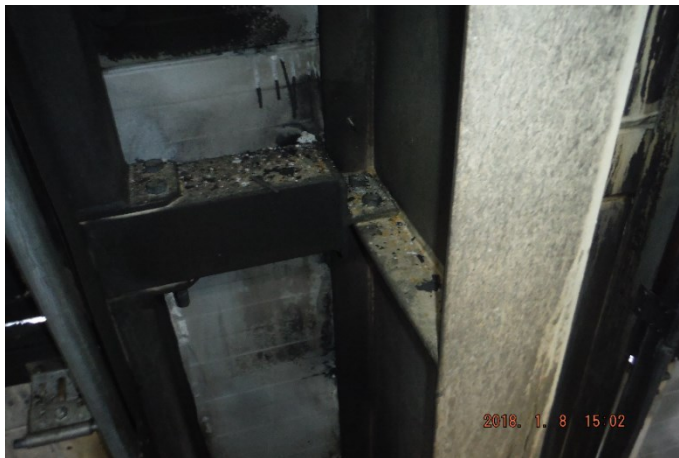
**Fig. 4.** Visible fire impact on steel construction elements.

In order to increase the capacity reduced buckling length of the column in the gable wall plane (from 6 to 3 m) was taken into account introducing additional transom and additional support points to fully protect the column against lateral torsional buckling. Due to this computational variant sufficient load-bearing capacity was confirmed. Finally, the assembly of steel strengthening (additional transom) was added and insulated wall assembly with a sheet cladding and insulated membrane roofing on top of self-supporting sheets was removed and replaced before the warehouse building partially damaged by fire caused by external source (fire of lorries close to the building) was being fully operational.
