On the current state of dovetail wall-corner joints in wooden Greek Catholic churches in Polish Subcarpathia with structural and sensitivity analyses

Izabela Lubowiecka¹, Tomasz Zybała¹, Grzegorz Bukal², Marcin Krajewski¹, Marcin Kujawa¹, Paweł Kłosowski¹

1) Department of Structural Mechanics, Faculty of Civil and Environmental Engineering, Gdańsk University of Technology, Gdańsk, Poland

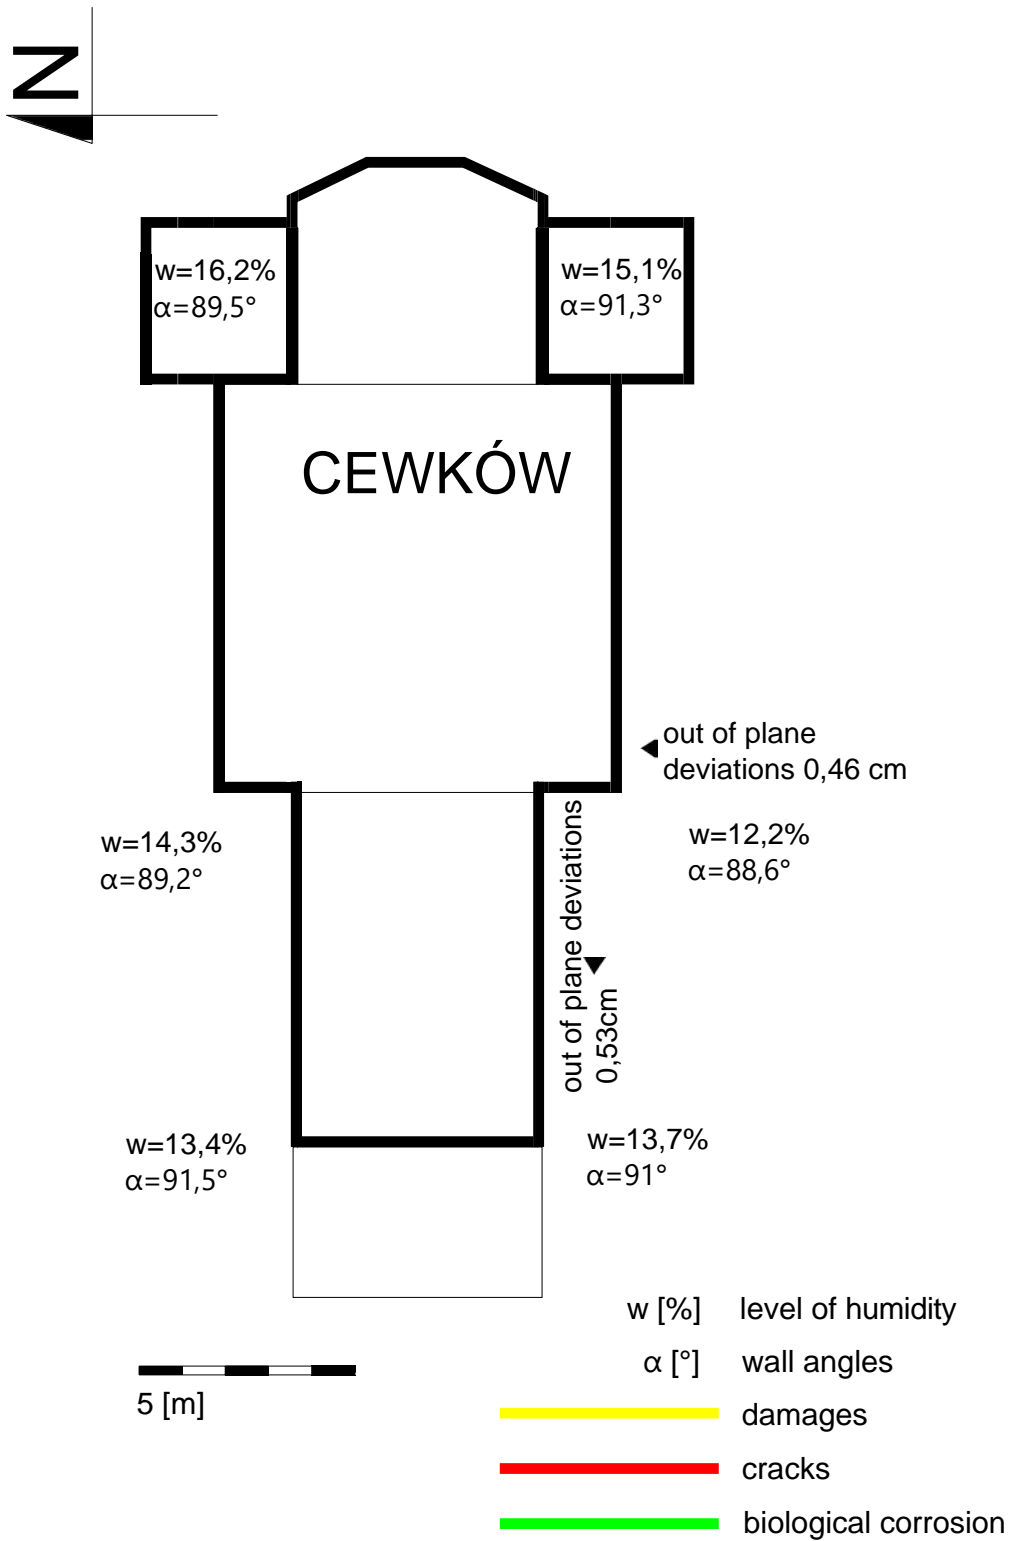
Figure 7. Results of measurements in the church in Cewków. The plan shows the level of humidity, angles, the scale and direction of deviations. Colors denote places where damage, cracks and biological corrosion occur.
