On the current state of dovetail wall-corner joints in wooden Greek Catholic churches in Polish Subcarpathia with structural and sensitivity analyses

Izabela Lubowiecka¹, Tomasz Zybała¹, Grzegorz Bukal², Marcin Krajewski¹, Marcin Kujawa¹, Paweł Kłosowski¹

1) Department of Structural Mechanics, Faculty of Civil and Environmental Engineering, Gdańsk University of Technology, Gdańsk, Poland

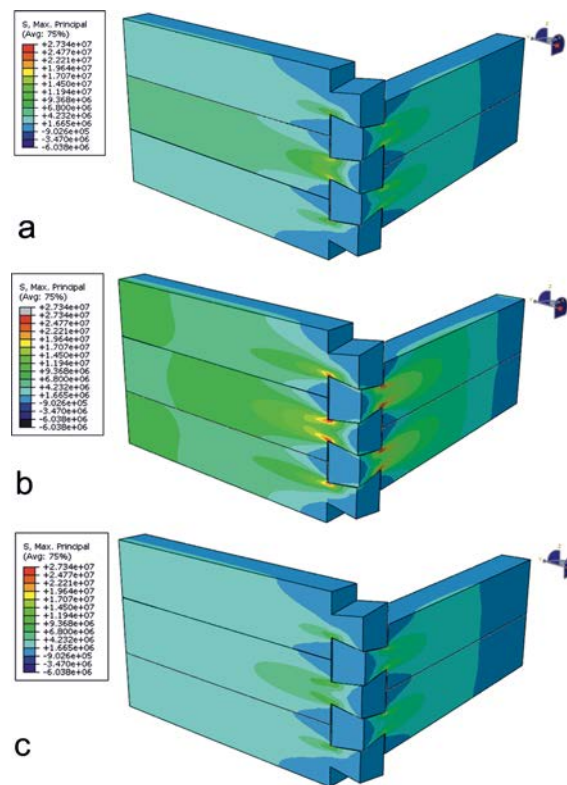
Significant deformations of the logs cause high stress on some contact surfaces. Large displacements can also expose the inside surfaces of the timber joints to environmental and biological degradation. The area of stress concentration area was therefore analysed and compared in the models considered. The principal stress and resultant force R_y were the significant quantities in the analysis. The maximum and minimum principal stress maps covering the three studied cases are shown in Figures (13-14). The comparison of the calculated values of the stress S and force R_y corresponding to the maximum lateral displacement u_y of each joint in each case studied is summarised in Table 2. The maximum principal stress is almost doubled when one member of an old joint ($S_{max} = 12.31$ MPa) is replaced with one made of dry new wood ($S_{max} = 22.82$ MPa).

Figure 13. Maximum principal stress in the joint where a) one log has been exchanged into a new wood; b) all logs are made of the same new wood; c) all logs are made of the same old wood.

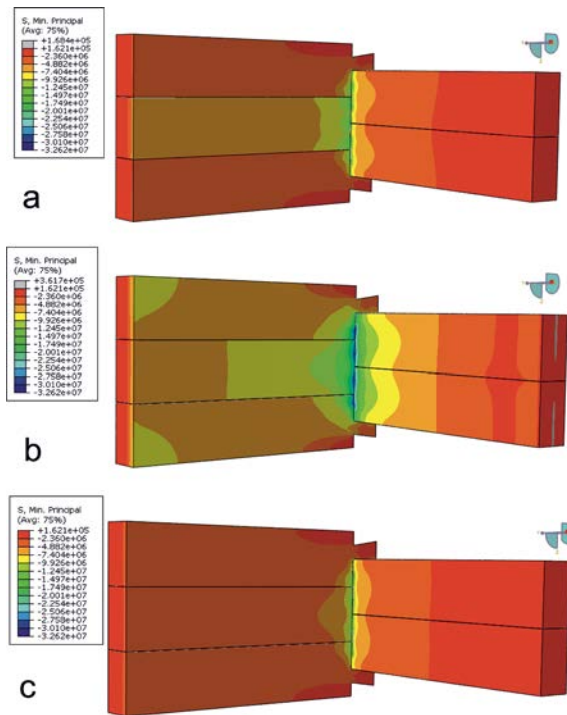
The minimum principal stress differs less and it is equal to $S_{min} = 14.66$ MPa in the case of old wood and $S_{min} = 15.87$ MPa with one new log in the joint. Under the applied displacement the stress concentration does not exceed the ultimate stress identified and described by (Pestka et al. 2018) as 71.9 MPa for dry wood. Moreover it appears is concentrated in the new log where the ultimate stress is higher than in the case of the old wood, which according to (Pestka et al. 2018) is 39.6 MPa. However, it indicates how such a replacement may affect the stress concentration in the joint. The force necessary to move the logs by 0.05 m, along their longitudinal axis is $R_y = 1.99$ kN in the case of the old joint, $R_y = 4.42$ kN in the new joint and $R_y = 2.20$ kN in the old joint with one log exchanged for new wood.

Figure 14. Minimum principal stress in the joint where a) one log has been exchanged into a new wood; b) all logs are made of the same new wood; c) all logs are made of the same old wood.
