## **On the current state of dovetail wall-corner joints in wooden Greek Catholic churches in Polish Subcarpathia with structural and sensitivity analyses**

# On the current state of dovetail wall-corner joints in wooden Greek Catholic Churches in Polish Subcarpathia with structural and sensitivity analyses

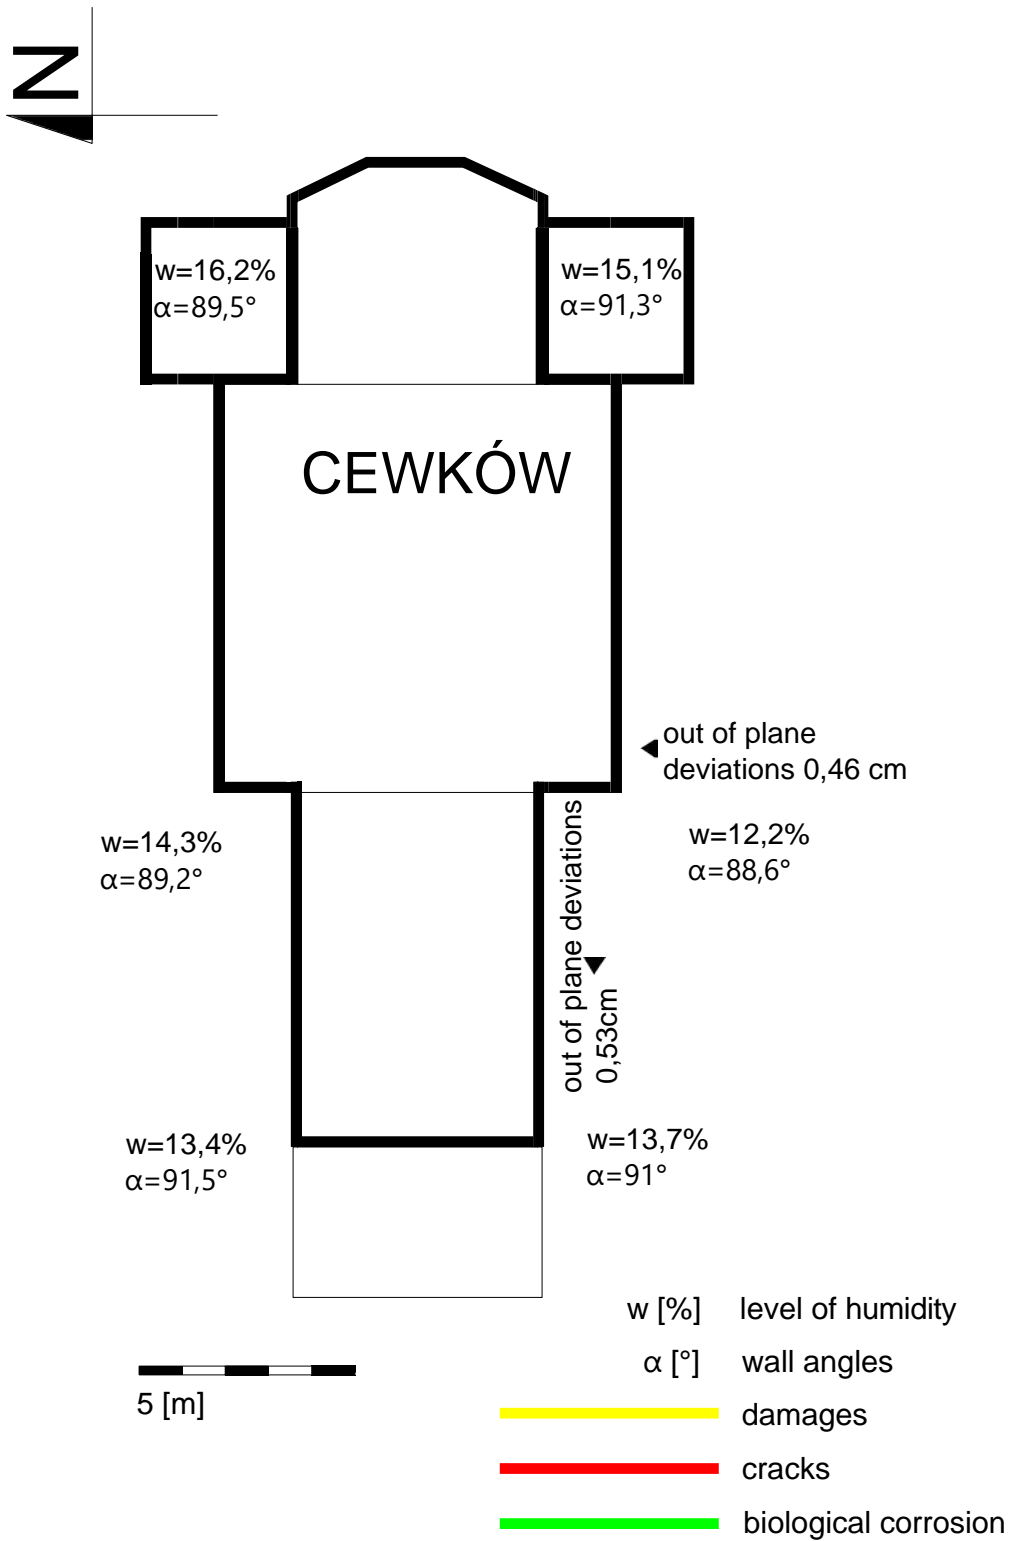
Figure 7. Results of measurements in the church in Cewków. The plan shows the level of humidity, angles, the scale and direction of deviations. Colors denote places where damage, cracks and biological corrosion occur.

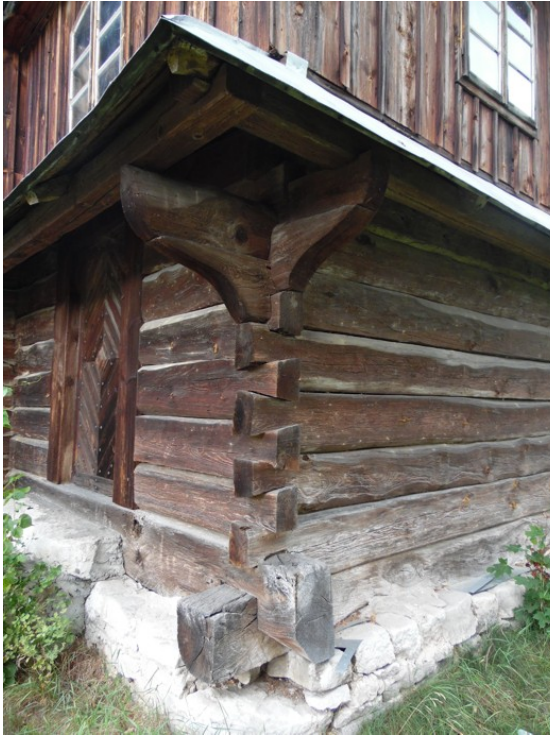
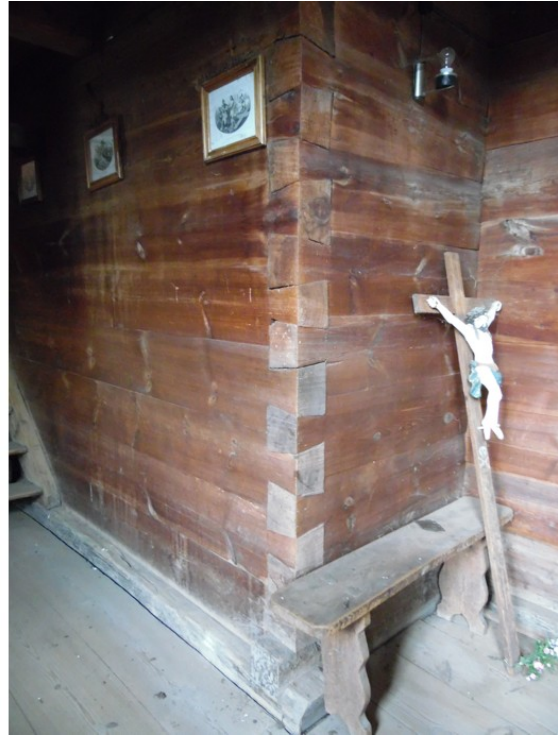
The current condition of the walls is good. The church has log walls with dovetail notches (Figure 9, 10). The walls are made of wood beams with a rectangular cross-section of 15 x 21 cm. No significant moisture has been found and the humidity level of the corners remains at 12.5% on the south side and 17.8% on the north side (Figure 11). The horizontal damp proof course in the foundations is not broken and the roof covering is rain-tight. There are some visible longitudinal cracks (Figure 10) and a few transverse cracks in the beams. There are also some signs of damage caused by insects and some

Figure 9. Current condition of log walls with dovetail notches in Chotylub outside and inside.

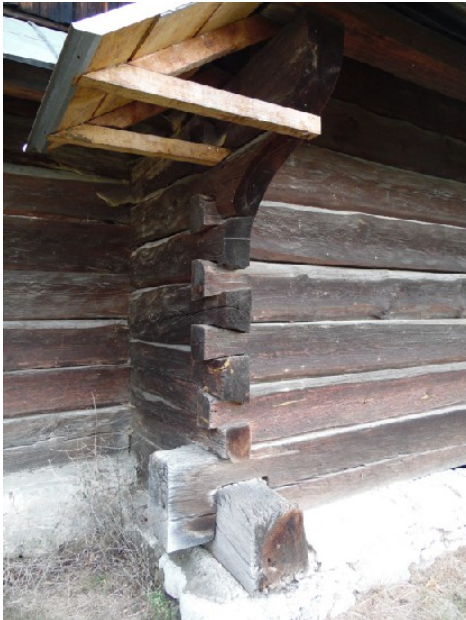
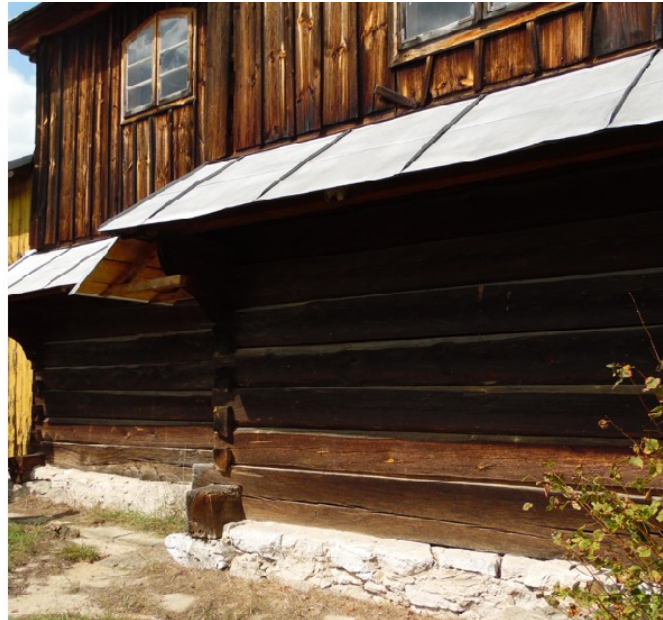
minor local cavities of the structure. The out-of- plane vertical deviations of the walls are relatively small - from 0.15 cm to 1.2 cm. The internal angles have not changed since the church assembly - deformations inside and outside the building range from 88.9° to 90.5°. The same is true for the construction as a whole which has never been rebuilt and hence there are no additional loads on the walls. Moreover, the gravity ventilation of the object is intact. At present the church is not in use but local authorities have designated a person responsible for taking care of it. Owing to this the building is closed and protected against vandalism and the area around it is well kept.

Figure 10. Current condition of log walls with dovetail notches in Chotylub: cracks in log walls in and contemporary repairs of the eaves roof.

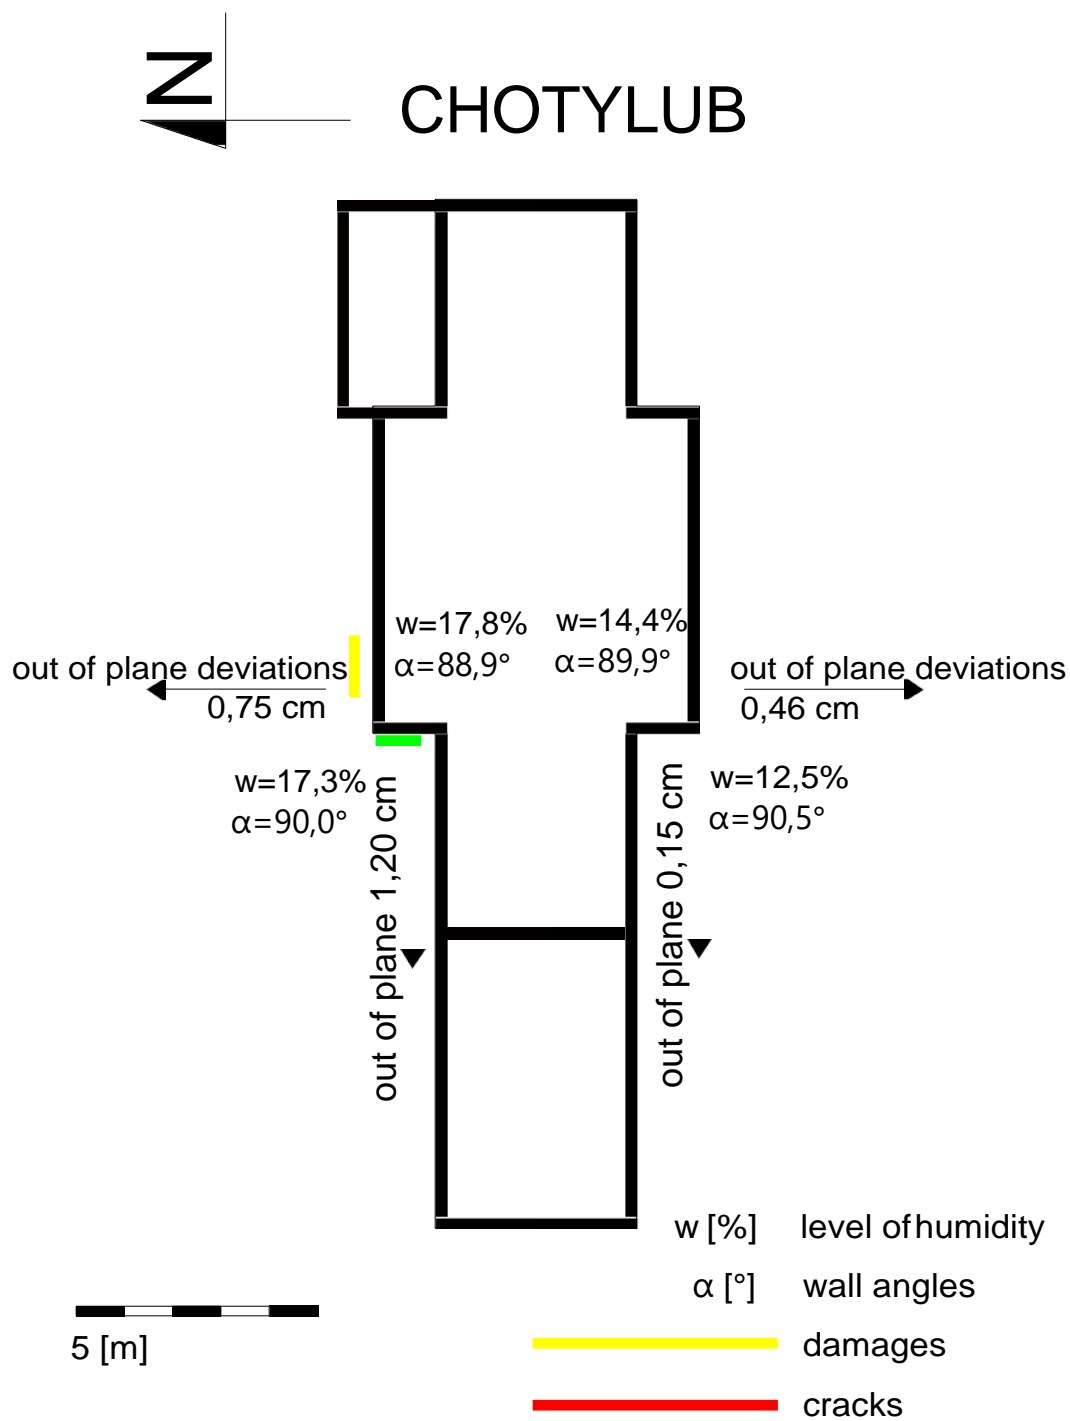
Figure 11. Results of measurements in the church in Chotylub. The picture shows: the level of humidity, the angles and the scale and direction of deviations. Colours indicate places where damage, cracks and biological corrosion occur.
