# Causes of damage and methods of repairing floor made on polystyrene concrete

**Abstract.** The paper describes damages, tests and repair of the floor made on existing ceiling and expanded polystyrene concrete underlay. The floor was built on a reinforced concrete ceiling with an area of about 1050 m<sup>2</sup>. Significant damage in the form of cracks, detachments and unevenness was found in the floor. In order to determine the causes of damage, in situ tests and laboratory tests were carried out. It was found that the damage was caused by numerous performance errors. A test repair of the damage (4.7x6.0 m) was carried out, and then the repair method was applied on the entire floor surface.

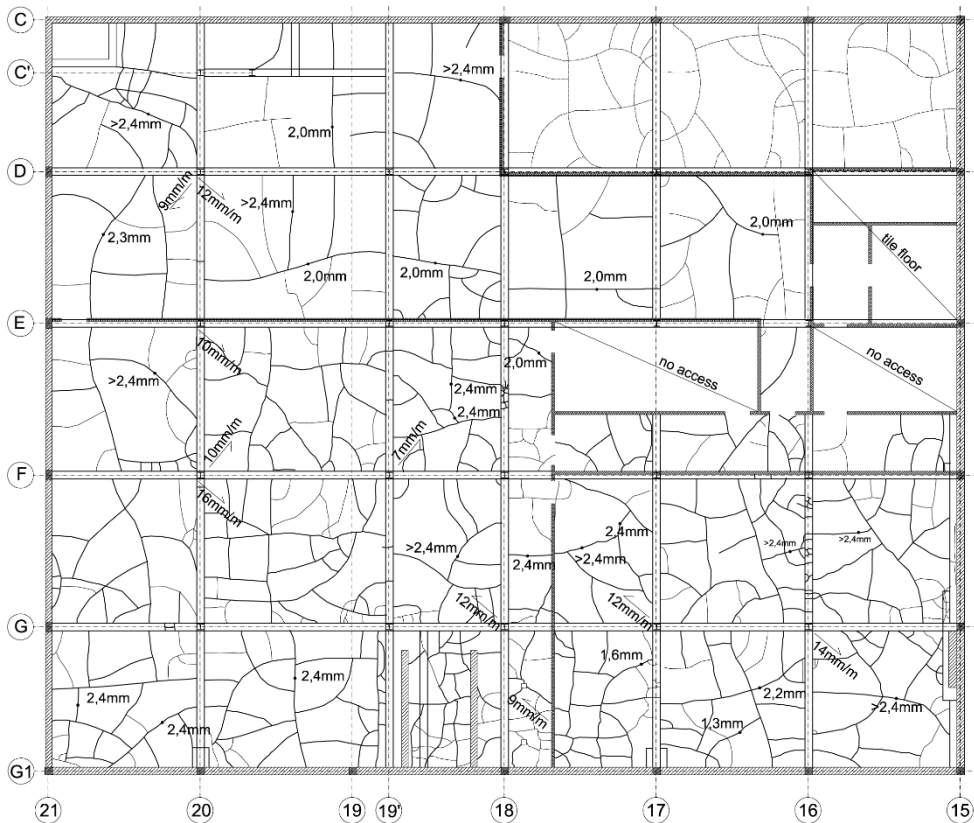
Visual inspection determined several performance errors, including uneven thickness of screed and EPSC, lack of precision in the execution of expansion joints and stratification of the concrete (up to three layers). The floor was clearly uneven - the slope of several slabs reached up to 16 mm/m, while spacing under two-metre-level and floor was up to 7 mm. It was observed that floor cracks protruded beyond expansion joints, which proves that the cuts were made too late.

Attempts to repair the damages by injection were made, however, the holes were drilled vertically at a distance from the cracks, not as supposed through the cracks at a certain angle. The map of cracks, their width as well as floor slope are presented in Fig. 3. Chosen damages to the floor were shown in Fig. 4 and Fig. 5.

**Fig. 3.** Floor damage. The values of slopes and crack width are given.

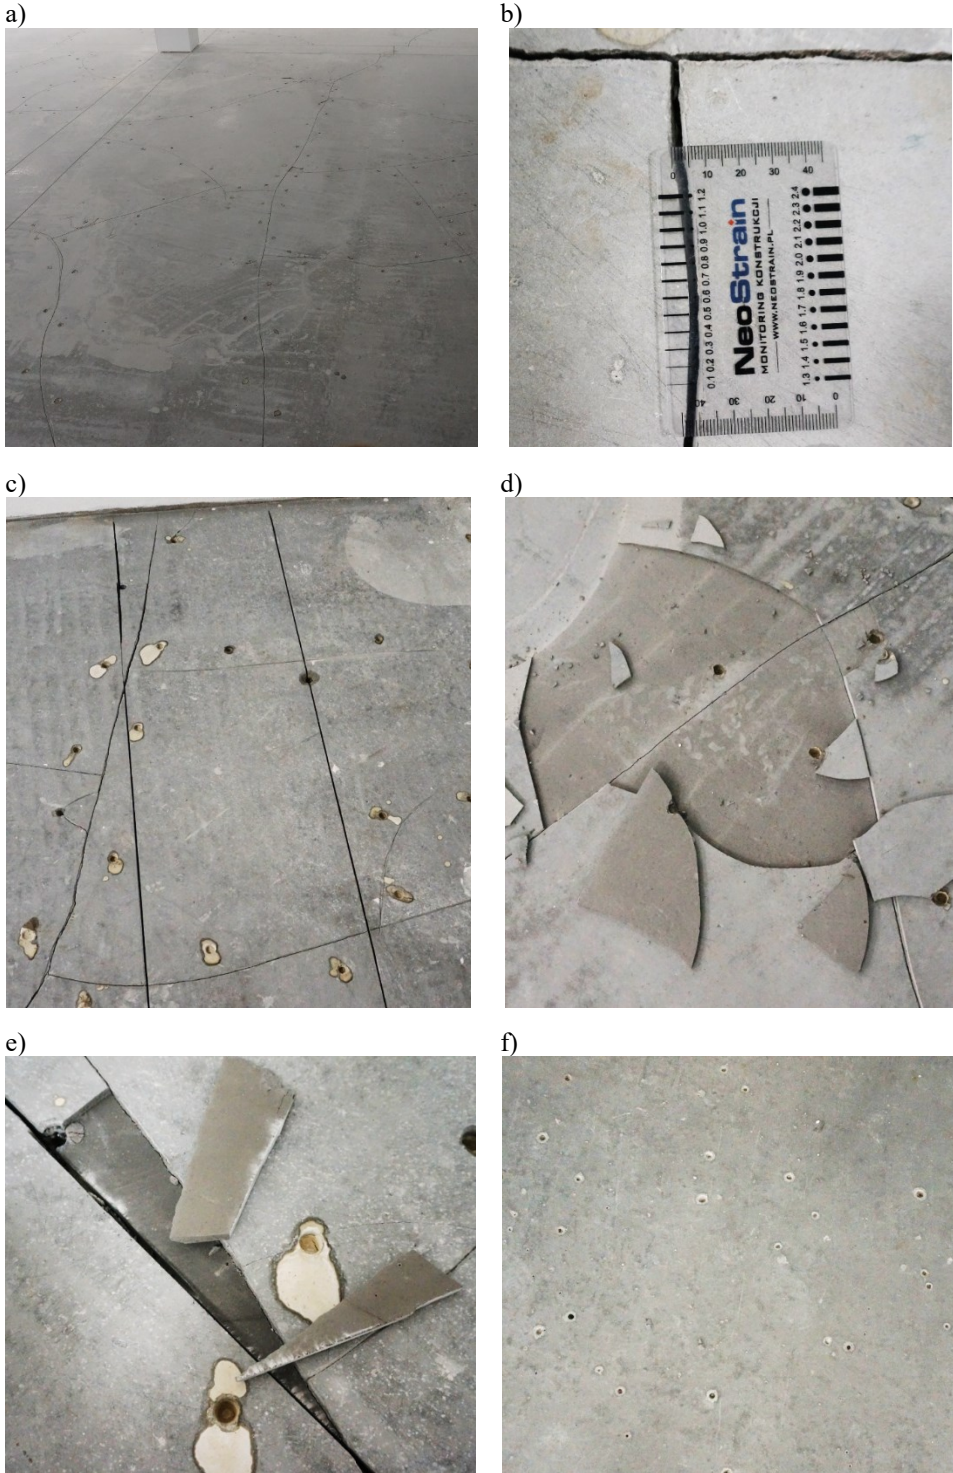
Already a few hours after the screed was made, numerous cracks have appeared on the surface. Additionally, top layer detachment as well as lack of homogeneity were observed. The crack width often exceeded 3 mm. The cracks occurred both on surfaces of self-levelling screed over the EPS concrete layer and concrete poured over reinforced joists. Near the joists the cracks propagated down to the layer of the EPS concrete.

**Fig. 4.** Damage type: a) cracking, b) crack width measurement, c) cracks protruding through expansion joint, d) e) self-leveling layer detachment, f) pores caused by improper mixing.

The cracking of the industrial floors can occur due to excessive load, improper material interaction or, like in the case of analyzed floor, performance errors. The errors included: uneven thickness of the screed, late preparation of expansion joints and uneven cuts, and performing works under higher than recommended temperatures. Condition assessment also showed uneven thickness of the self-leveling screed, stratification of the layers and improper mixing of the screed components. Those numerous performance errors resulted in cracking, stratification, lack of flatness and uneven surface. Each additional tie added to a freely deforming system generates internal forces. In this particular case the unevenness in the interaction zone between EPSC and screed and lack of homogeneity in both materials generated additional stresses.

An attempt was made to repair damaged floor in a selected field of 4.7 x 6.0 m. It was decided to perform repair by stitching cracks with a thin copper stainless steel wire, perpendicular to their course, filling possible empty spaces with cement-based mortar. Stitching reinforcement was placed in incisions every 20÷25 cm. The places of stitching and cracks were filled with an injection resin (Fig. 13). This method allowed for a tight connection of floor fragments separated by cracks. It also allowed to obtain a smooth surface under the planned top floor, which was the base for the final finishing of carpet floors. Since the sample repair has proved correct, the whole floor was repaired with this method.

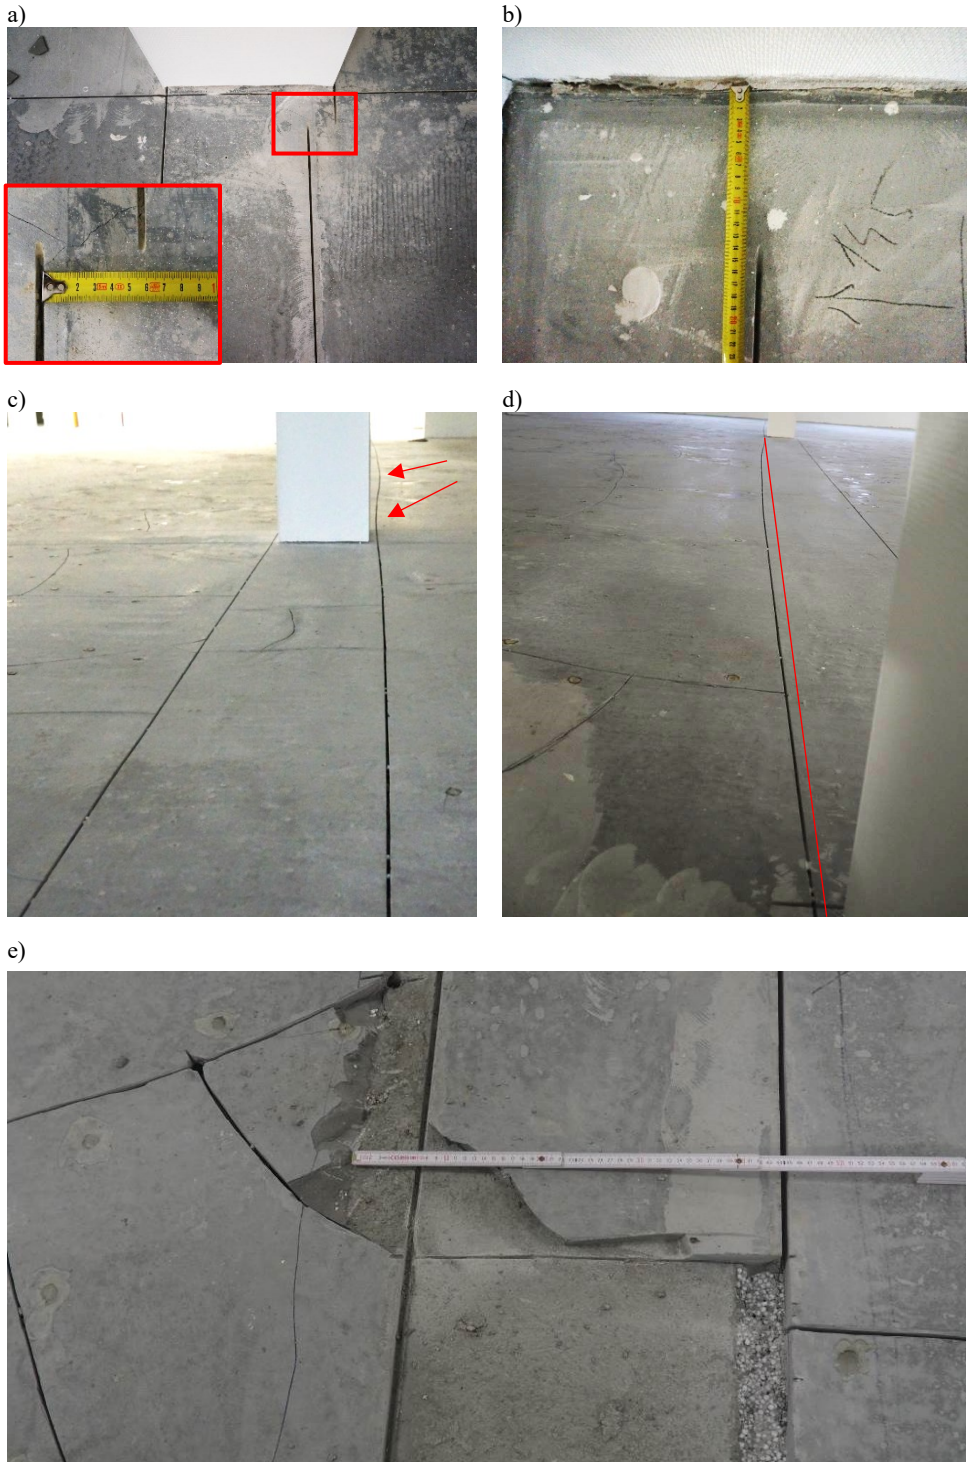
**Fig. 5.** Imprecise expansion joints: a) lack of continuity, b) improper cut near the wall, c), d) uneven cuts e) inverted beam exposure. Expansion joints are at the distance of 7 cm.

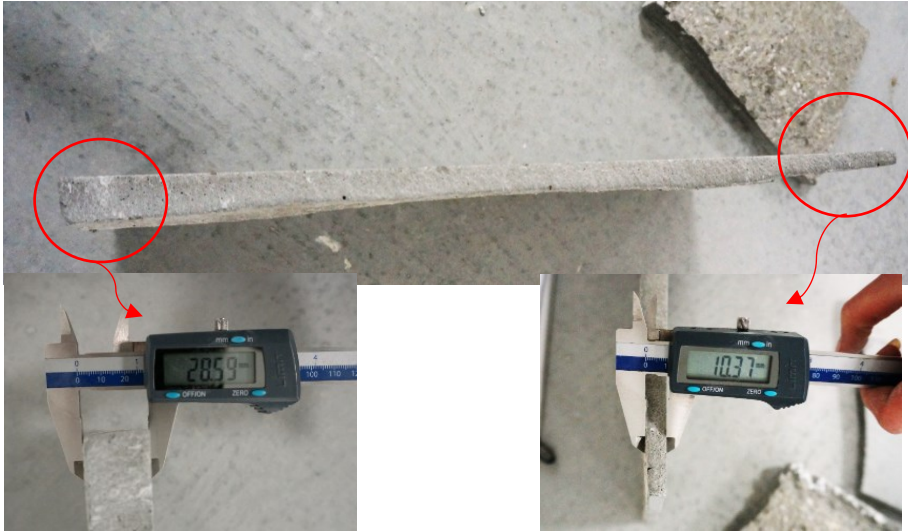
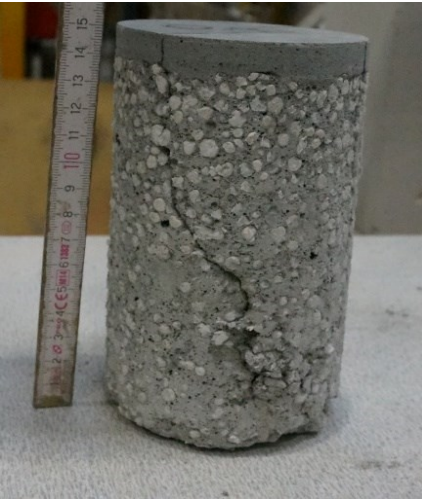
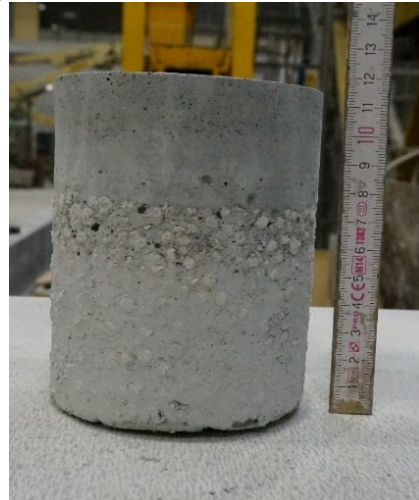
**Fig. 6.** Changes in thickness of self-leveling screed and EPSC layer: a) measurement of detached screed layer  $10.37 \div 28.59$  mm, b) EPS concrete layer (140 mm) in a core sample, 10 mm of screed, c), EPS concrete layer (75 mm) in a core sample, 42 mm of screed.

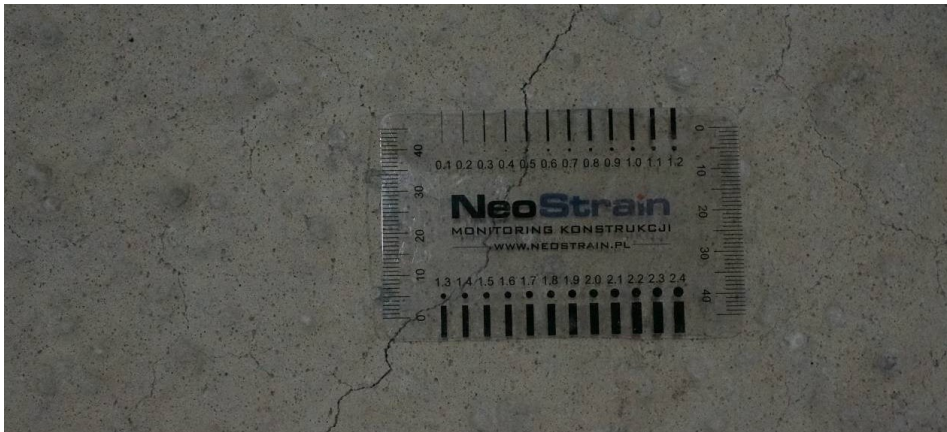
The visual evaluation of the samples was being conducted for over 2 months. The observations lasted over 2,5 times longer than the time in which the cracks occurred in analyzed floor. After 49 days first three samples did not exhibit any signs of cracking. The last sample exhibited small shrinkage cracks. Local width of the crack reached between  $0.1 \div 0.5$  mm. The cracks on the surface of the EPSC occurred after two weeks due to lack of curing. The cracks are shown in Fig. 10.

**Fig. 10.** Measurement of the cracks in sample no. 4.

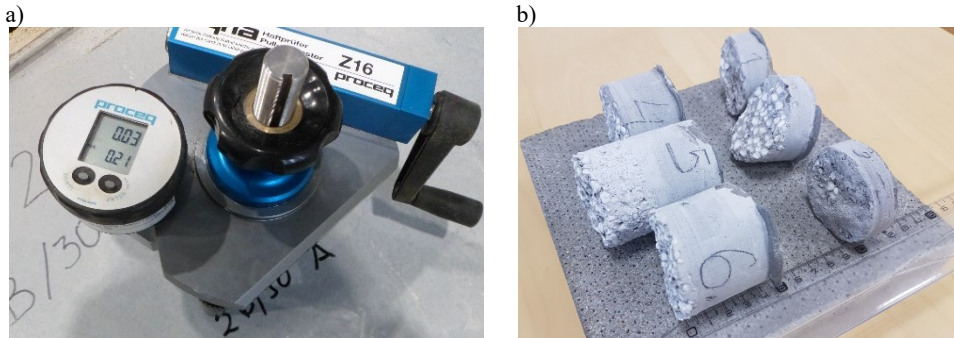
The pull-off tests conducted on the damaged floor resulted in the stress at break between 0.12÷0.34 N/mm<sup>2</sup>. The test concurred previous observation of uneven thickness of the floor screed. The thickness of the screed was between 12 and 40 mm, only in P1 measurement point obtaining desired value. The samples before and after the pull-off test are shown in Fig. 11.

In the performance declaration, the manufacturer declares layer-to-layer adhesion of at least 0.2 N/mm<sup>2</sup>. As seen from the results, the local adhesion did not meet the requirements.

**Fig. 11.** Sample (no. 2) during the test and afterwards (samples from the damaged floor).

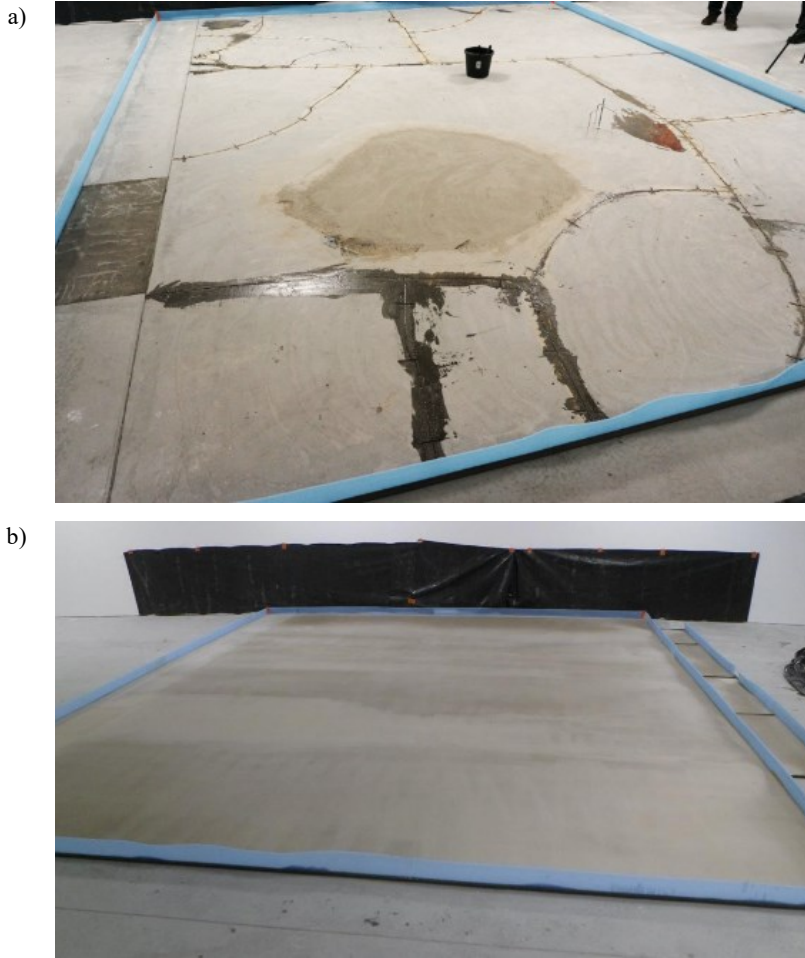
**Fig. 13.** Repair method: a) view after stitching and injection of the cracks, b) finished top layer.
