Causes of damage and methods of repairing floor made on polystyrene concrete

Abstract. The paper describes damages, tests and repair of the floor made on existing ceiling and expanded polystyrene concrete underlay. The floor was built on a reinforced concrete ceiling with an area of about 1050 m². Significant damage in the form of cracks, detachments and unevenness was found in the floor. In order to determine the causes of damage, in situ tests and laboratory tests were carried out. It was found that the damage was caused by numerous performance errors. A test repair of the damage (4.7x6.0 m) was carried out, and then the repair method was applied on the entire floor surface.

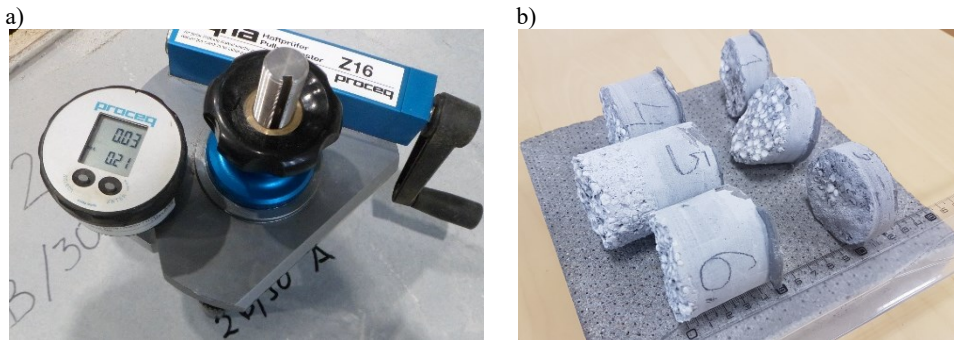
The pull-off tests conducted on the damaged floor resulted in the stress at break between 0.12÷0.34 N/mm². The test concurred previous observation of uneven thickness of the floor screed. The thickness of the screed was between 12 and 40 mm, only in P1 measurement point obtaining desired value. The samples before and after the pull-off test are shown in Fig. 11.

In the performance declaration, the manufacturer declares layer-to-layer adhesion of at least 0.2 N/mm². As seen from the results, the local adhesion did not meet the requirements.

Fig. 11. Sample (no. 2) during the test and afterwards (samples from the damaged floor).
