Analysis of the Ways to Identify Rail Running Surface Defects by Means of Vibration Signals

Roksana LICOW¹, Franciszek TOMASZEWSKI²

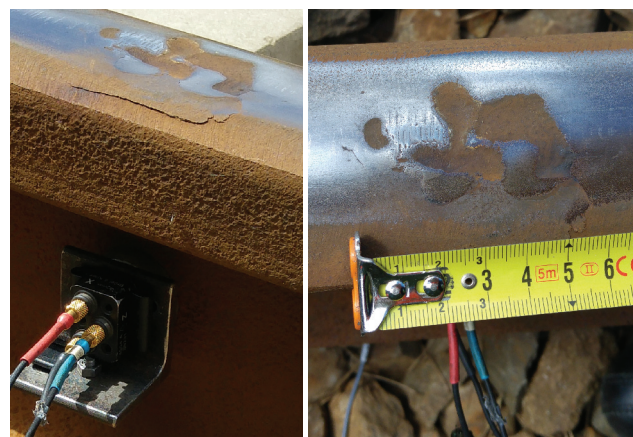
The first defect subject to analysis was defect no. 227 in accordance with PLK's Catalogue of Rail Defects. A squat defect is defined as a crack and local indentation of a rail's running surface, occurring outside rail ends on the running surface of a railhead, on straight sections of a track and on elevations of a grade of up to 4.0‰ (Fig. 1) [3].

At its earliest stage, a squat appears to be a dark semicircular spot, often still without any cracks. Further stages of its development involve material peeling off and cracking. The lack of appropriate diagnostics

of rails as well as no visual inspections and no application of proper preventive measures may lead to rails breaking completely and trains derailing. The causes of this type of defect are not fully known, hence it is important to perform appropriate diagnostics involving, among others, careful visual inspections of the occurring defects and rail observations involving ultrasound testing [4, 6].

Fig. 1. Squat defect on railway line no. 213 Reda – Hel [authors' own work]

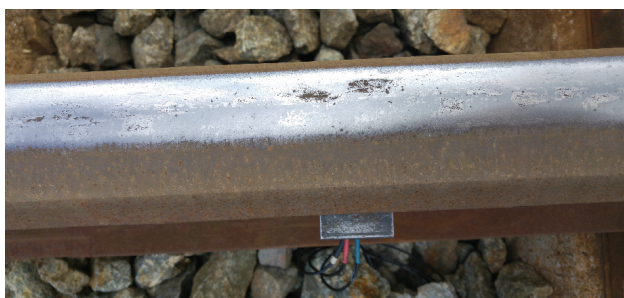
The next defect is spalling, defect no. 2252 and no. 2251, single and multiple spalling in accordance with PLK's Catalogue of Rail Defects (Fig. 2). Spalling involves the damage of rail running surfaces resulting entirely from the standard use and operation of rails, found commonly on track sections where trains brake violently or where heavy freight trains are accelerated to operational speed. Spalling occurs most often before home signals as well as before level crossings and turnouts.

Spalling occurs symmetrically on both isolated rail sections and is identified by means of visual inspection. Recommended measures to be taken are observation, grinding, replacement or immediate replacement of the rail [3, 7].

Fig. 2. Spalling defect on railway line no. 213 Reda – Hel [authors' own work]

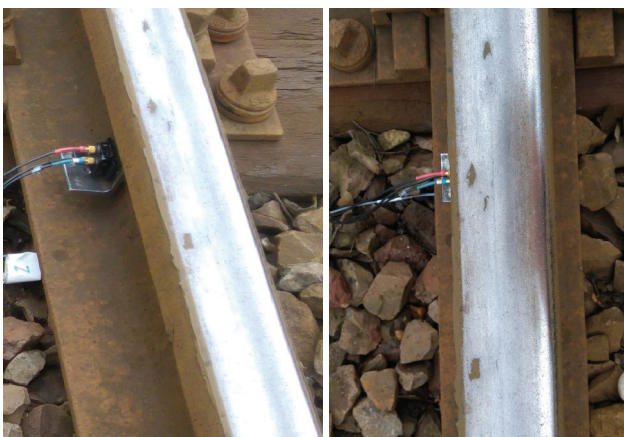
The last of the analysed defects is the rail running surface defect no. 221 in accordance with PLK's Catalogue of Rail Defects (Fig. 3). Defect no. 221 appears only on the railhead during the standard use and operation of the track. It is damage with a metallurgical origin. Its most common manifestations include shelling of the running surface or groove-shaped cracks.

Fig. 3. Defect 221 – damage of the running surface on railway line no. 213 Reda – Hel [authors' own work]

Damage 221 is identified most often by means of visual inspection. Depending on the degree of defect development, the recommendation is to inspect the rail visually on a continual basis, grind it or re-surface it [3].

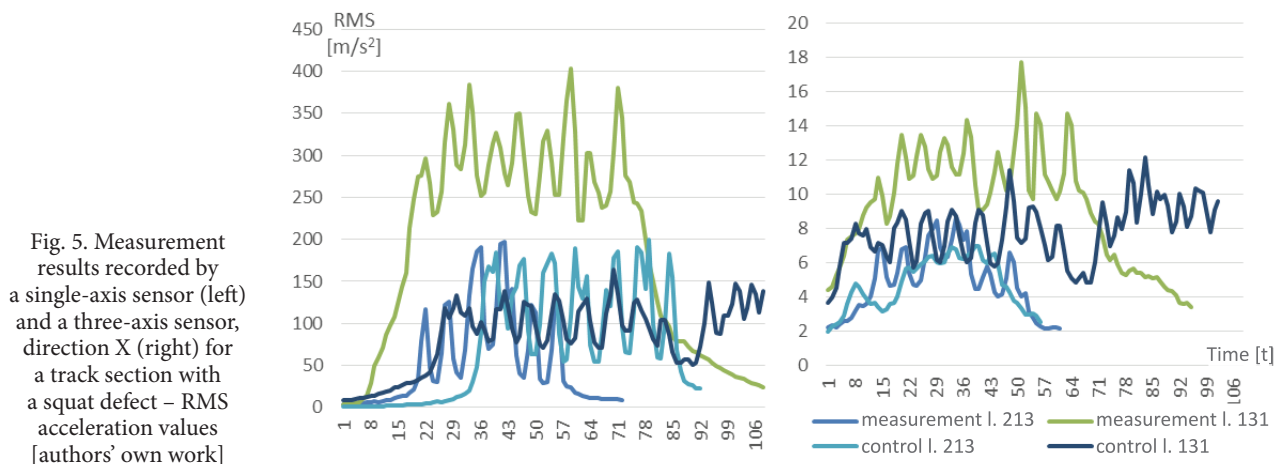
Figure 5 presents a comparison of the RMS values of vibration acceleration for the control track section with a track section featuring a squat defect on lines no. 213 and no. 131. The results were recorded by a 4513-B-001 single-axis sensor placed under the

Fig. 5. Measurement results recorded by a single-axis sensor (left) and a three-axis sensor, direction X (right) for a track section with a squat defect – RMS acceleration values [authors' own work]

The maximum values recorded by the single-axis sensor for the track section with a squat defect on line no. 131 amounted to 400 m/s². In the case of line no. 131, the values of acceleration of travel over the squat defect were four times higher than the values of signals recorded on the control track section. In the case of line no. 213, the recorded values were two times higher than those recorded on the control track section. The acceleration values recorded by the three-axis sensor for direction X were twenty times lower than the acceleration values recorded by the single-axis sensor. In the case of line no. 131, the maximum RMS value obtained for the three-axis sensor in direction X was 18 m/s², which is two times more than the values obtained for the control track.

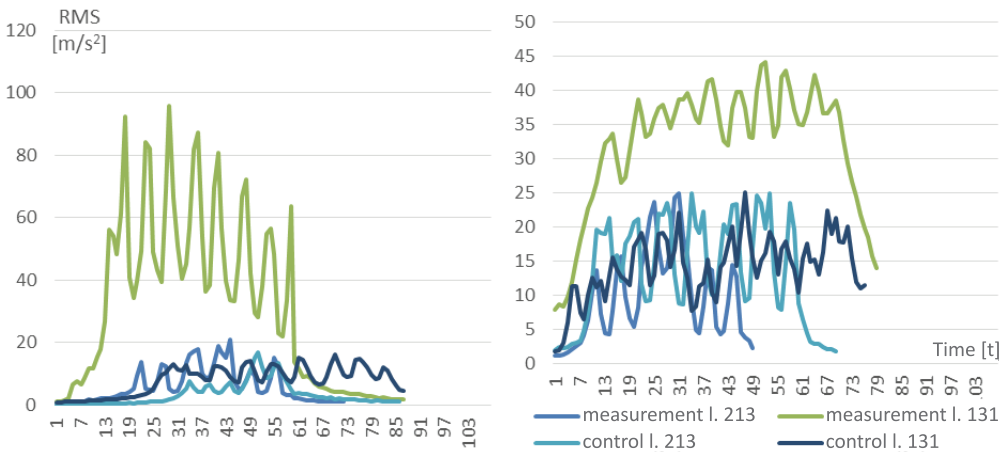
Figure 6 presents measurement results provided by a three-axis sensor for direction Y – transverse to the rail-borne vehicle movement direction – and for direction Z – perpendicular to the rail-borne vehicle

The RMS values of vibration acceleration for line 131 recorded during travel along a track section with a defect in axis Y were nine times higher than in the case of the control track section. The maximum value for axis Y was 98 m/s². The results given by the three-axis sensor in direction Z are ten times lower than those recorded by the single-axis sensor.

Fig. 6. Measurement results recorded by a three-axis sensor, direction Y (left) and direction Z (right) for a track section with a squat defect – RMS acceleration values [authors' own work]

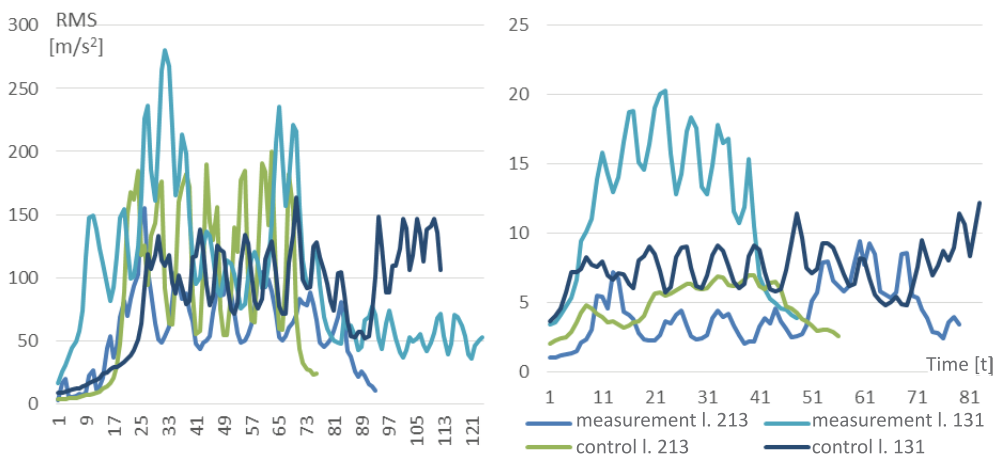
Figure 7 presents a comparison of the RMS values of vibration acceleration for the control track section with a track section featuring a spalling defect on lines no. 213 and no. 131.

When trains travelled along a section with a spalling defect, the single-axis sensor recorded values similar to those recorded on the control track section on line no. 213. In the case of the results recorded by the three-axis sensor in direction X, the RMS values obtained for travelling over the defect were two times higher than the values recorded on the control track for both railway lines.

Fig. 7. Measurement results recorded by a single-axis sensor (left) and a three-axis sensor, direction X (right) for a track section with a spalling defect – RMS acceleration values [authors' own work]

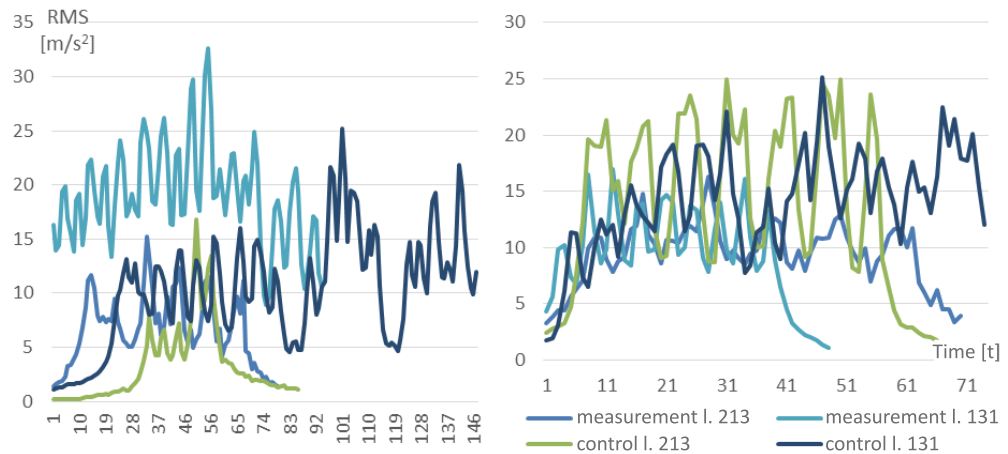
Figure 8 presents measurement results provided by a three-axis sensor for direction Y and direction Z for travel over a track section with a spalling defect.

The maximum RMS value was recorded by the three-axis sensor in direction Y for the measurement on line no. 131, amounting to 32 m/s². In the case of both railway lines, the recorded values were two times higher than the values for the control track section in direction Y. The results of the measurements performed using the three-axis sensor in direction Z showed values for travelling over the defect that were two times lower than in the case of the values for the control track section.

Fig. 8. Measurement results recorded by a three-axis sensor, direction Y (left) and direction Z (right) for a track section with a spalling defect – RMS acceleration values [authors' own work]

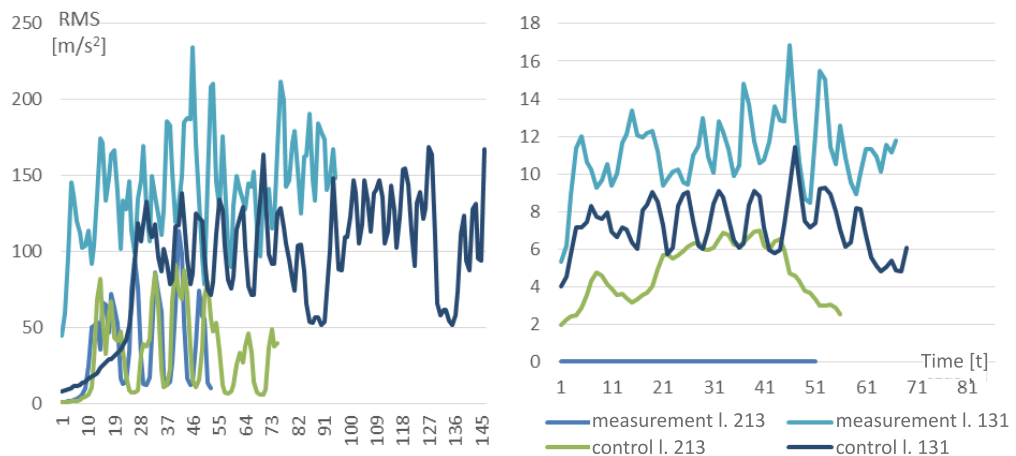
Figure 9 shows a comparison of the RMS values of vibration acceleration for the single-axis sensor and the three-axis sensor in direction X for the control track section and the track section with a running surface defect no. 221 on lines 213 and 131.

The values of the results recorded by the single-axis sensor placed under the rail foot were similar to

those recorded for travelling over the spalling defect. The three-axis sensor in direction X showed values which were two times higher for travelling over a defective track section than in the case of the control track section.

Fig. 9. Measurement results recorded by a single-axis sensor (left) and a three-axis sensor, direction X (right) for a track section with a running surface defect – RMS acceleration values [authors' own work]

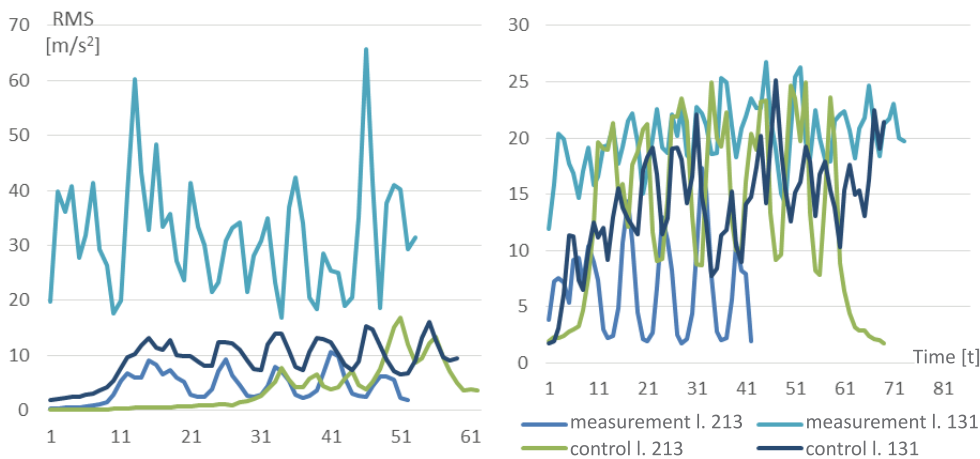
Figure 10 shows a comparison of the RMS values of vibration acceleration for the three-axis sensor in directions Y and Z for the control track section and the track section with a running surface defect no. 221 on lines 213 and 131.

The results obtained for travelling over a running surface defect, as recorded by the three-axis sensor in direction Y, featured values which were, on average, five times higher than in the case of values for the control track section on line no. 131. No similar relationship occurred on line no. 213. The measurements performed using the three-axis sensor for direction Z produced similar values for travelling over the defect and over the control track section in the case of both railway lines.

Fig. 10. Measurement results recorded by a three-axis sensor, direction Y (left) and direction Z (right) for a track section with a running surface defect – RMS acceleration values [authors' own work]
