Integrated Application of GPR and Ultrasonic Testing in the Diagnostics of a Historical Floor

Abstract: The paper presents the results of integrated ground penetrating radar (GPR) and ultrasonic testing (UT) measurements conducted on a historical floor in St. Nicholas' Church, Gdańsk, Poland. The described inspection was the first stage of the technical state assessment of the building. The aim of the study was the detection of underfloor air gaps, which were observed in a few trial pits. The condition of the ground under the floor was determined by localizing other inclusions such as rubble, human remains, brick walls and pipes. To identify the phenomenon of electromagnetic and ultrasonic wave propagation within the air gap, laboratory tests were conducted on physical models consisting of two concrete slabs stacked on top of each other and gradually moved apart to simulate a slot of varying thickness. The conducted research was supported by the numerical models of electromagnetic wave propagation. The obtained results showed that the integration of the GPR and UT methods provided an effective imaging of the floor and the area under it. Ultrasonic testing was proved to be a good t

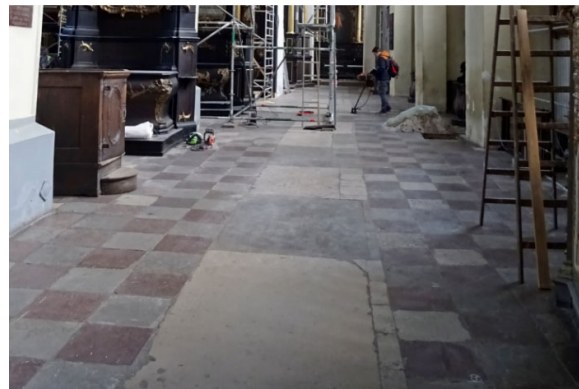
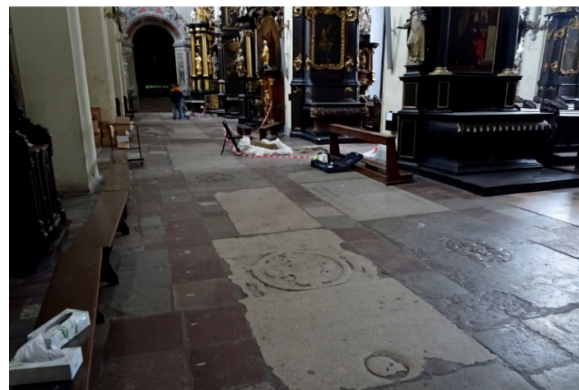
The conducted floor inspection reported in this paper was the first stage of investigations directed to assess the technical state of the church. NDT tests were performed on the floor of two aisles, south and north, as shown in Figure 1. In both aisles, the top floor layer was made of stone tiles measuring approximately 43 cm × 43 cm. In the central part of each aisle, tombstones were laid. The cross-section layers of the floor were identified in a few trial pits. One of the pits located in the north aisle is shown in Figure 2. Based on a visual inspection of the cross-section visible in the trial pit, particular layers in the floor were identified (Figure 3). It was found that the stone tiles laid on the cement mortar layer had a thickness of approximately 2–6 cm. Below was a layer of sand and ground backfill. It was also identified that at some edges, an air gap with a thickness of approximately 1–2 cm was visible below the cement mortar.

Figure 1. Photograph of the floor in St. Nicholas' Church in Gdańsk, Poland (Google Maps coordinates in a WGS84 system: 54.352206 N, 18.651510 E): (a) south aisle; (b) north aisle.

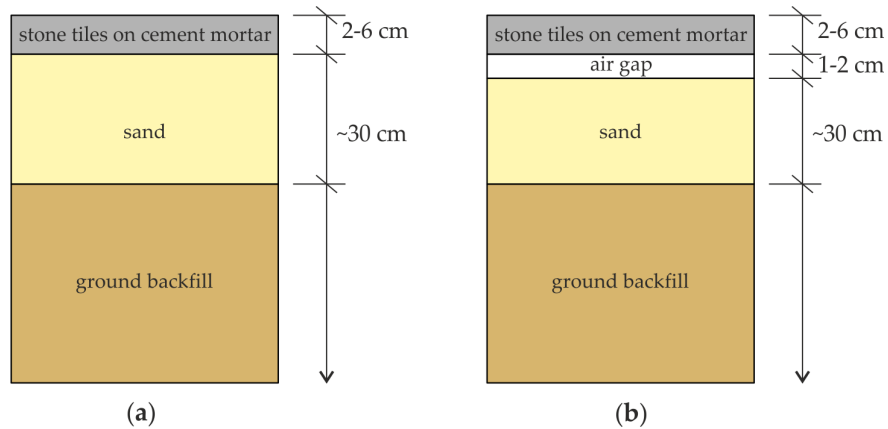
Figure 3. Schematic sketch of floor layers in the trial pit: (a) appropriate cross-section (without air gap); (b) cross-section with damage (air gap).

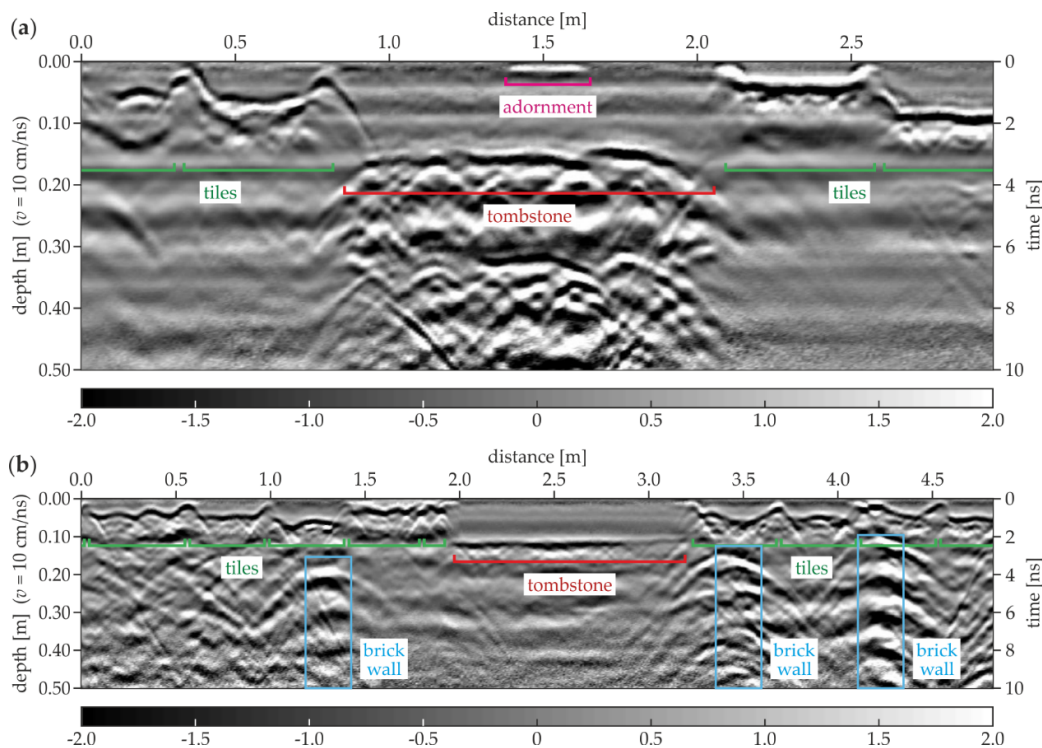
Figure 17 presents two examples of the GPR B-scans acquired in the area of the south aisle. The A-19 scan (Figure 17a) clearly reveals the location of the tiles based on the reflections from the tile grouts. The bottom faces of the tiles were identified at different depths, thus they had different thicknesses, varying between 0.04 and 0.09 m. The tombstone with a thickness of approximately 0.16 m could be observed in the center of the scan. An additional reflection denoting the tombstone adornment was also visible at the top of the scan. The ground under the tombstone had many concentrated inclusions, probably being the rubble or the human remains from the original crypts (cf. Figure 14c,d). Aside from this area, inhomogeneities were not observed. It was difficult to state whether there were any brick walls under the edges of the tombstone because the hyperbolas denoting the concentrated inclusions blurred the image. The A-117 scan (Figure 17b) shows the tiles with different thicknesses between 0.03 and 0.08 m. The tombstone was also visible; however, its shape was far more regular compared with the one from the A-19 scan. The ground below the tombstone had no strong inhomogeneities, thus it could be stated that not all the tombstones were laid in the area of the original crypts. Other interesting reflections were the hyperbolas located vertically one above another at the distances of 1.3, 3.4 and 4.2 m. They indicated the presence of three brick walls (cf. Figure 14b,d), that might be the remainders of the original supporting structures of the crypts.

Figure 17. GPR B-scans for the south aisle (survey A): (a) A-19; (b) A-117.

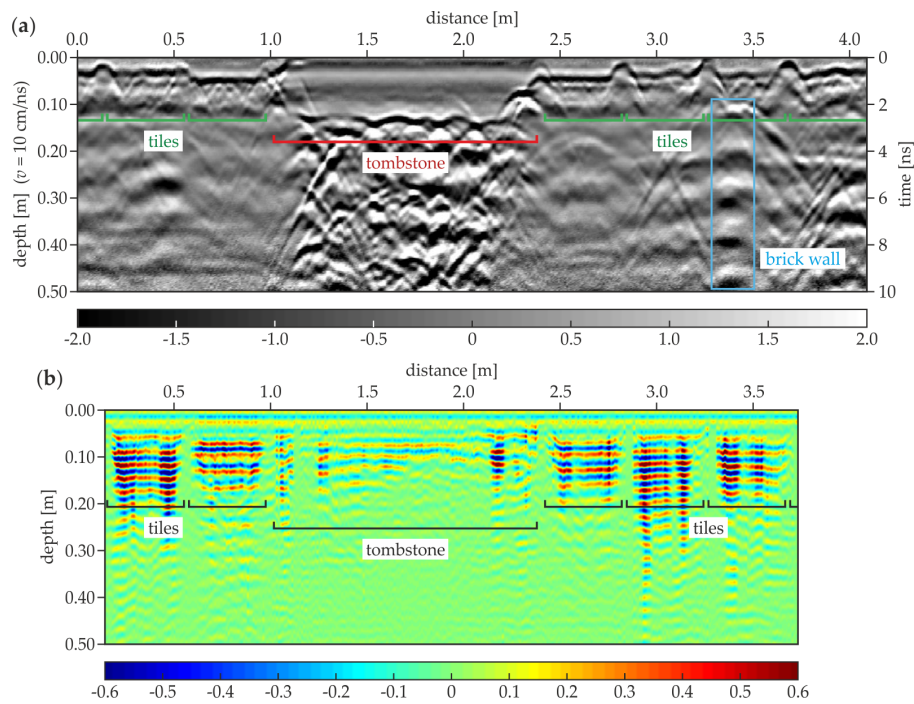
The next two GPR B-scans from the south aisle are presented together with the corresponding results of the UT scanning. In the A-121 GPR B-scan (Figure 18a), the tiles with different thicknesses (in the range of 0.02–0.04 m) were visible, and also a tombstone with the thickness of about 0.12 m was identified. The ground below the tombstone contained some concentrated inclusions (probably rubble or human remains). The brick wall was present at a distance of about 3.4 m. The UT scan (Figure 18b) clearly revealed the tile pattern, and also the tombstone was observed. The presence of the multiple reflections under each tile allowed stating that there were many air gaps below them, which agreed with the fact that the floor of the south aisle experienced significant settlement. The reflections denoting the air gaps generally did not appear below the tombstone, probably because of

its weight. What is also worth noting is that no additional reflections from the ground heterogeneities could be identified. The UT scanning did not detect concentrated inclusions, which were already observed for the pipe in the area of the trial pit and the table tennis ball in the concrete slab. The GPR B-scan for the trace A-129 is presented in Figure 19a. The tiles with different thicknesses (varying between 0.02 and 0.06 m) are clearly detectable. Two tombstones with a thickness of approximately 0.12 m and irregular shape of the bottom face were also present. The ground under both tombstones had many concentrated inclusions unlike aside from this area. The brick wall could be visible at the distance of about 4.3 m; however, the intensity of the reflections from the bricks was not as strong as in the A-121 scan. In the UT scan (Figure 19b), the tiles and the tombstones could be localized. There were no significant reflections under the tombstones, thus the air gaps were not likely to be there, unlike under the most of the tiles, where multiple reflections appeared. This observation corresponded with the settlement of the floor in the area of the south aisle.

Figure 18. GPR and UT B-scans for trace A-121 (south aisle): (a) GPR scan; (b) UT scan.

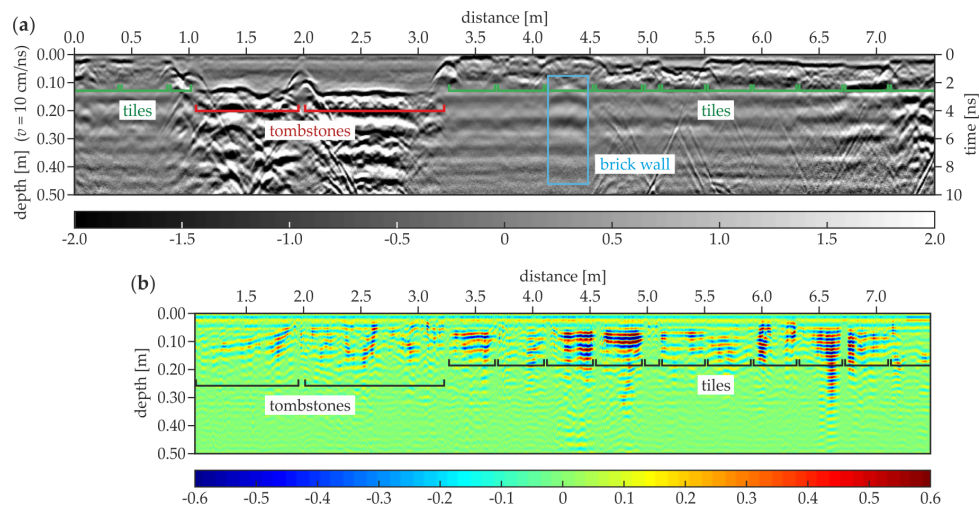
Figure 19. GPR and UT B-scans for trace A-129 (south aisle): (a) GPR scan; (b) UT scan.

and 4.5 m (it was seen in the A-129 scan, Figure 19). The distinction of singular tombstones from the main row was not possible; the scanning was performed along the tombstone grouts, thus they could not be imaged. The singular tiles were not detected due to a single direction profiling. The tile grouts in the lengthwise direction (perpendicular to the measurement traces) were identified, unlike the crosswise grouts (oriented in the same direction as the scan traces). At the depth of 4.06 cm (Figure 21b), the imaging of the tombstones was far clearer; however, there was still no possibility to distinguish the singular elements. On the contrary, the individual tiles could be detected; the chosen tomography depth was between the minimum and the maximum thickness of the tiles, thus some of them were visible, whereas other ones could not be observed. At the depth of 12.19 cm (Figure 21c), most of the tombstones were clearly visible. The lower faces of some thicker tombstones were below the tomography depth, unlike the thinner ones, which were not detected at this level. The adornment was detected on the second tombstone from the left. The tiles could not be identified because their bottom faces were located certainly above the actual tomography level. What is more, the brick wall was moderately imaged at the width of about 5.2 m and the length between 2.2 and 13.8 m. The tombstones were still distinguishable at the depth of 23.75 cm (Figure 21d). The inhomogeneities in the ground under certain tombstones were visible, especially on the right side of the tomography. The brick wall discovered at the depth of 12.19 cm was still detectable and seemed to be longer. What is more, another two brick walls were identified: the first one at the width of 4.5 m and the length between 5.5 and 14.0 m, the second at the width of 2.2 m and the length between 6.5 and 15.0 m. All of the three walls were clearly imaged in the A-117 B-scan (see Figure 17b).
