# Integrated Application of GPR and Ultrasonic Testing in the Diagnostics of a Historical Floor

**Abstract:** The paper presents the results of integrated ground penetrating radar (GPR) and ultrasonic testing (UT) measurements conducted on a historical floor in St. Nicholas' Church, Gdańsk, Poland. The described inspection was the first stage of the technical state assessment of the building. The aim of the study was the detection of underfloor air gaps, which were observed in a few trial pits. The condition of the ground under the floor was determined by localizing other inclusions such as rubble, human remains, brick walls and pipes. To identify the phenomenon of electromagnetic and ultrasonic wave propagation within the air gap, laboratory tests were conducted on physical models consisting of two concrete slabs stacked on top of each other and gradually moved apart to simulate a slot of varying thickness. The conducted research was supported by the numerical models of electromagnetic wave propagation. The obtained results showed that the integration of the GPR and UT methods provided an effective imaging of the floor and the area under it. Ultrasonic testing was proved to be a

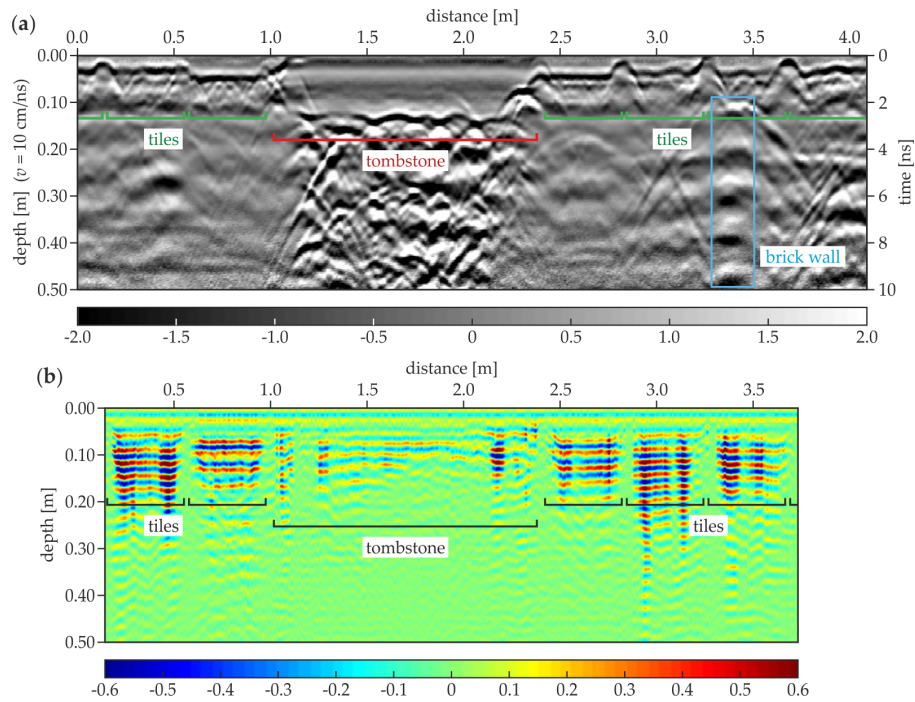
The next two GPR B-scans from the south aisle are presented together with the corresponding results of the UT scanning. In the A-121 GPR B-scan (Figure 18a), the tiles with different thicknesses (in the range of 0.02–0.04 m) were visible, and also a tombstone with the thickness of about 0.12 m was identified. The ground below the tombstone contained some concentrated inclusions (probably rubble or human remains). The brick wall was present at a distance of about 3.4 m. The UT scan (Figure 18b) clearly revealed the tile pattern, and also the tombstone was observed. The presence of the multiple reflections under each tile allowed stating that there were many air gaps below them, which agreed with the fact that the floor of the south aisle experienced significant settlement. The reflections denoting the air gaps generally did not appear below the tombstone, probably because of

its weight. What is also worth noting is that no additional reflections from the ground heterogeneities could be identified. The UT scanning did not detect concentrated inclusions, which were already observed for the pipe in the area of the trial pit and the table tennis ball in the concrete slab. The GPR B-scan for the trace A-129 is presented in Figure 19a. The tiles with different thicknesses (varying between 0.02 and 0.06 m) are clearly detectable. Two tombstones with a thickness of approximately 0.12 m and irregular shape of the bottom face were also present. The ground under both tombstones had many concentrated inclusions unlike aside from this area. The brick wall could be visible at the distance of about 4.3 m; however, the intensity of the reflections from the bricks was not as strong as in the A-121 scan. In the UT scan (Figure 19b), the tiles and the tombstones could be localized. There were no significant reflections under the tombstones, thus the air gaps were not likely to be there, unlike under the most of the tiles, where multiple reflections appeared. This observation corresponded with the settlement of the floor in the area of the south aisle.

Figure 18. GPR and UT B-scans for trace A-121 (south aisle): (a) GPR scan; (b) UT scan.

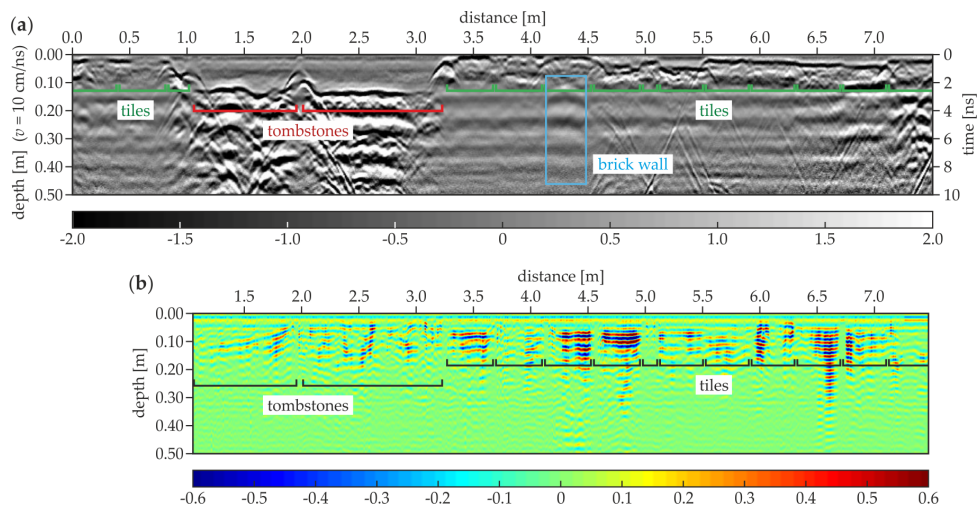
Figure 19. GPR and UT B-scans for trace A-129 (south aisle): (a) GPR scan; (b) UT scan.

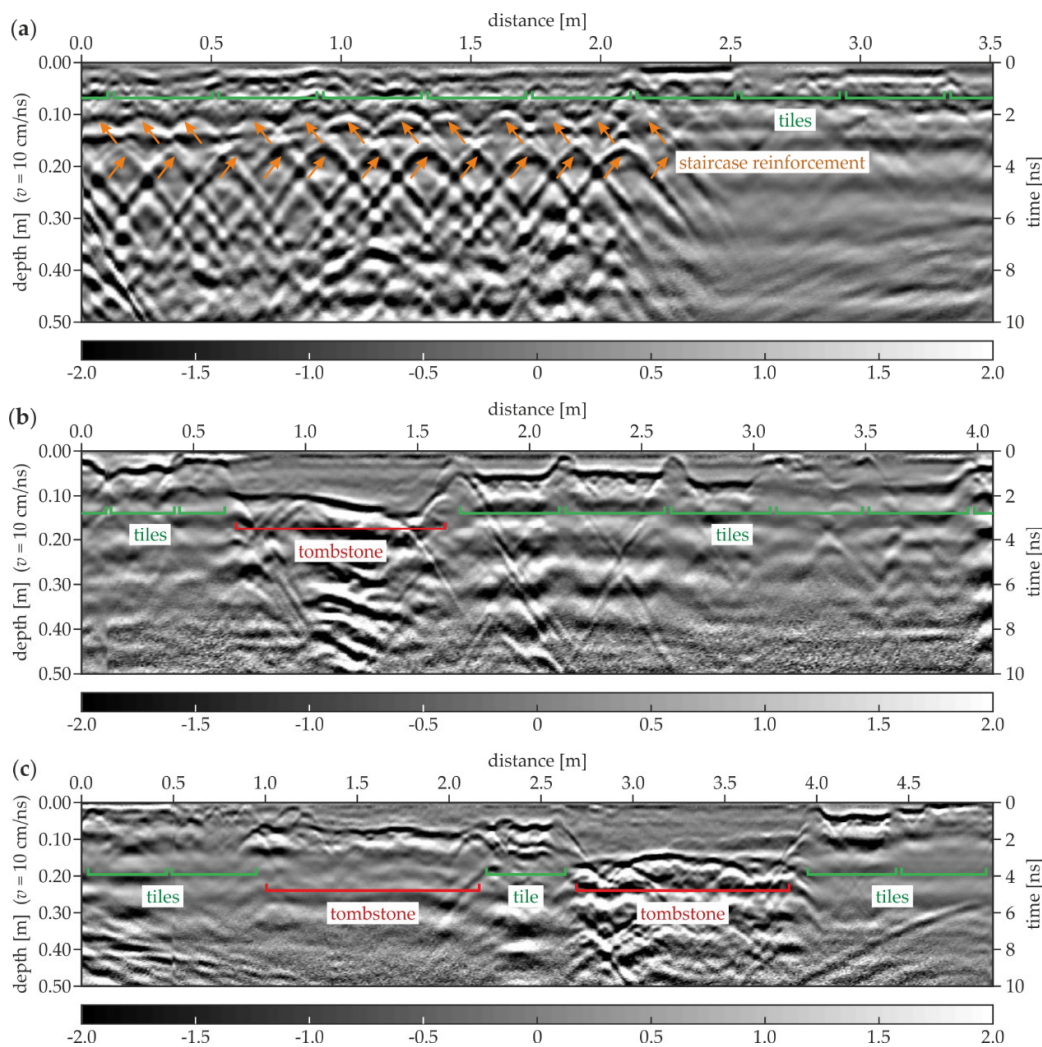
Figure 20 shows the examples of the GPR B-scans for the north aisle. The B-5 scan (Figure 20a) shows the regular pattern of tiles with a constant thickness of 0.03 m. Several evenly spaced hyperbolas were visible at two levels (the depth of 0.11 and 0.18 m) and the distance of 0.0–2.1 m. These reflections represented the reinforcement of the staircase located under the floor. The ground below the tiles aside of the staircase seemed to be devoid of significant heterogeneity. In the B-35 scan (Figure 20b), the tiles had different thicknesses in the range of 0.02–0.06 m. The tombstone had a thickness varying between 0.10 and 0.15 m and the skew shape of the bottom face. The ground below the tombstone had some concentrated inclusions. The B-143 scan (Figure 20c) presents the tiles with the thicknesses between 0.02 and 0.05 m. Two tombstones were also visible, the left one with the thickness of about 0.09 m and the right with the thickness of approximately 0.16 m. The ground under the thinner tombstone did not have inhomogeneities, unlike the ground under the second one, where multiple reflections from the concentrated inclusions occurred. This observation confirms the fact that some of the tombstones were placed aside from the area of the original crypts.

Figure 20. GPR B-scans for the north aisle (survey B): (a) B-5; (b) B-35; (c) B-143.
