Integrated Application of GPR and Ultrasonic Testing in the Diagnostics of a Historical Floor

Abstract: The paper presents the results of integrated ground penetrating radar (GPR) and ultrasonic testing (UT) measurements conducted on a historical floor in St. Nicholas' Church, Gdańsk, Poland. The described inspection was the first stage of the technical state assessment of the building. The aim of the study was the detection of underfloor air gaps, which were observed in a few trial pits. The condition of the ground under the floor was determined by localizing other inclusions such as rubble, human remains, brick walls and pipes. To identify the phenomenon of electromagnetic and ultrasonic wave propagation within the air gap, laboratory tests were conducted on physical models consisting of two concrete slabs stacked on top of each other and gradually moved apart to simulate a slot of varying thickness. The conducted research was supported by the numerical models of electromagnetic wave propagation. The obtained results showed that the integration of the GPR and UT methods provided an effective imaging of the floor and the area under it. Ultrasonic testing was proved to be a good t

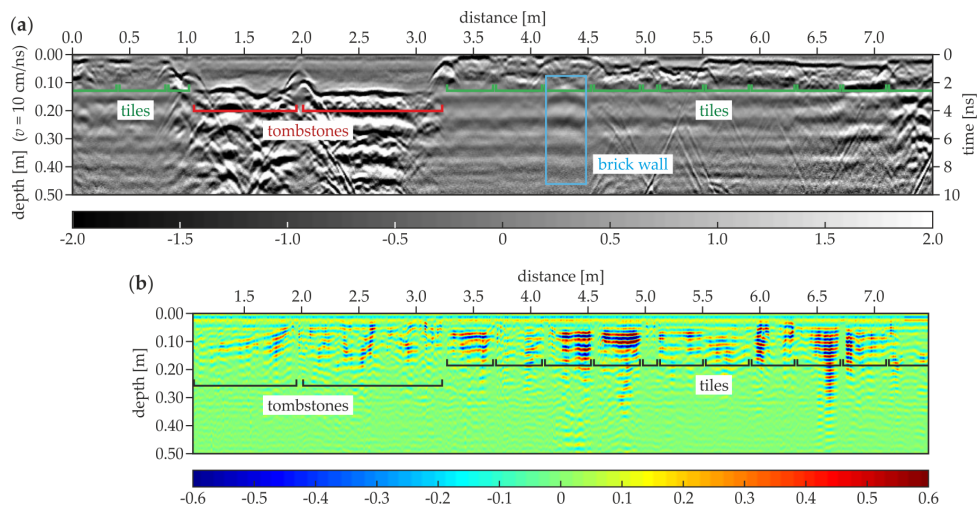
Figure 19. GPR and UT B-scans for trace A-129 (south aisle): (a) GPR scan; (b) UT scan.
