1 Thermal failure of a second rotor stage in heavy duty gas turbine

10 11 Abstract

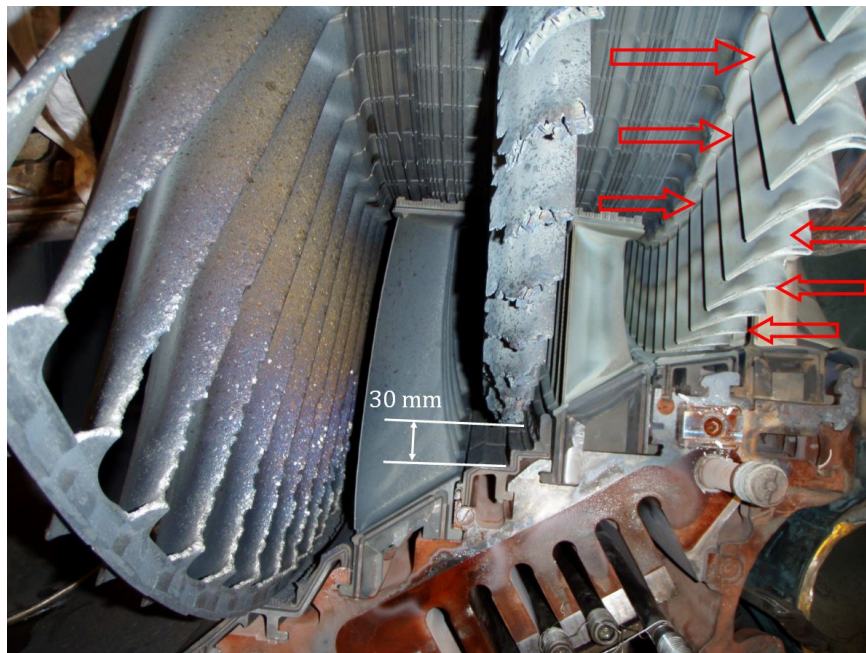
37 The gas turbine blade was broken in the upper part of the blade, near the bandage. The even
38 melting of all blades of the rotor stage and the jagged nature of the damage proves that we
39 are dealing with failure resulting from the presence of a large heat source. This source was,

1 most likely, (Fig. 1) the friction of the rotating blade bandages against the seals separating the
2 body case. The specific stepped shape of this seal, which has no equivalent in subject
3 literature, is also not without significance here.

4
5 Figure 1 View of the 2nd stage following the failure with a characteristic even melting
6 of the upper parts of the blades.

7 The melting occurred evenly, stopping at a distance of 30 mm from the internal walls of the
8 body case. An additional argument in favour of thermal damage to the blades are tarnish
9 indicated by arrows, clearly visible on the first stage of the turbine. These stains are the result
10 of high temperatures, and their formation is primary in its nature, resulting from too high a
11 temperature of the flowing exhaust gas. In an interview with the power plant operator, we
12 determined that the failure was preceded by a change in the fuel supplied to the turbine.
