The Impact of Material Selection on Durability of Exhaust Valve Faces of a Ship Engine – A Case Study

ABSTRACT

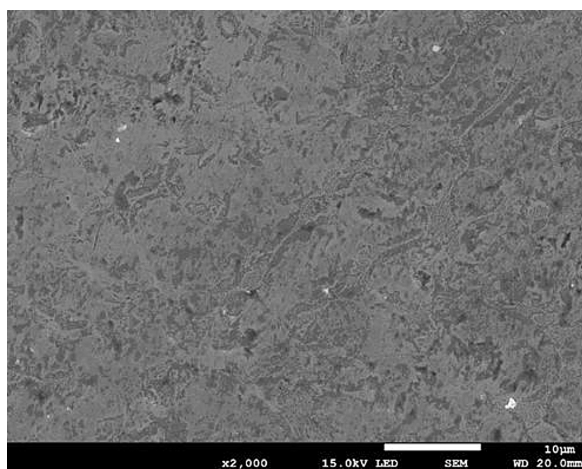
Fig. 7. L12 valve face after operation – plastic deformation

Figure 6 a multilayer scale with a tendency to crack and delaminate is visible. However, the largest layer thickness did not exceed 60 μm. SEM analysis of the valve face marked L12 showed the slight plastic deformation of the surface was observed, which can be interpreted as the effects of plastic deformation during work, this is illustrated in Figure 7.

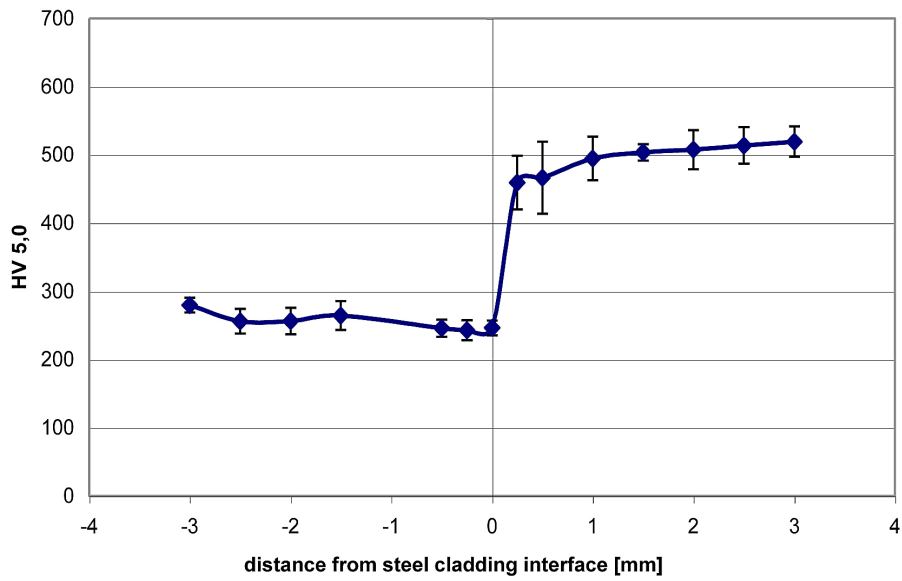
were affected by the dendrite structure and can also be attributed to the morphology of the carbides [6, 12, 16]. This phenomenon is related to the multiple heating and cooling during the multilayer cladding process. The heat treatment in high temperature and exhaust gases atmosphere may led to the changes in the hardness especially in the upper part of the clad. The results are shown in Figures 10–12. In each of the examined cases, the hardness of the surfacing layer was significantly higher than the hardness of the substrate. In the case of L12 sample hardness was found in the range 473 to 581 HV5.0 at distance 3mm from the steel-clad interface (close to clad top surface) and remained at a similar value to a distance of 1mm from the interface. In the fusion line hardness was rapidly falling to value 231-251 HV5.0. The obtained results indicate an uniform hardness of the entire weld. In the case of N sample hardness was

Fig. 10. Statistical analysis of the hardness measurements for the L12 valve after 3000 hours of operation

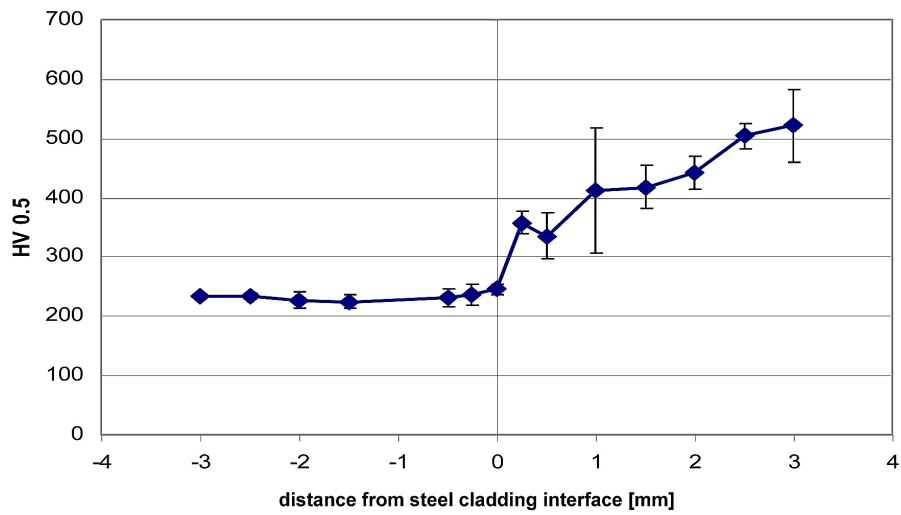
Fig. 11. Statistical analysis of the hardness measurements for N valve after 2000 hours of operation

found in the range 480 to 581 HV5.0 at distance 3mm from the steel-clad interface (close to clad top surface) – similar to L12, but in the deep of the clad hardness decreases up to 195-447 HV5.0. In means large changes in hardness on the cross-section. In both cases no significant decrease in hardness was observed close to the top surface, which indicates that despite the formation of the oxide layer, no degradation of the material will occur.
