## The Impact of Material Selection on Durability of Exhaust Valve Faces of a Ship Engine – A Case Study

### ABSTRACT

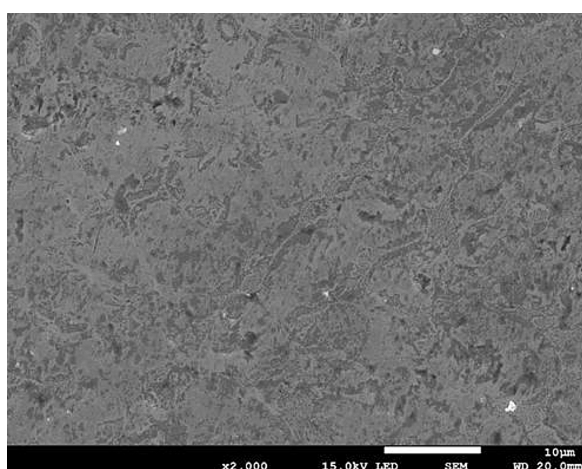
**Fig. 7.** L12 valve face after operation – plastic deformation

Figure 6 a multilayer scale with a tendency to crack and delaminate is visible. However, the largest layer thickness did not exceed 60 μm. SEM analysis of the valve face marked L12 showed the slight plastic deformation of the surface was observed, which can be interpreted as the effects of plastic deformation during work, this is illustrated in Figure 7.
