# Corrosion hazards and inhibitor protection in the seawater injection system on the Baltic sea rig

#### **Abstract**

Oil extraction efficiency in LOTOS Petrobaltic Company is increased by means of injection of seawater into an oilfield aquifer, which is implemented on the Baltic Beta rig, operating on the Baltic Sea. Operational experience has shown a significant degree of corrosion aggressiveness in the injected water, which necessitates frequent repairs of the seawater injection installation. Evaluation of the corrosion phenomena is crucial for rig platforms due to extremely high renovation costs and a negative impact on injected water quality. Chemical and microbiological analyses of seawater treated in the technological process have been carried out. Actions to estimate the corrosion risk in the installation and the estimated corrosion rates measured using an automated monitoring system are presented in this work. Monitoring of the corrosion rate conducted alongside measurements of the physicochemical properties of water allowed to identify the corrosion mechanisms of stainless steel in a seawater environment. Additionally, it became possible to assess the impact of the chlo

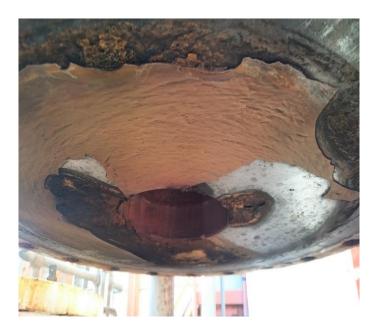
The operational experience of the Baltic Beta rig has shown a significant degree of corrosion aggressiveness of water, which necessitates frequent repairs of the installation, especially downstream of the dual media filters. Such a poor condition of the installation had a negative impact on the injected water quality. The average content of total suspended solids content in the last year was 2.25 mg/l and total iron content was 1.19 mg/l. These values exceed the permissible quality indices for injected water. Figure 2 presents the actual state of the hatches of the dual media filters.

Figure 2. Surface of the inner parts of the dual media filter.

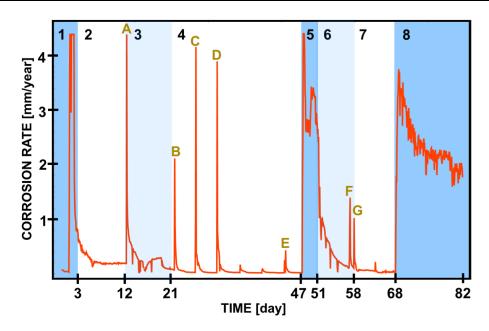
The average rate of corrosion affecting the S236JR non-alloy steel remained at the level of 1 mm/year, which is ten times higher than the safe level of 0.1 mm/year.

**Figure 3.** Corrosion rate measured at a point downstream of the deaerator tower (sensor 2).

In the periods 1, 5 and 8 (dark blue area), when the internal circuit was in use, the water flow through the installation amounted to 80 m<sup>3</sup>/h, no deoxidization was performed, and the water chlorination process was carried out only to the point at which the free chlorine content reached the level of 0.2 ppm. Corrosion inhibitor was switched off. The average corrosion rates noted in these periods of time were, respectively, 1.68, 2.66 and 2.38 mm/year. Such high levels were associated with high water expenditures (erosion, corrosion), the presence of oxygen at the level of 12.5 ppm, free chlorine at the level of 0.2 ppm, and chlorides. In each of these periods the corrosion rate was decreasing gradually, indicating that some corrosion products might have developed on the metal surface.

In the periods 3 and 6 (light blue area), the process of water injections into the oil formation was being performed. The installation operated at the flow rate of  $40 \text{ m}^3/\text{h}$ , while water was being deoxygenated and corrosion inhibitor was added. The average levels of corrosion rate recorded in these periods were, respectively, 0.26 and 0.36 mm/year. The low oxygen content, lack of free chlorine, lower water flow rate and dosage of corrosion inhibitor brought the corrosion rate down significantly. Despite this fact, its level was still too high. This might prove the occurrence of MIC or low efficiency of the corrosion inhibitor. These periods were characterized also by a gradual decrease in the corrosion rate. However, the corrosion rate drops occurred faster here than in the periods when the internal water circuit was switched on. This is due to the lower water flow rate, which does not wash the corrosion products off from the inner surface of the pipes and an addition of a corrosion inhibitor. Peak A in the area 3 shows when the water flow in the system was switched on and the corrosion products became detached. Peaks F and G in the area 6 result from temporary adjustments of the water flow rate.

Very interesting results were recorded in the periods marked 2, 4 and 7 (in white), when the water flow through the installation was entirely shut off, In the first period (2), the installation was filled with water without a corrosion inhibitor. The average corrosion rate was 0.33 mm/year at the time. In the periods 4 and 7 the water flow was turned on every five days for a period of one hour in order to flush the equipment with water containing the corrosion inhibitor. The average corrosion rate in this period equaled 0.129 and 0.075 mm/year, which shows that the inhibitor used is highly effective under stationary conditions, when there is no water flow through the installation. Peaks *B*, *C*, *D* and *E* occurred when large flows of water treated with corrosion inhibitor were turned on, whole the smaller peaks correspond to turning the installation on with less expenditure.

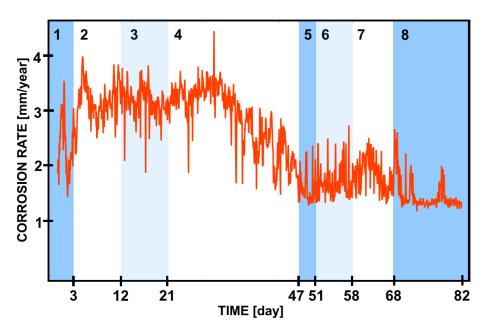
**Figure 4.** The corrosion rate measured at a point downstream of the dual media filters (sensor 1).

The average corrosion rate in non-alloy steel measured at a point before introduction of an inhibitor totaled 2 mm/year (which is twenty times higher than the safe level). The measured corrosion rates tended to oscillate. It was related to the fact that the installation was functioning on a periodic basis at the time. The noticeable oscillations match the devices operation schedule.

In the periods marked 1,5 and 8 (dark blue area), when the internal circuit was on, the average corrosion rates dropped down (~2.28, 1.52, 1.4 mm/year). When the water was being injected (light blue area, marked 3 and 6) and flow rate was 40 m³/h, the corrosion rate was higher (3.07, 1.65 mm/year). Hence, it can be noted that at this point the changes in the installation's operating mode did not have a significant impact on the corrosion rate measurements. The drop in the water flow velocity was not mirrored by a drop in the

corrosion rate. It must be also noted that at times when water was not flowing through the installation, no significant drop in the corrosion rate could be recorded. At the time when the installation remained filled with water not treated with the corrosion inhibitor (white area marked 2), the corrosion rate was 3.05 mm/year, and in the periods marked 4 and 7, when the filters were poured with water containing the corrosion inhibitor, the sensor recorded the corrosion rate of 2.74 and 1.78 mm/year. This may be a proof that chlorination of water in this part of the installation does not prevent biofilm development, and that MIC is the dominant corrosion mechanism here, which is why the corrosion inhibitor does not work properly.

We can also notice a decrease in the corrosion rate starting in the middle of period 4. Presumably, turning on a heavy water flow several times in period made some of the biofilm detach, thus slowing the microbiological corrosion rate.

A comparison of the measured corrosion rates with the contents of SRB and GHB showed only a partial correlation between these parameters. However, it must be underlined that only bacteria swimming freely in the water were analyzed. This indicator demonstrates only the potential of water to develop a biofilm. In the future, the number of bacteria in the biofilm will have to be determined to assess the possibility of MIC occurrence, as activity of bacteria proliferating in the biofilm is the main factor behind corrosion of this type. There will have to be performed a mechanical cleaning of the installation and find a new inhibitor

preventing microbiological corrosion more successfully (which may prove difficult). It is particularly important to develop a means of biological protection for the section of the installation upstream of the deaeration tower for the times when only the internal circuit is used.

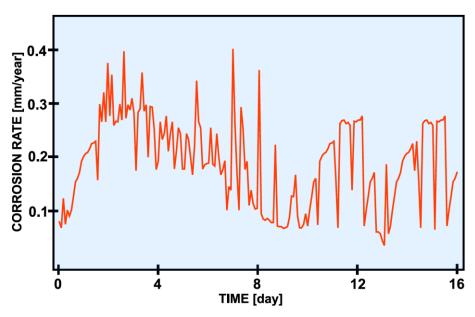
Figure 5. The corrosion rate measured downstream of the deaerator during the second inhibitor test.

The average corrosion rate during the test was 0.2 mm/year. This value is still too high, so the effectiveness of the tested inhibitor was poor. Similar to the corrosion inhibitor used previously.
