A Critical Reanalysis of Uncontrollable Washboarding Phenomenon in Metal Band Sawing

Abstract: The article analyzes the cutting process of hard bars. Investigations conducted in industrial conditions demonstrated the presence of surface errors in the machined workpieces in the form of washboard patterns. The purpose of this study was to analyze the results of cutting on band sawing machines with different band saw blades. The cutting processes were conducted on three different horizontal band sawing machine types. Analyzed material was an alloy steel Ø40 mm rod with a hardened surface covered with a thin layer of chromium. The hardness of the outer layer was 547 HV with a core hardness of 180 HV. The surface topography measurements of the processed workpieces were carried out with the 3D Optical Profiler, which supplied information on the irregularities of the processed material texture. In each of the analyzed cases, a corrugated surface was obtained after sawing, which is the effect of the occurrence of the washboarding phenomenon, despite the fact that the teeth of each band saw had variable pitches. The washboarding phenomenon when cutting rods with hard surfaces is caused by

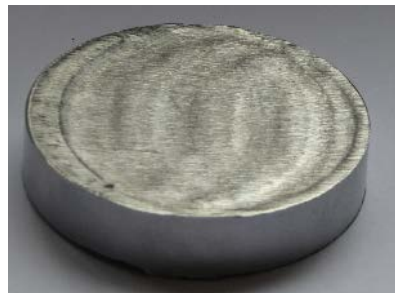
In each of the analyzed cases, a corrugated surface was obtained after sawing (Figure 4), which is the effect of the occurrence of the washboarding phenomenon, despite the fact that the teeth of each band saw had variable pitches (#1—4/6 TPI, #2—3/4 TPI and #3—2/3 TPI), which should prevent instability in the machining process according to the theory [11].

Figure 4. General view of the sample #1 with the washboard pattern on the sawn surface.

Based on the study, the performed application of bandsaws with spring setting teeth is strongly discouraged for cutting-off hard-to-machine materials. If this type of bandsaw is used, in the next step another technological operation, e.g., turning, is needed. On the other hand, with such a difficult technological task, cutting-off wire electro discharging machining (WEDM) could be recommended.

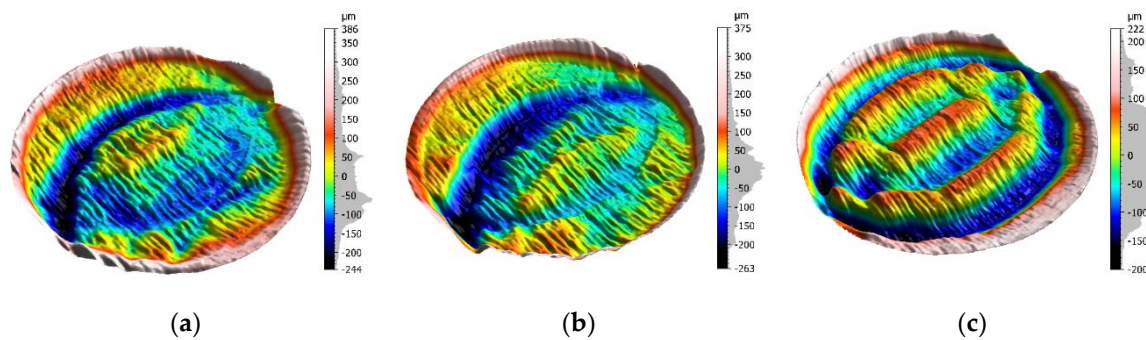
In Figure 5, exemplary 3D waviness surfaces of the samples #1, #2 and #3 are presented. All S-F surfaces of samples were obtained by applying a Gaussian filter, in accordance with ISO 16610-61 [23]. The choice of the nesting index (cut-off) of 0.8 mm was connected with obtaining a surface texture with visible reliefs of the workpiece surface after sawing.

Figure 5. 3D waviness surface under investigation of the samples #1 (a), #2(b), and #3 (c).

The height parameters of the S-F surfaces (Table 1) point out that the maximum height between the edge of the sample and the maximum depth of the furrows is much larger for samples #1 and #2. In the case of sample #3, such value reaches 422 μm , and it is 200 μm smaller than for other samples. S_p and S_v parameters of the sample #3 indicate regular spacing of hills and valleys.

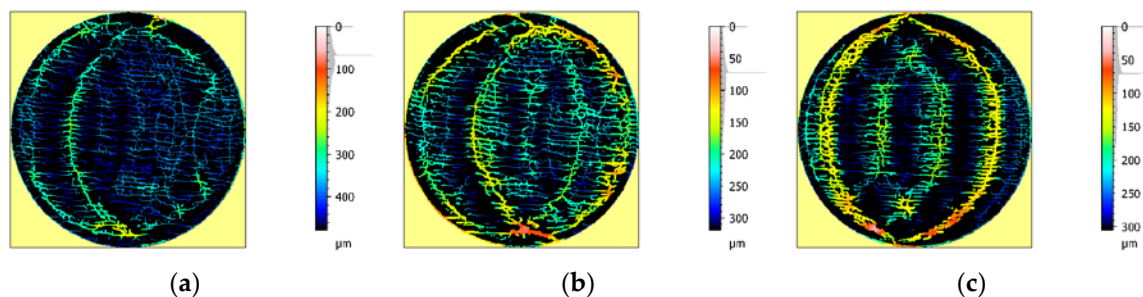
Figure 6. View of the furrows of the samples #1 (a), #2 (b), and #3 (c).

Data on furrow depth and density gathered from the examined surfaces are presented in Table 3. The obtained mean values oscillated around 100 μm , the maximum depth of samples of furrows for sample #3 was about 200 μm lower than for sample #1. In all cases, the density of the furrows, defined as a cumulative length per area unit (in 1/cm), were at the similar level.
