# A Critical Reanalysis of Uncontrollable Washboarding Phenomenon in Metal Band Sawing

**Abstract:** The article analyzes the cutting process of hard bars. Investigations conducted in industrial conditions demonstrated the presence of surface errors in the machined workpieces in the form of washboard patterns. The purpose of this study was to analyze the results of cutting on band sawing machines with different band saw blades. The cutting processes were conducted on three different horizontal band sawing machine types. Analyzed material was an alloy steel Ø40 mm rod with a hardened surface covered with a thin layer of chromium. The hardness of the outer layer was 547 HV with a core hardness of 180 HV. The surface topography measurements of the processed workpieces were carried out with the 3D Optical Profiler, which supplied information on the irregularities of the processed material texture. In each of the analyzed cases, a corrugated surface was obtained after sawing, which is the effect of the occurrence of the washboarding phenomenon, despite the fact that the teeth of each band saw had variable pitches. The washboarding phenomenon when cutting rods with hard surfaces is caus

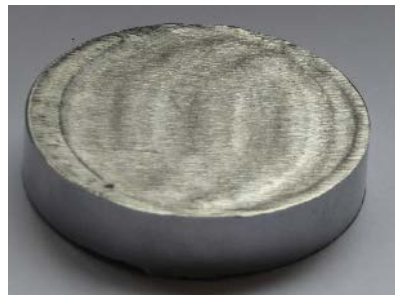
In each of the analyzed cases, a corrugated surface was obtained after sawing (Figure 4), which is the effect of the occurrence of the washboarding phenomenon, despite the fact that the teeth of each band saw had variable pitches (#1—4/6 TPI, #2—3/4 TPI and #3—2/3 TPI), which should prevent instability in the machining process according to the theory [11].

**Figure 4.** General view of the sample #1 with the washboard pattern on the sawn surface.

The phenomenon of the occurrence of the corrugated surfaces after sawing in this case could be due to the behavior of the saw blade with spring setting teeth caused by the high hardness of the outer layer of the sawn rod (547 HV). For spring setting teeth, the saw blade during entrance into cut material is twisted by the lateral forces (back forces). Under specific cutting conditions, while the washboard pattern is formed, every successive cutting edge regenerates a wave performed by the previous one. Nevertheless, this new wave is part of a distance velocity lag in the direction of primary motion. The result of this wave regeneration on the sawn surface is visible as a washboard pattern, which can be described by parameters of waviness. The wave regeneration in the examined cases is not a time function but a function of the saw blade position and simultaneous effect of forced excitations of the formed wave upon the saw blade lateral displacements. This phenomenon was described in detail by Orłowski and Wasielewski [15], who analyzed process of sawing beech and pine wood on the sash gang saw PRW15-M. In the sawing process, they used saw blades of poor quality of teeth cutting edges after grinding (minor cutting edges with feathers). It should be emphasized that waviness parameters for those species were almost equal.

Based on the study, the performed application of bandsaws with spring setting teeth is strongly discouraged for cutting-off hard-to-machine materials. If this type of bandsaw is used, in the next step another technological operation, e.g., turning, is needed. On the other hand, with such a difficult technological task, cutting-off wire electro discharging machining (WEDM) could be recommended.

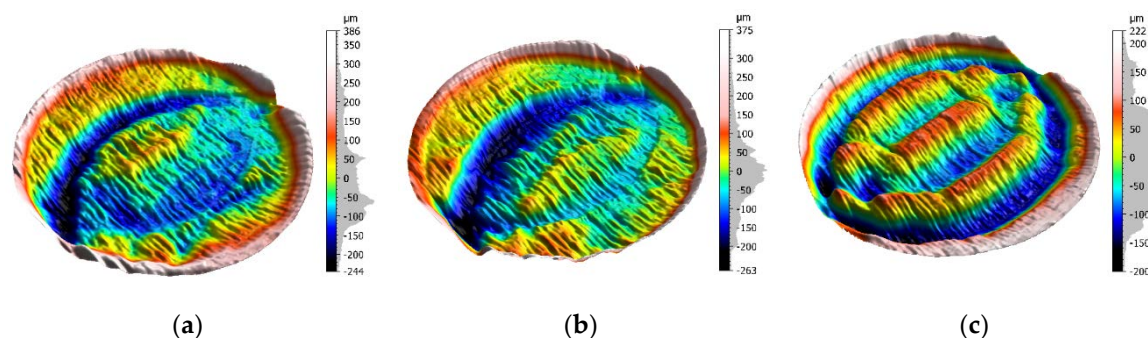
**Figure 5.** 3D waviness surface under investigation of the samples #1 (a), #2(b), and #3 (c).

The height parameters of the S-F surfaces (Table 1) point out that the maximum height between the edge of the sample and the maximum depth of the furrows is much larger for samples #1 and #2. In the case of sample #3, such value reaches 422  $\mu\text{m}$ , and it is 200  $\mu\text{m}$  smaller than for other samples.  $S_p$  and  $S_v$  parameters of the sample #3 indicate regular spacing of hills and valleys.

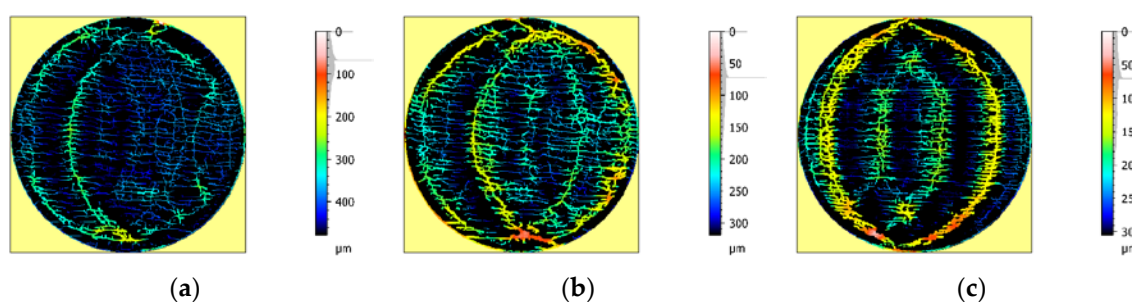
**Figure 6.** View of the furrows of the samples #1 (a), #2 (b), and #3 (c).

Data on furrow depth and density gathered from the examined surfaces are presented in Table 3. The obtained mean values oscillated around 100  $\mu\text{m}$ , the maximum depth of samples of furrows for sample #3 was about 200  $\mu\text{m}$  lower than for sample #1. In all cases, the density of the furrows, defined as a cumulative length per area unit (in 1/cm), were at the similar level.

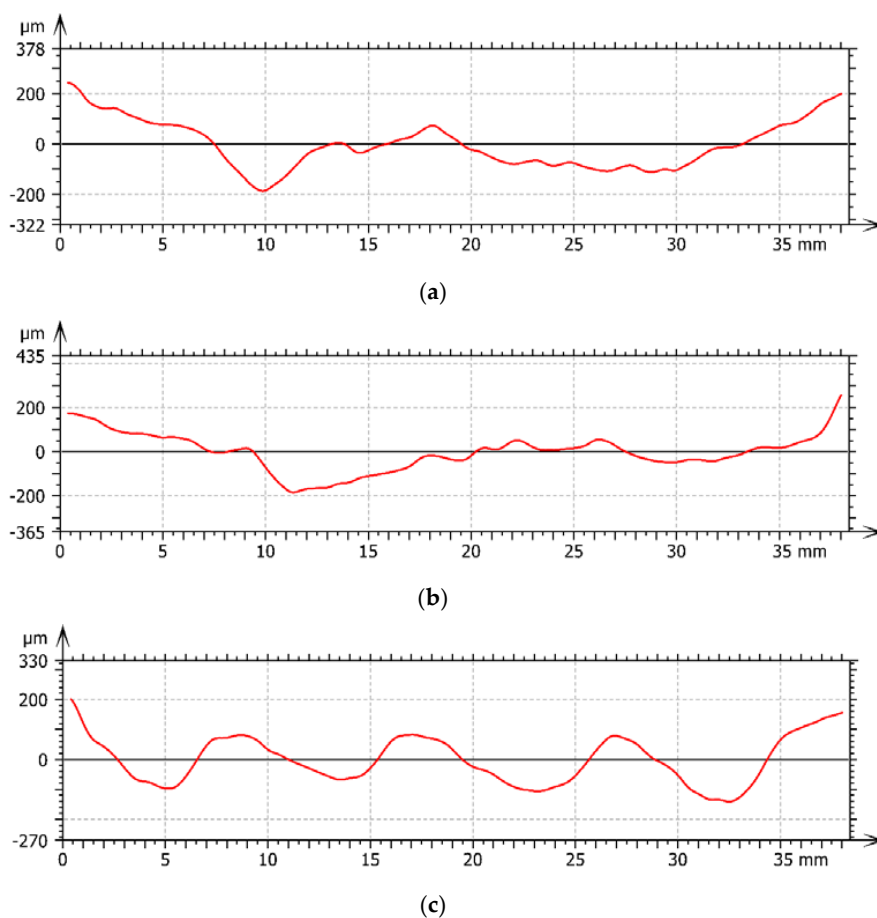
An exemplary W-profile at 50% position of the sample #3 is presented in Figure 7. According to the values of waviness parameters and profile information given in Table 3, the middle of the machined samples #1 and #2 was distinctly above the edge, 2–3  $\mu\text{m}$  wide, and with deep furrows. In sample #3, all of the furrows after machining process were well visible and their height was similar level to regular spacing of hills and valleys.

**Figure 7.** Exemplary W—profile at 50% position of the samples #1 (a), #2 (b), and #3 (c).
