Investigation of the 0.4C-35Cr-45Ni-Nb Alloy after Service in High-Temperature Steam and Hydrocarbons Environment

Abstract: The paper presents the results of investigation of the 0.4C-35Cr-45Ni-Nb alloy, which operated in the cracked hydrocarbon feeds and dilution steam at 1125 °C. The material originated from the pyrolytic furnace coil tubes, of which internal walls were in contact with the aforementioned medium, whereas the external walls were in contact with the flue gases. The examination included metallographic and mechanical tests on the material after service exposure, the results of which were compared with the ones obtained for the as-received non-exposed specimens. The metallographic tests revealed changes in the alloy's structure manifested by formation of significant amount of the carbides due to carburization of the alloy from the steam and cracked hydrocarbon feeds side. The central and external parts of the alloy samples (having no contact with the process medium) underwent substantial degradation but within a relatively narrow zone of the material. The investigations of hydrogen and methane content in the alloy showed a high amount of these gases, resulting from hi

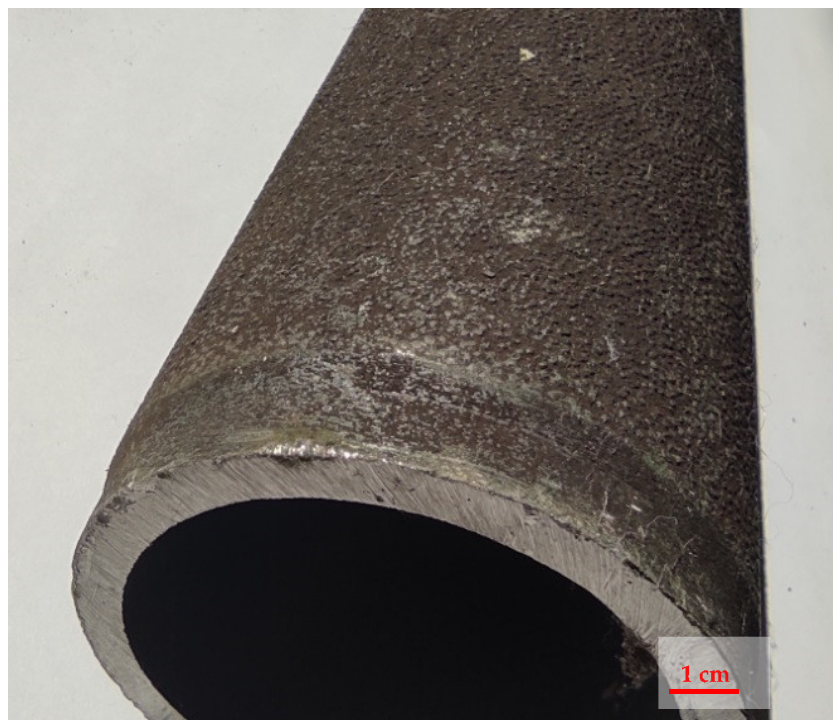
Figure 2. Pyrolytic furnace's coil tube subjected to investigation.

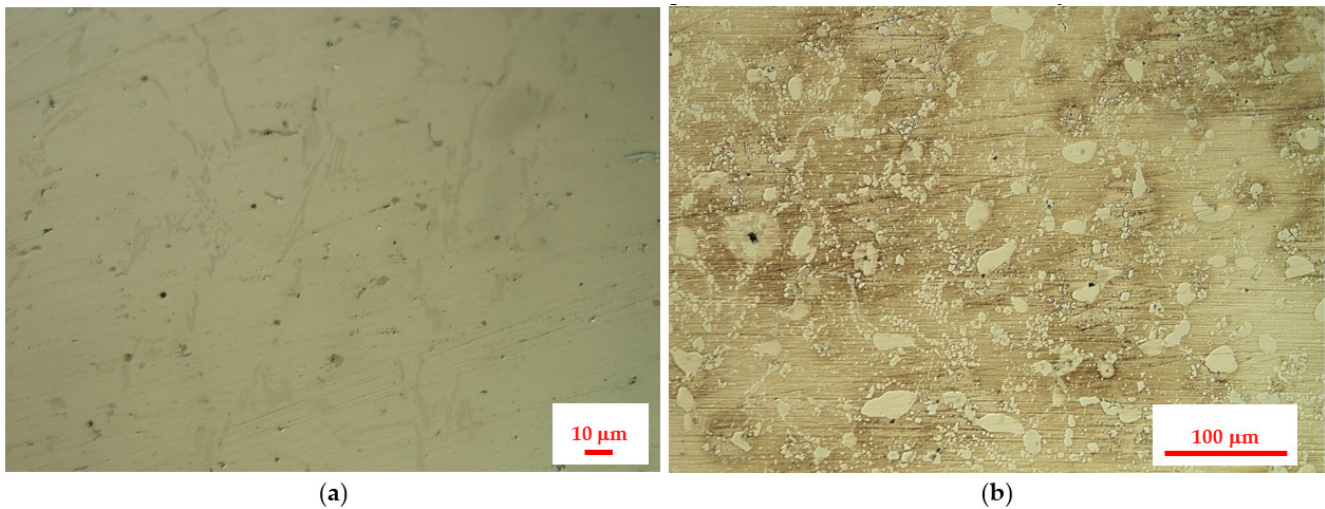
Figure 3. Surface images of the 0.4C-35Cr-45Ni-Nb alloy obtained during metallographic investigations: (a) as-received reference sample; (b) material after 5 years of service in the furnace.

The results of the investigation of the non-exposed reference sample are in accordance with the literature data [6–8]. The metallographic tests revealed carbides present in the form of branched lines (Figure 3a) [9,10]. The SEM image (Figure 4) shows dark structures (spot 1) containing significant amount of chromium and bright structures (spot 3) with higher niobium content with respect to the matrix. Very similar structure and elemental composition of particular phases of the alloy can be found in the paper [8].

In case of the alloy after 5 years of service exposure, one can notice a significant change in the microstructure. There are much more distinct precipitates of the carbides, which occupy a substantial area of the sample (Figure 3b). The change of microstructure results from long-term exposure to the temperature above 805–866 °C and from the influence of the stream inside the coil tubes, which favored carburization [2]. SEM and EDX also reveal chromium-rich phases (spot 1—Figure 5); however, the composition of particular phases differs with respect to the alloys subjected only to an ageing process [2,8]. This fact indicates that the change of microstructure is related to the impact of both aggressive environment and high temperature [11]. No creep process was identified, which suggests a high resistance of the alloy to this phenomenon.

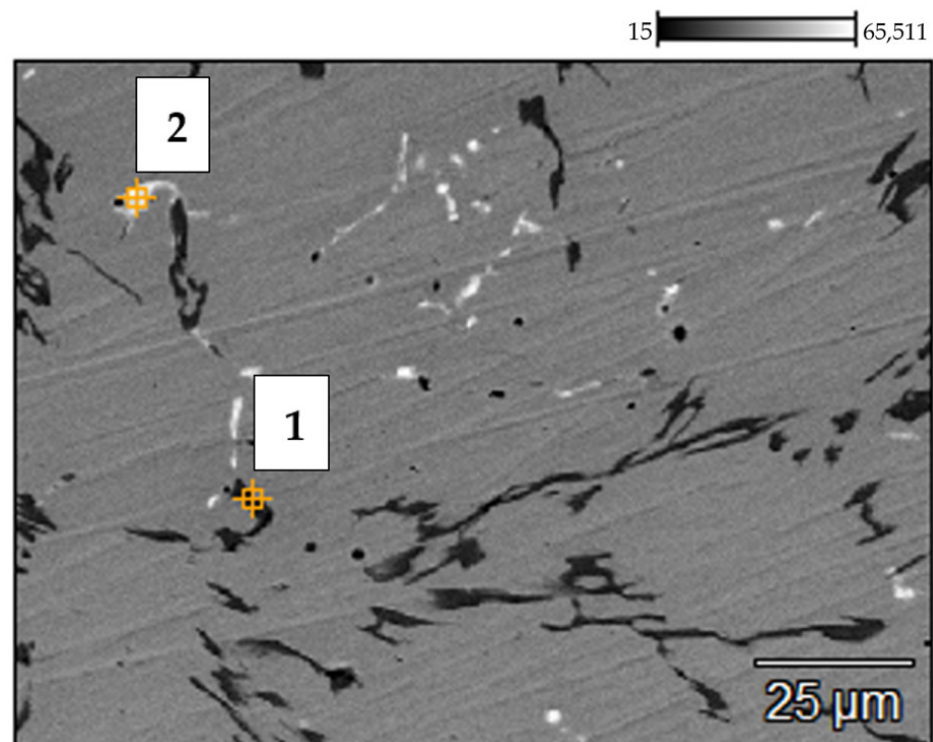
Figure 4. Backscattered electron (BSE) mode scanning electron microscopy (SEM) image of the 0.4C-35Cr-45Ni-Nb alloy—non-exposed reference sample's surface. Numbers indicate the spots of energy dispersive X-ray (EDX) analysis.

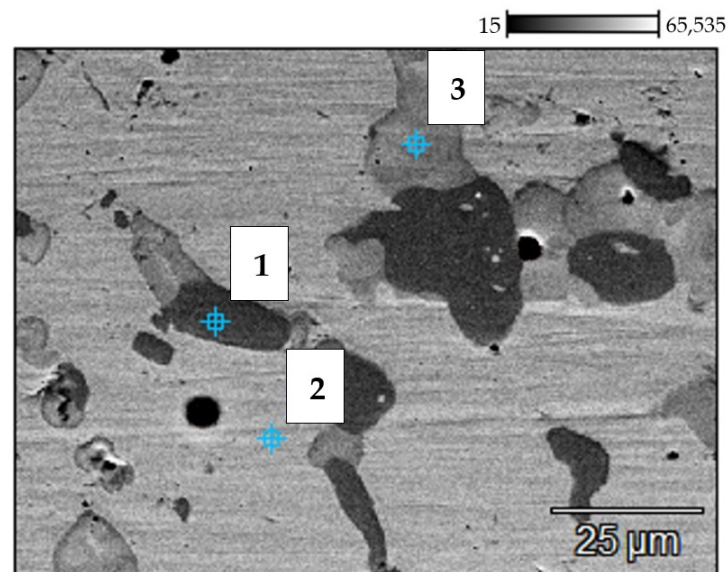
Figure 5. BSE SEM image of the 0.4C-35Cr-45Ni-Nb alloy—service exposed sample’s surface. Numbers indicate the spots of the EDX analysis.

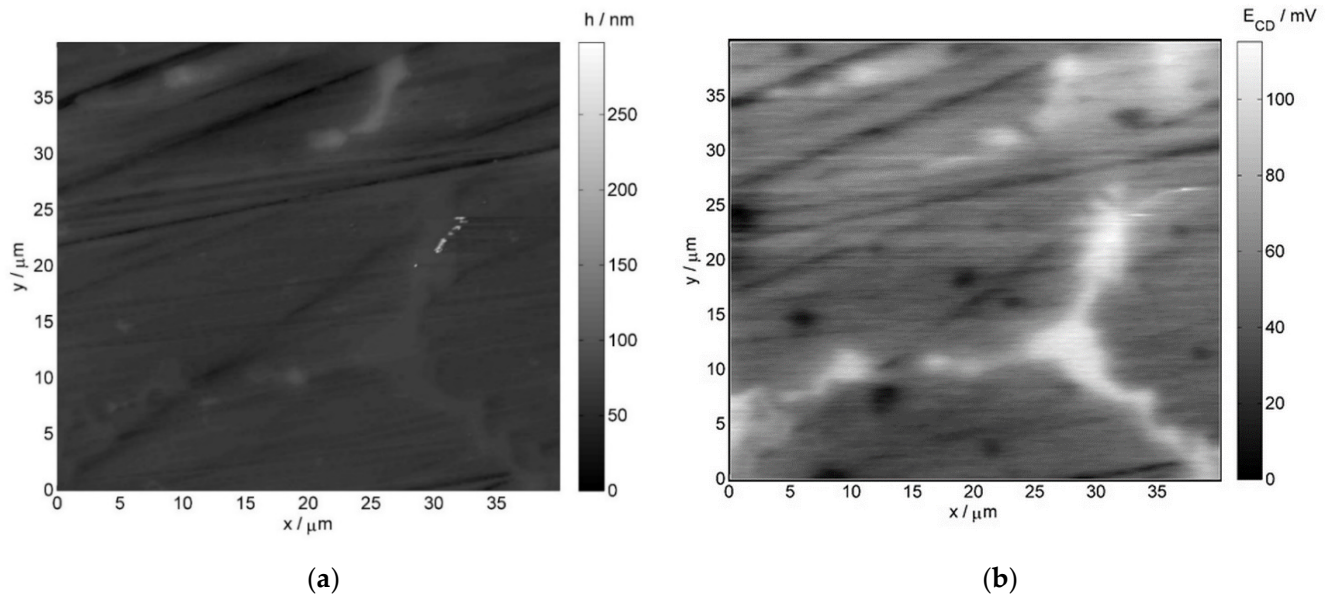
Figure 6. (a) AFM and (b) SKPFM images of the 0.4C-35Cr-45Ni-Nb alloy—non-exposed reference sample's surface.

In case of the non-exposed reference sample, the chromium-rich inclusions (more noble) are present on grain boundaries, which is visible on both the AFM image (brighter elevated regions) and SKPFM image (bright regions indicating higher potential as compared to the matrix)—Figure 6. After the service exposure, niobium-rich phases are clearly resolved on the AFM and SKPFM images (Figure 7). They can be identified as brighter regions on the topographical AFM image, whereas on the SKPFM image, the niobium-rich phases are dark regions due to their lower potential with respect to the matrix. These results are consistent with the EDX measurements presented earlier.

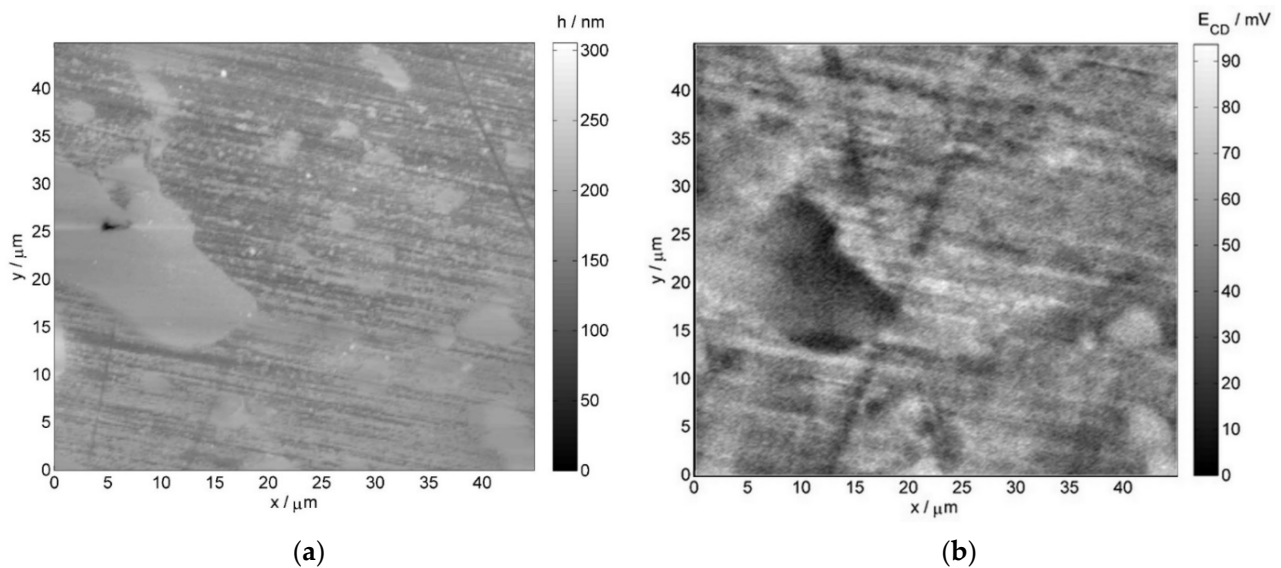
Figure 7. (a) AFM and (b) SKPFM images of the 0.4C-35Cr-45Ni-Nb alloy—service exposed sample's surface.

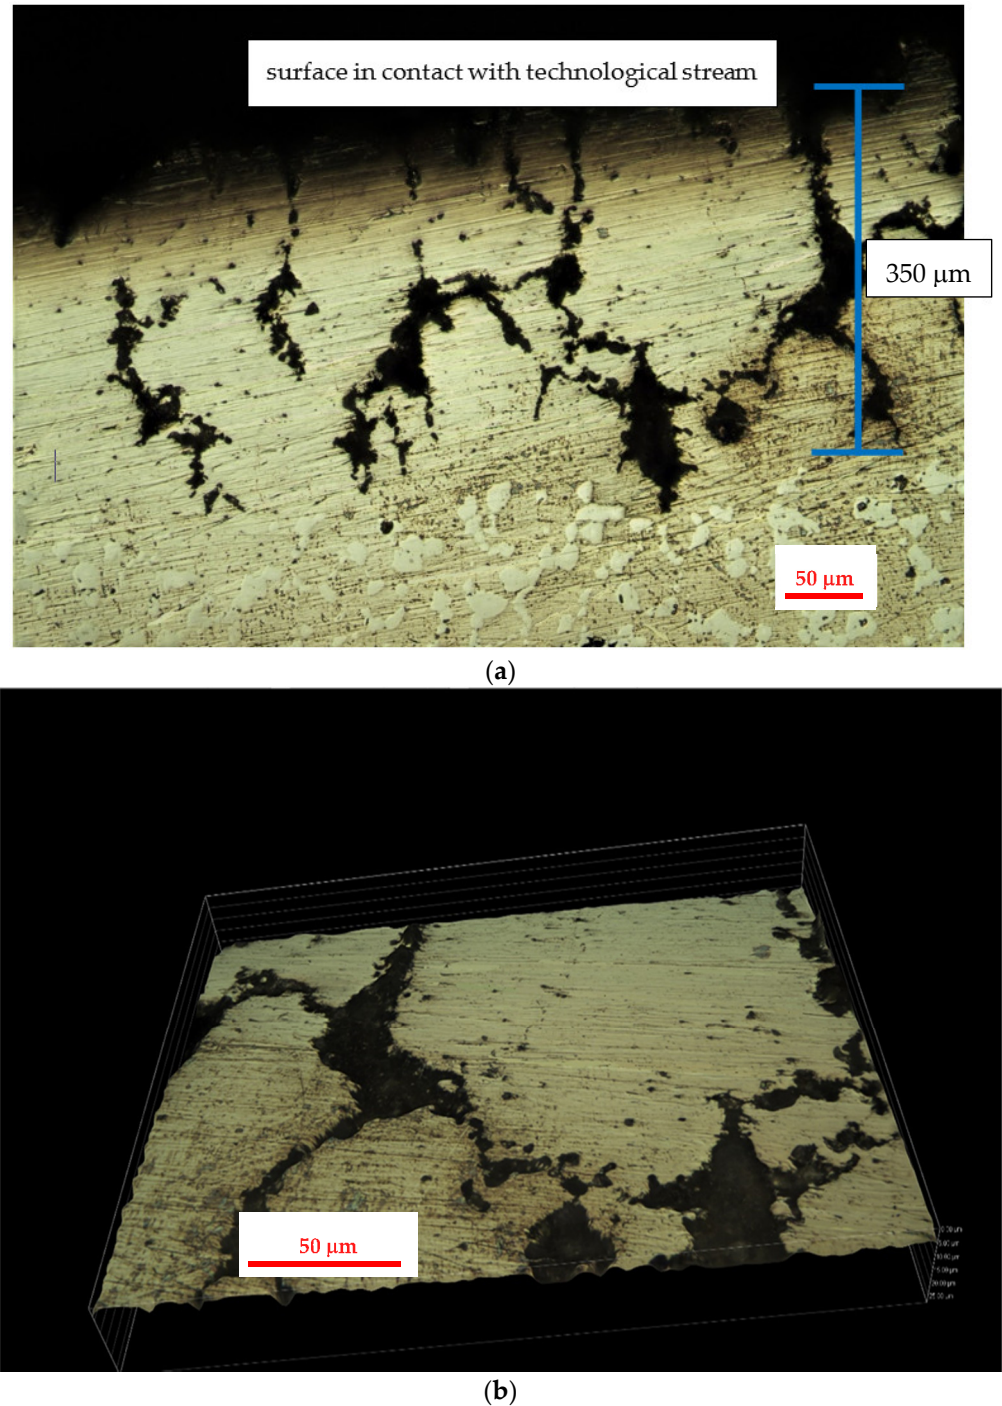
Figure 8. Surface images of the 0.4C-35Cr-45Ni-Nb alloy obtained during metallographic investigations of internal part of service exposed coil tube: (a) internal wall neighboring region; (b) magnification of a fragment of the region presented in (a).

The metallographic investigations show high degradation of the alloy structure in the part of the coil tube. This degradation extends ca. 300 μm from the internal wall to the bulk of the specimen. Visible dark structures are characterized by high amount of silicon and lower content of chromium (spot 1—Figure 9) as compared to the matrix. The presence of a narrow region suffering from dechromization process is also reported in some literature sources [2,12]. Moreover, the degraded zone of the alloy is much more carburized due to the presence of coke, which is formed during thermal degradation of cracked hydrocarbon feeds. Upon service conditions, the internal part of coil tubes can be subjected to metal dusting, although no significant corrosion losses were detected [13,14].

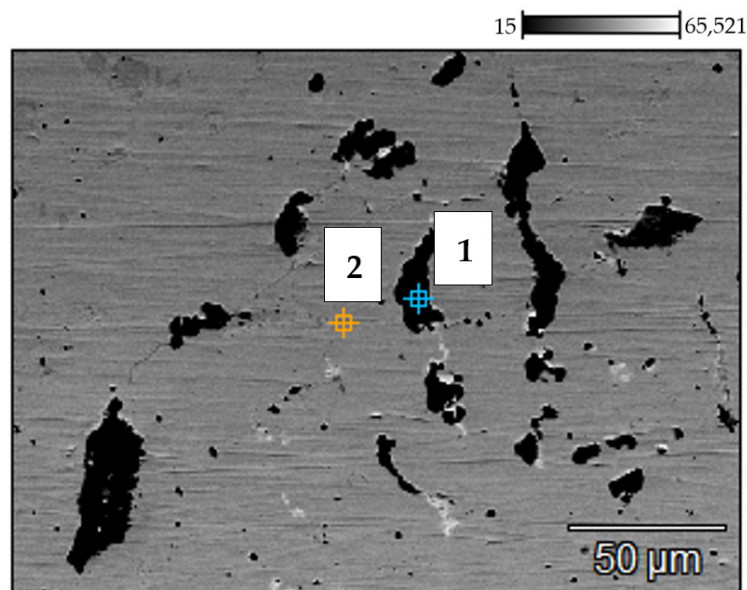
Figure 9. BSE SEM image of the 0.4C-35Cr-45Ni-Nb alloy surface—internal part of the service exposed sample. Numbers indicate the spots of EDX analysis.

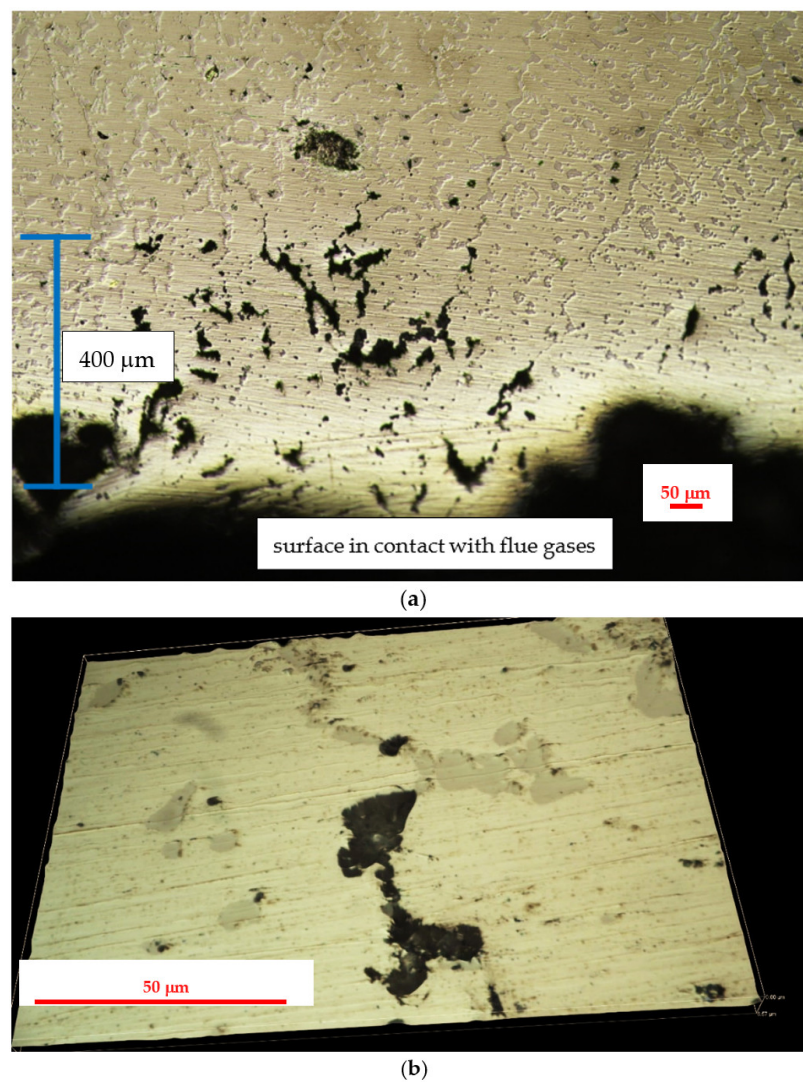
The external part of the coil tube was in contact with the flue gases used for heating of the furnace. In the analyzed case, the fuel consisted of gas hydrocarbons, mainly methane. Oxygen content in the flue gases stream was low, which indicated no risk of the oxidation mechanism [3]. The gas fuel utilized was of high purity, thus eliminating the mechanisms of fuel ash corrosion and flue gas dew point corrosion [3]. High temperature and low content of carbon compounds in the flue gases resulted in decarburization, which is evident on the metallographic images (Figure 10). It occupies a zone of ca. 200 μm , which corresponds to the region with a limited number of carbides [11]. The entire zone of significant structural degradation covers 400 μm .

Figure 10. Surface images of the 0.4C-35Cr-45Ni-Nb alloy obtained during metallographic investigations of external part of service exposed coil tube: (a) external wall neighboring region; (b) magnification of a fragment of the region presented in (a).

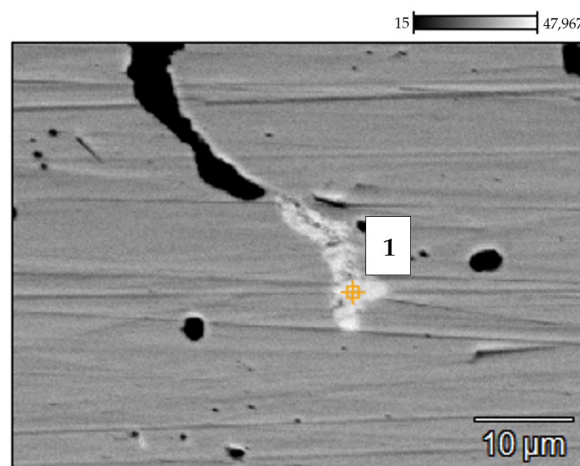
Figure 11. BSE SEM image of the 0.4C-35Cr-45Ni-Nb alloy surface—external part of the service exposed sample. The number indicates the spot of the EDX analysis.

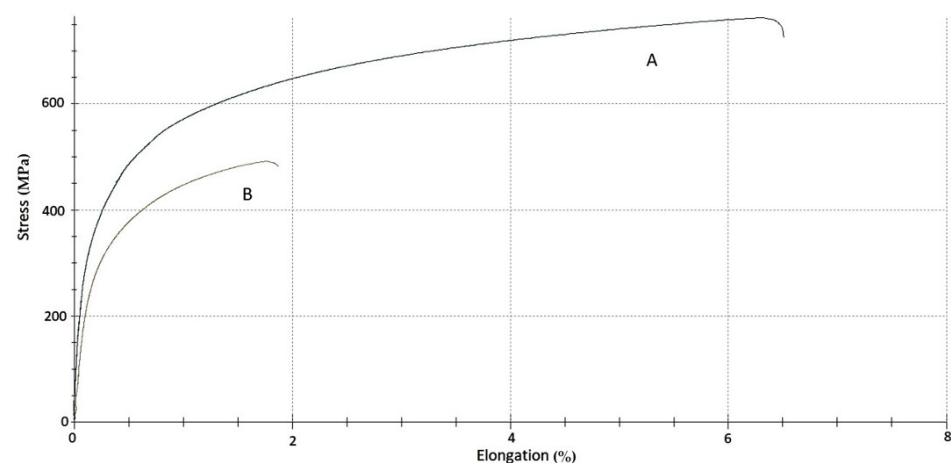
**Figure 12.** Results of mechanical tests of: (A) non-exposed reference sample; (B) service exposed sample.

The mechanical investigations revealed significant changes of the mechanical properties of the service exposed sample as compared to the reference material. Deterioration of plastic properties of the alloy is evident. The ultimate elongation of the exposed material decreased by more than three times compared to the non-exposed reference specimen. The maximum tensile stress also decreased by ca. 10%. Substantial deterioration of the mechanical properties is probably associated with the process of hydrogen and methane bubbles formation inside the alloy structure due to corrosion processes. Indisputably, it is a dangerous phenomenon (with potential negative influence on impact strength), which calls for more detailed investigation.
