# Investigation of the 0.4C-35Cr-45Ni-Nb Alloy after Service in High-Temperature Steam and Hydrocarbons Environment

**Abstract:** The paper presents the results of investigation of the 0.4C-35Cr-45Ni-Nb alloy, which operated in the cracked hydrocarbon feeds and dilution steam at 1125 °C. The material originated from the pyrolytic furnace coil tubes, of which internal walls were in contact with the aforementioned medium, whereas the external walls were in contact with the flue gases. The examination included metallographic and mechanical tests on the material after service exposure, the results of which were compared with the ones obtained for the as-received non-exposed specimens. The metallographic tests revealed changes in the alloy's structure manifested by formation of significant amount of the carbides due to carburization of the alloy from the steam and cracked hydrocarbon feeds side. The central and external parts of the alloy samples (having no contact with the process medium) underwent substantial degradation but within a relatively narrow zone of the material. The investigations of hydrogen and methane content in the alloy showed a high amount of these gases, resulting f

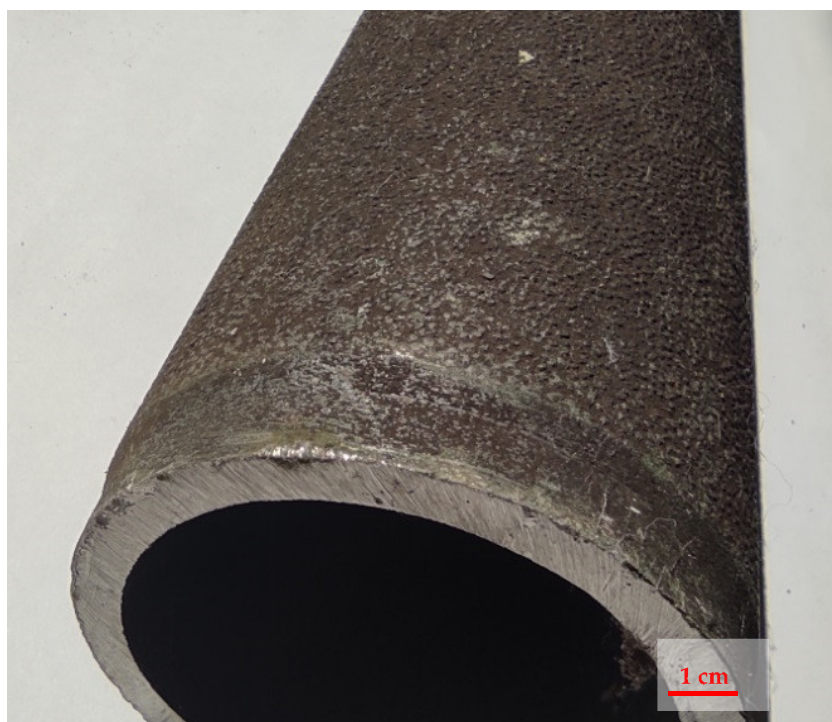
**Figure 2.** Pyrolytic furnace's coil tube subjected to investigation.

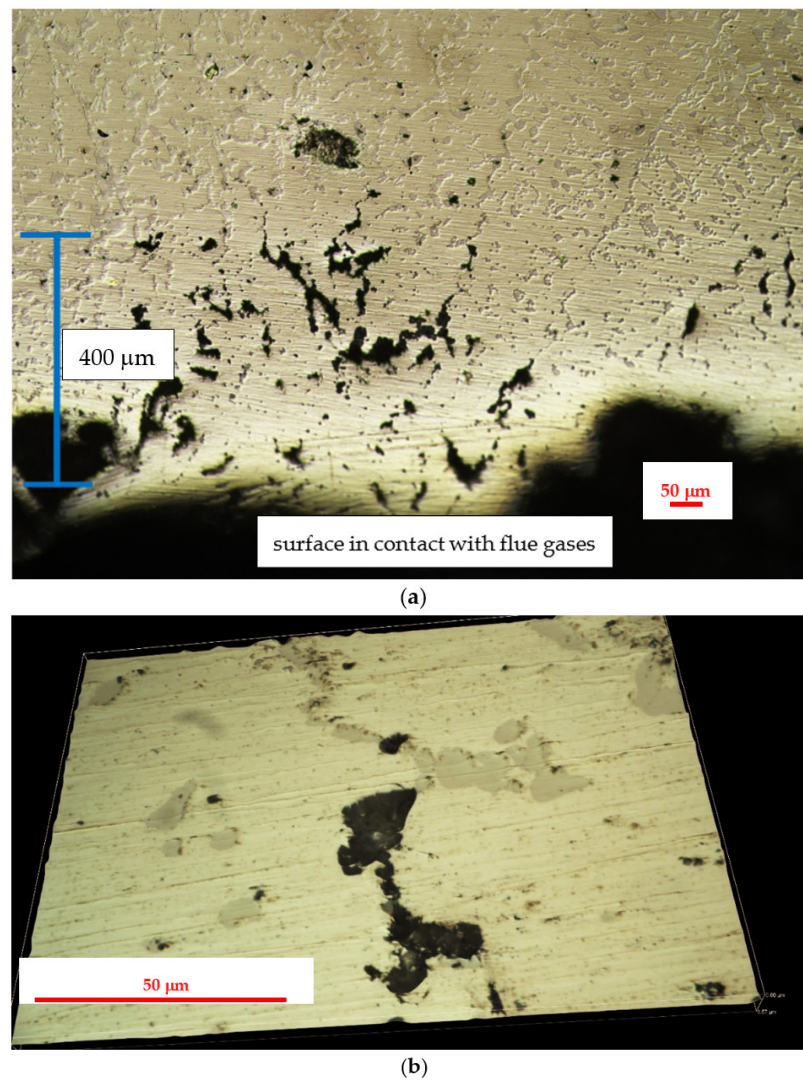
The external part of the coil tube was in contact with the flue gases used for heating of the furnace. In the analyzed case, the fuel consisted of gas hydrocarbons, mainly methane. Oxygen content in the flue gases stream was low, which indicated no risk of the oxidation mechanism [3]. The gas fuel utilized was of high purity, thus eliminating the mechanisms of fuel ash corrosion and flue gas dew point corrosion [3]. High temperature and low content of carbon compounds in the flue gases resulted in decarburization, which is evident on the metallographic images (Figure 10). It occupies a zone of ca. 200  $\mu\text{m}$ , which corresponds to the region with a limited number of carbides [11]. The entire zone of significant structural degradation covers 400  $\mu\text{m}$ .

**Figure 10.** Surface images of the 0.4C-35Cr-45Ni-Nb alloy obtained during metallographic investigations of external part of service exposed coil tube: (a) external wall neighboring region; (b) magnification of a fragment of the region presented in (a).

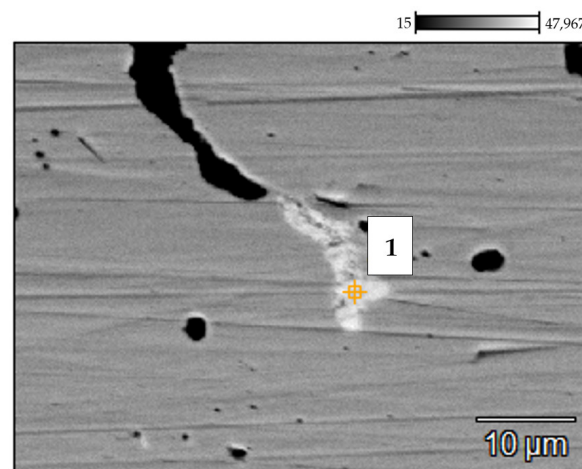
**Figure 11.** BSE SEM image of the 0.4C-35Cr-45Ni-Nb alloy surface—external part of the service exposed sample. The number indicates the spot of the EDX analysis.
