# Investigation of the 0.4C-35Cr-45Ni-Nb Alloy after Service in High-Temperature Steam and Hydrocarbons Environment

**Abstract:** The paper presents the results of investigation of the 0.4C-35Cr-45Ni-Nb alloy, which operated in the cracked hydrocarbon feeds and dilution steam at 1125 °C. The material originated from the pyrolytic furnace coil tubes, of which internal walls were in contact with the aforementioned medium, whereas the external walls were in contact with the flue gases. The examination included metallographic and mechanical tests on the material after service exposure, the results of which were compared with the ones obtained for the as-received non-exposed specimens. The metallographic tests revealed changes in the alloy's structure manifested by formation of significant amount of the carbides due to carburization of the alloy from the steam and cracked hydrocarbon feeds side. The central and external parts of the alloy samples (having no contact with the process medium) underwent substantial degradation but within a relatively narrow zone of the material. The investigations of hydrogen and methane content in the alloy showed a high amount of these gases, resulting f

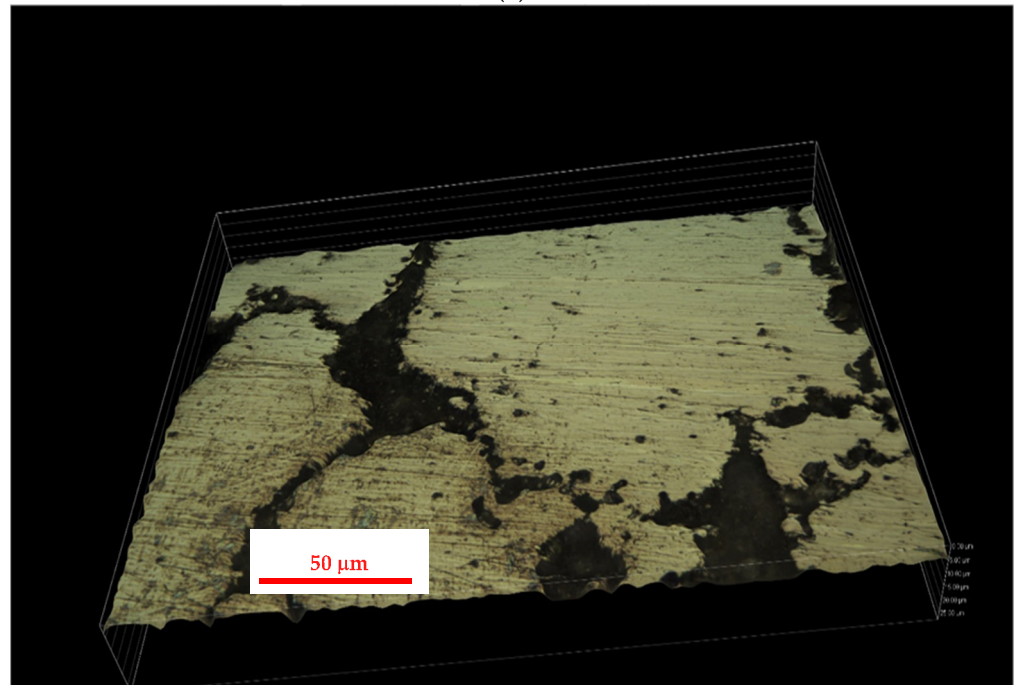
**Figure 8.** Surface images of the 0.4C-35Cr-45Ni-Nb alloy obtained during metallographic investigations of internal part of service exposed coil tube: (a) internal wall neighboring region; (b) magnification of a fragment of the region presented in (a).

The metallographic investigations show high degradation of the alloy structure in the part of the coil tube. This degradation extends ca. 300  $\mu\text{m}$  from the internal wall to the bulk of the specimen. Visible dark structures are characterized by high amount of silicon and lower content of chromium (spot 1—Figure 9) as compared to the matrix. The presence of a narrow region suffering from dechromization process is also reported in some literature sources [2,12]. Moreover, the degraded zone of the alloy is much more carburized due to the presence of coke, which is formed during thermal degradation of cracked hydrocarbon feeds. Upon service conditions, the internal part of coil tubes can be subjected to metal dusting, although no significant corrosion losses were detected [13,14].

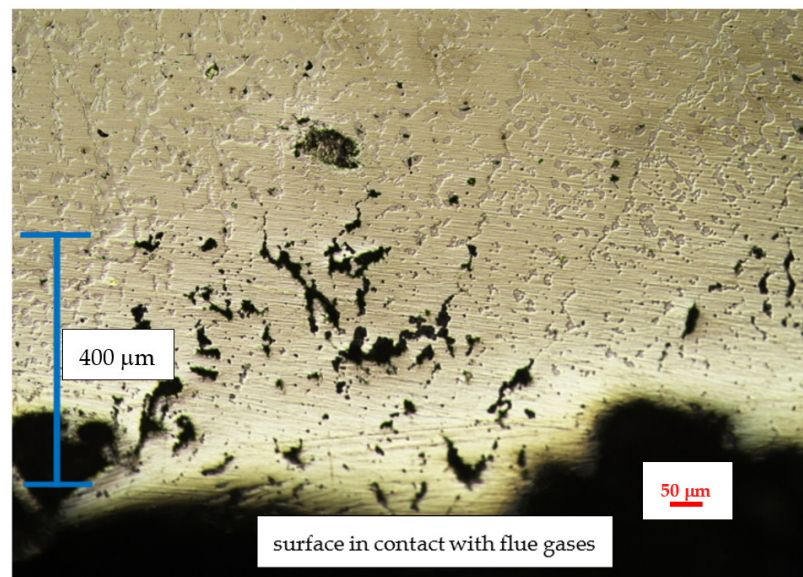
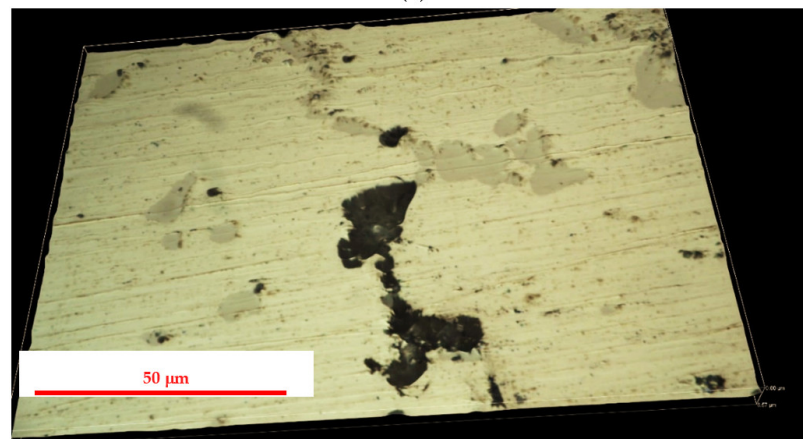
The external part of the coil tube was in contact with the flue gases used for heating of the furnace. In the analyzed case, the fuel consisted of gas hydrocarbons, mainly methane. Oxygen content in the flue gases stream was low, which indicated no risk of the oxidation mechanism [3]. The gas fuel utilized was of high purity, thus eliminating the mechanisms of fuel ash corrosion and flue gas dew point corrosion [3]. High temperature and low content of carbon compounds in the flue gases resulted in decarburization, which is evident on the metallographic images (Figure 10). It occupies a zone of ca. 200  $\mu\text{m}$ , which corresponds to the region with a limited number of carbides [11]. The entire zone of significant structural degradation covers 400  $\mu\text{m}$ .

**Figure 10.** Surface images of the 0.4C-35Cr-45Ni-Nb alloy obtained during metallographic investigations of external part of service exposed coil tube: (a) external wall neighboring region; (b) magnification of a fragment of the region presented in (a).

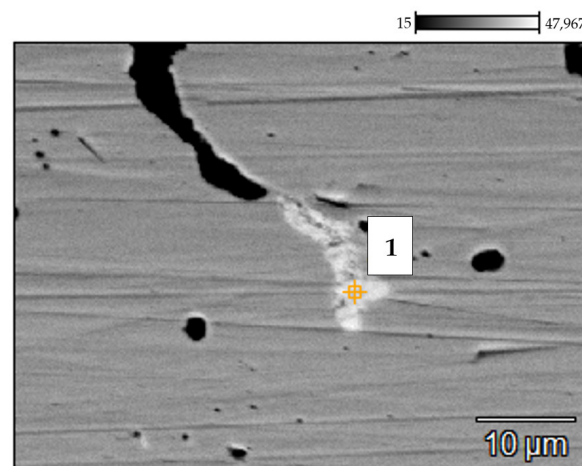
**Figure 11.** BSE SEM image of the 0.4C-35Cr-45Ni-Nb alloy surface—external part of the service exposed sample. The number indicates the spot of the EDX analysis.
