Building modernization located in the conservation protection zone in the aspect of technical conditions

Maciej NIEDOSTATKIEWICZ*¹

Abstract

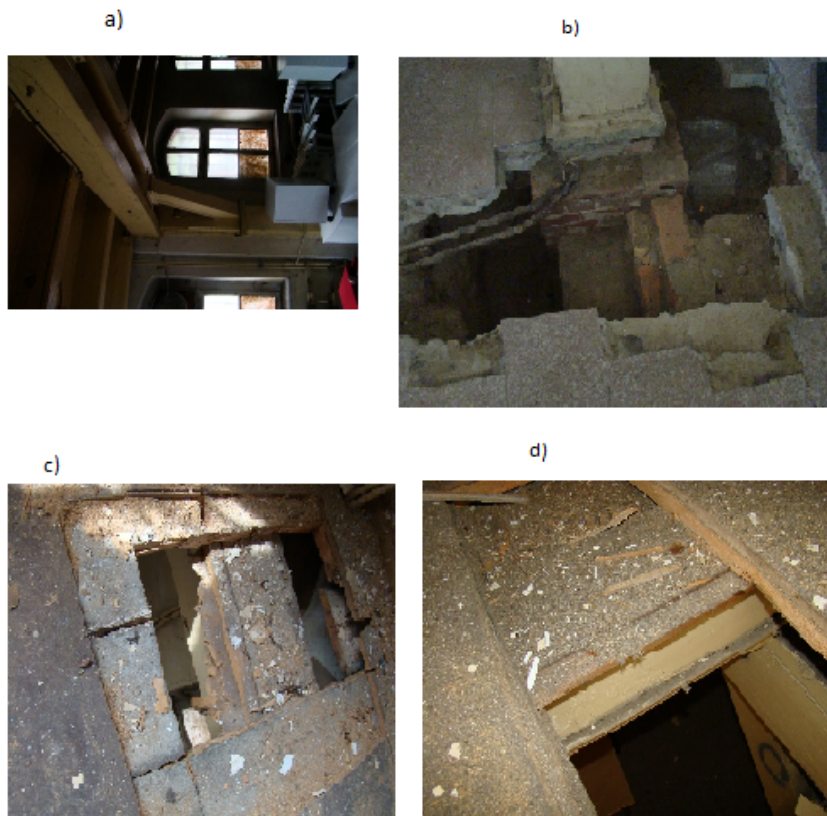
Figure 7. Building planned for modernization ceiling above the ground floor: a) fragment of the wooden frame, b) foundation of the column, c), d) structure of the stop

Wooden posts and wooden bolts on the ground floor level showed numerous scratches, delamination and cracks (Fig. 7a). The dimensions of the wooden poles in the cross-section were 32x32 cm, the transoms were made as two-branch transoms from beams 2x15x31 cm. The foundation of the columns on a brick foundation (Figure 7b) was to ensure the vertical non-deformability of the wooden structure. Stiffening of the structure of wooden frames was provided by swords measuring 15x35 cm. Wooden ceiling beams with dimensions of 15.5x28 cm were spaced from 65 to 80 cm. The ceiling above the ground floor was made of wooden naked. In the outcrops, it was found that the floor beams were made of 3.8 cm thick boards (Fig. 7c and Fig. 7d). On a part of the ceiling, additionally, during the period of operation, a hard-type fibreboard with a thickness of 0.5 cm was impaled on the boards.

The wooden beams of the ceilings above the ground floor, first and second floors had locally visible traces of larvae and insect feeding. Damage of this type occurred in the level of all inter-story ceilings and was caused by the lack of protection of wooden elements during the building's operation period against the action of technical wood pests.
